# Structure Maintenance & Investigations Load Rating Summary Sheet

Bridge Number: 27C0008  
 Facility Carried: MEADOW WAY  
 Location: IN FAIRFAX  
 City: FAIRFAX

Bridge Name: <u>SAN ANSELMO CREEK</u>						
Structural Element <u>All girders</u>						
Rated:						
Rating Summary						
<b>DESIGN LOADING</b>			<b>Critical Location</b>			
	Rating Factor	Metric Tons	Structure	Control Element	Load Action	Location
Inventory:	0.41	13.3	Span 3,4	Girder	Allowable Moment	0.5pt of Span 3,4 Interior Girders
Operating:	0.57	18.5	Span 3,4	Girder	Allowable Moment	0.5pt of Span 3,4 Interior Girders
<b>LEGAL RATING</b>		Posting U.S. Tons				
Type 3 (25T):	0.72	18	Span 3,4	Girder	Allowable Moment	0.4&0.6pt of Span 3,4 Interior Girders
Type 3S2 (36T):	0.80	28	Span 3,4	Girder	Allowable Moment	0.4&0.6pt of Span 3,4 Interior Girders
Type 3-3 (40T):	0.88	35	Span 3,4	Girder	Allowable Moment	0.4&0.6pt of Span 3,4 Interior Girders
<b>PERMIT RATING</b>		Permit Rating				
5 Axle Truck :	0.53	X	Span 3,4	Girder	Allowable Moment	0.4&0.6pt of Span 3,4 Interior Girders
7 Axle Truck :	0.53	X	Span 3,4	Girder	Allowable Moment	0.4&0.6pt of Span 3,4 Interior Girders

## Bridge Inspection Report

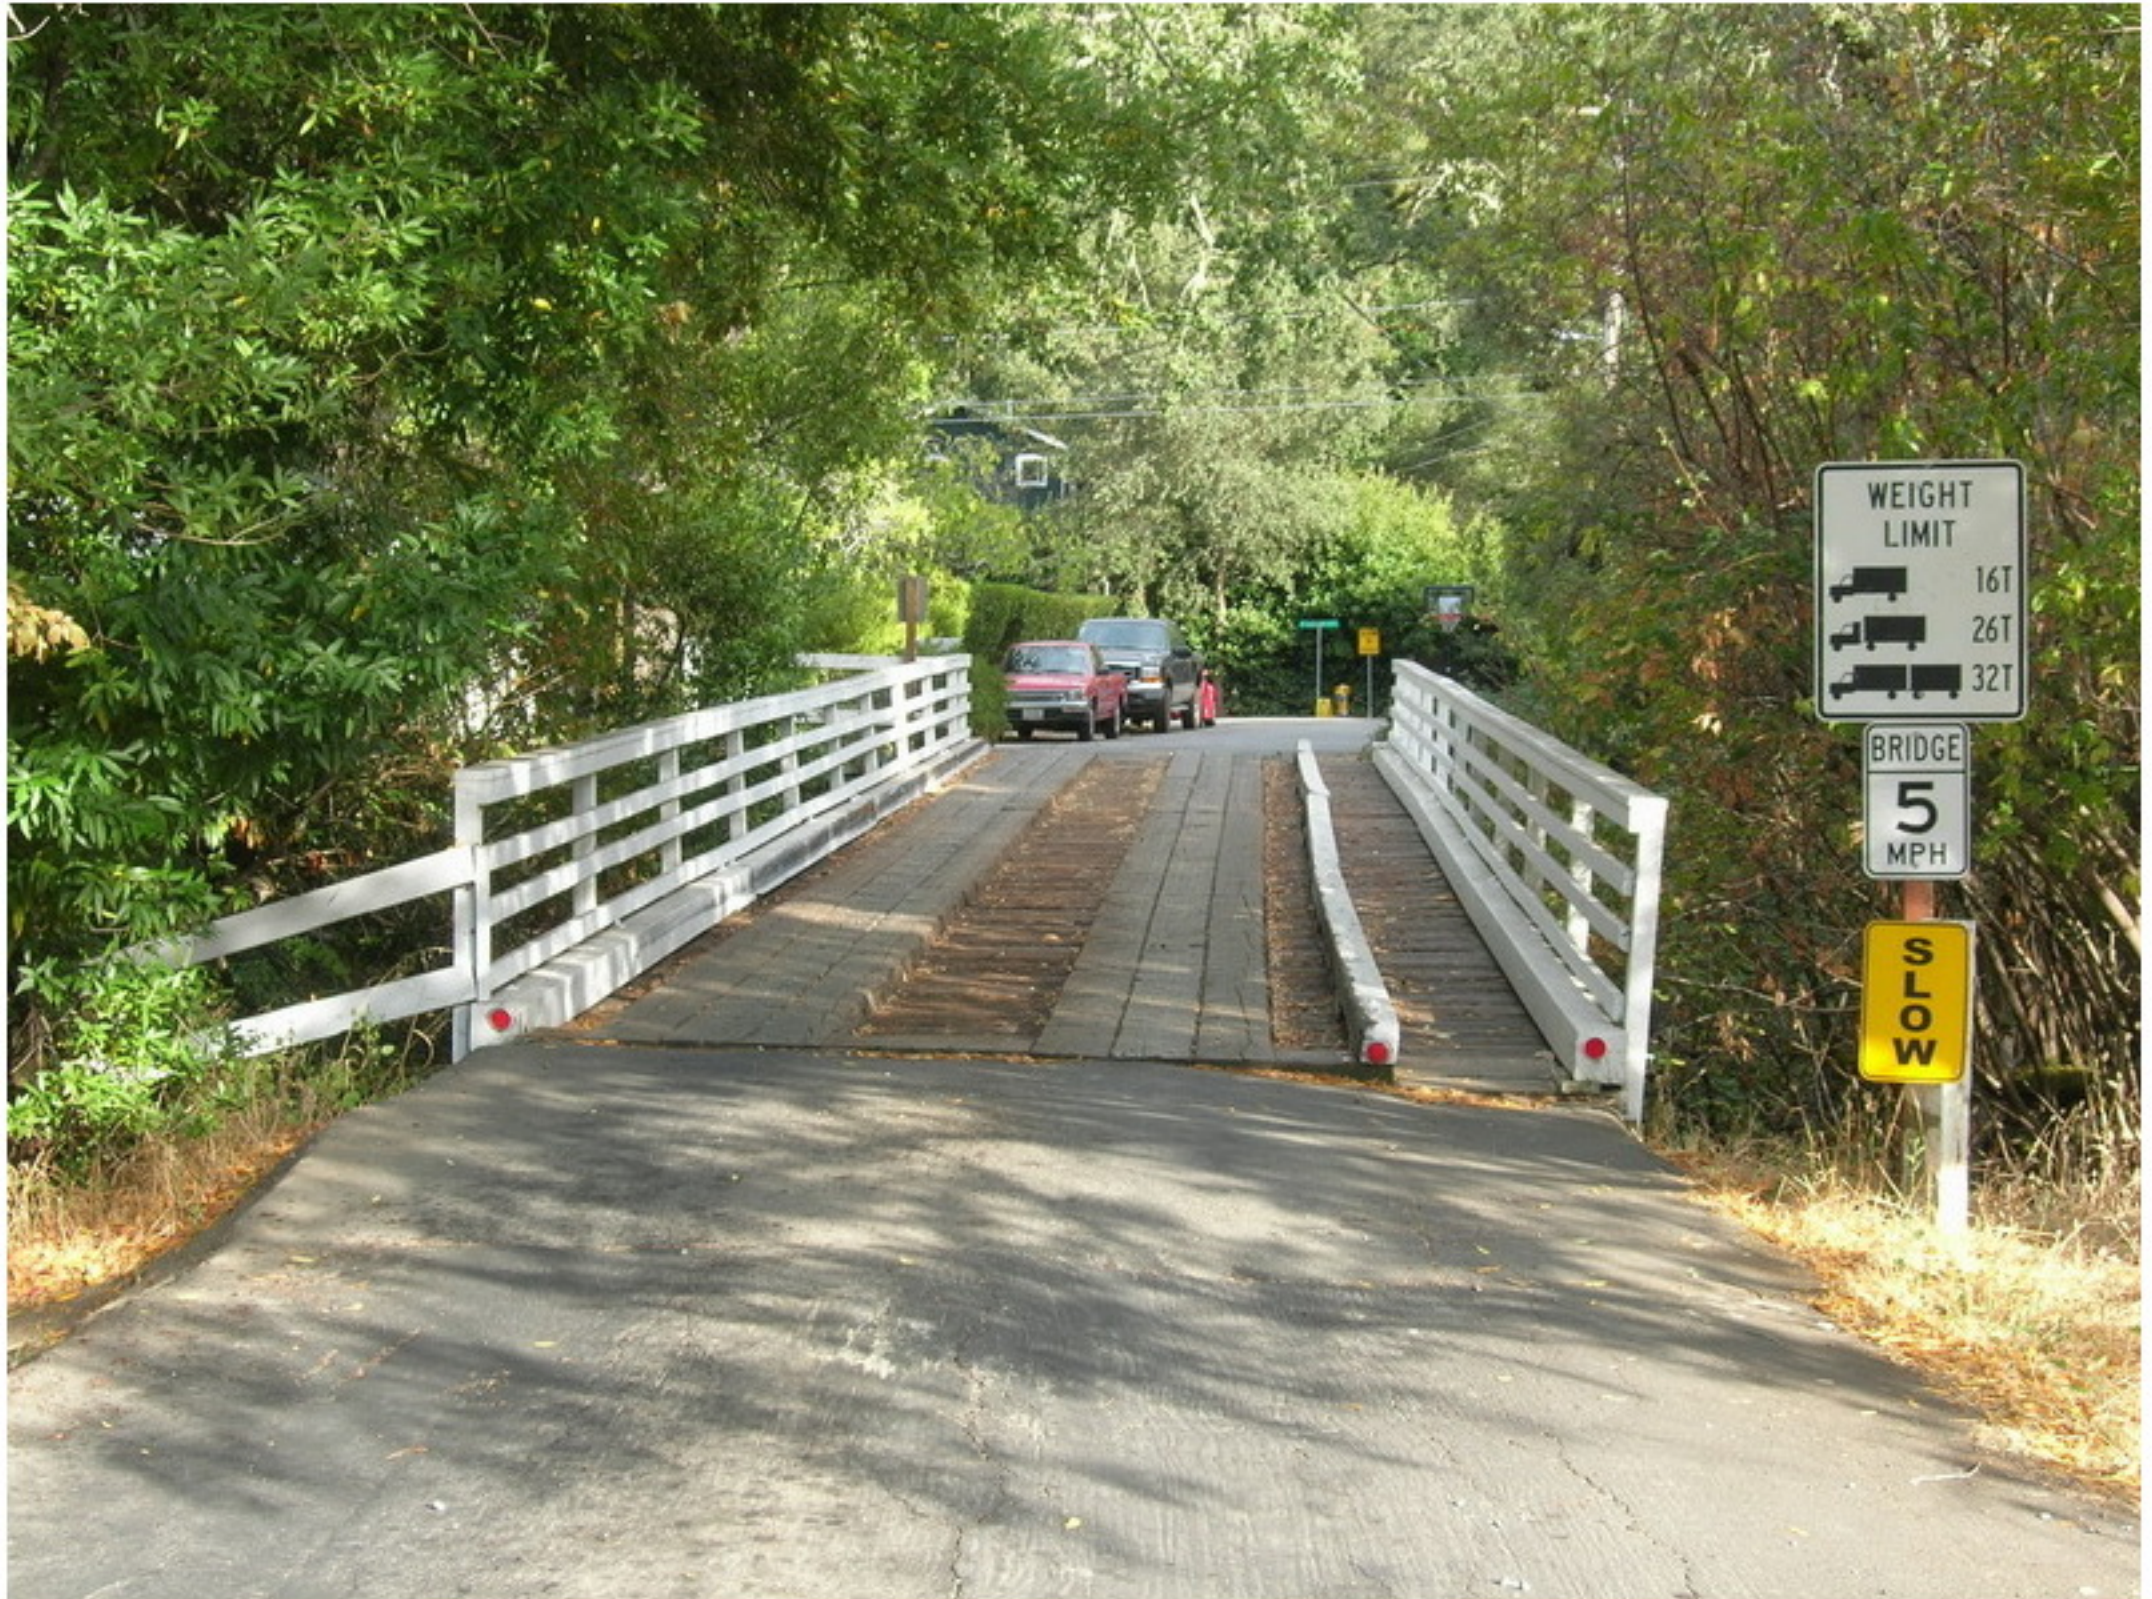
Photo No. 1  
Roadway looking east.

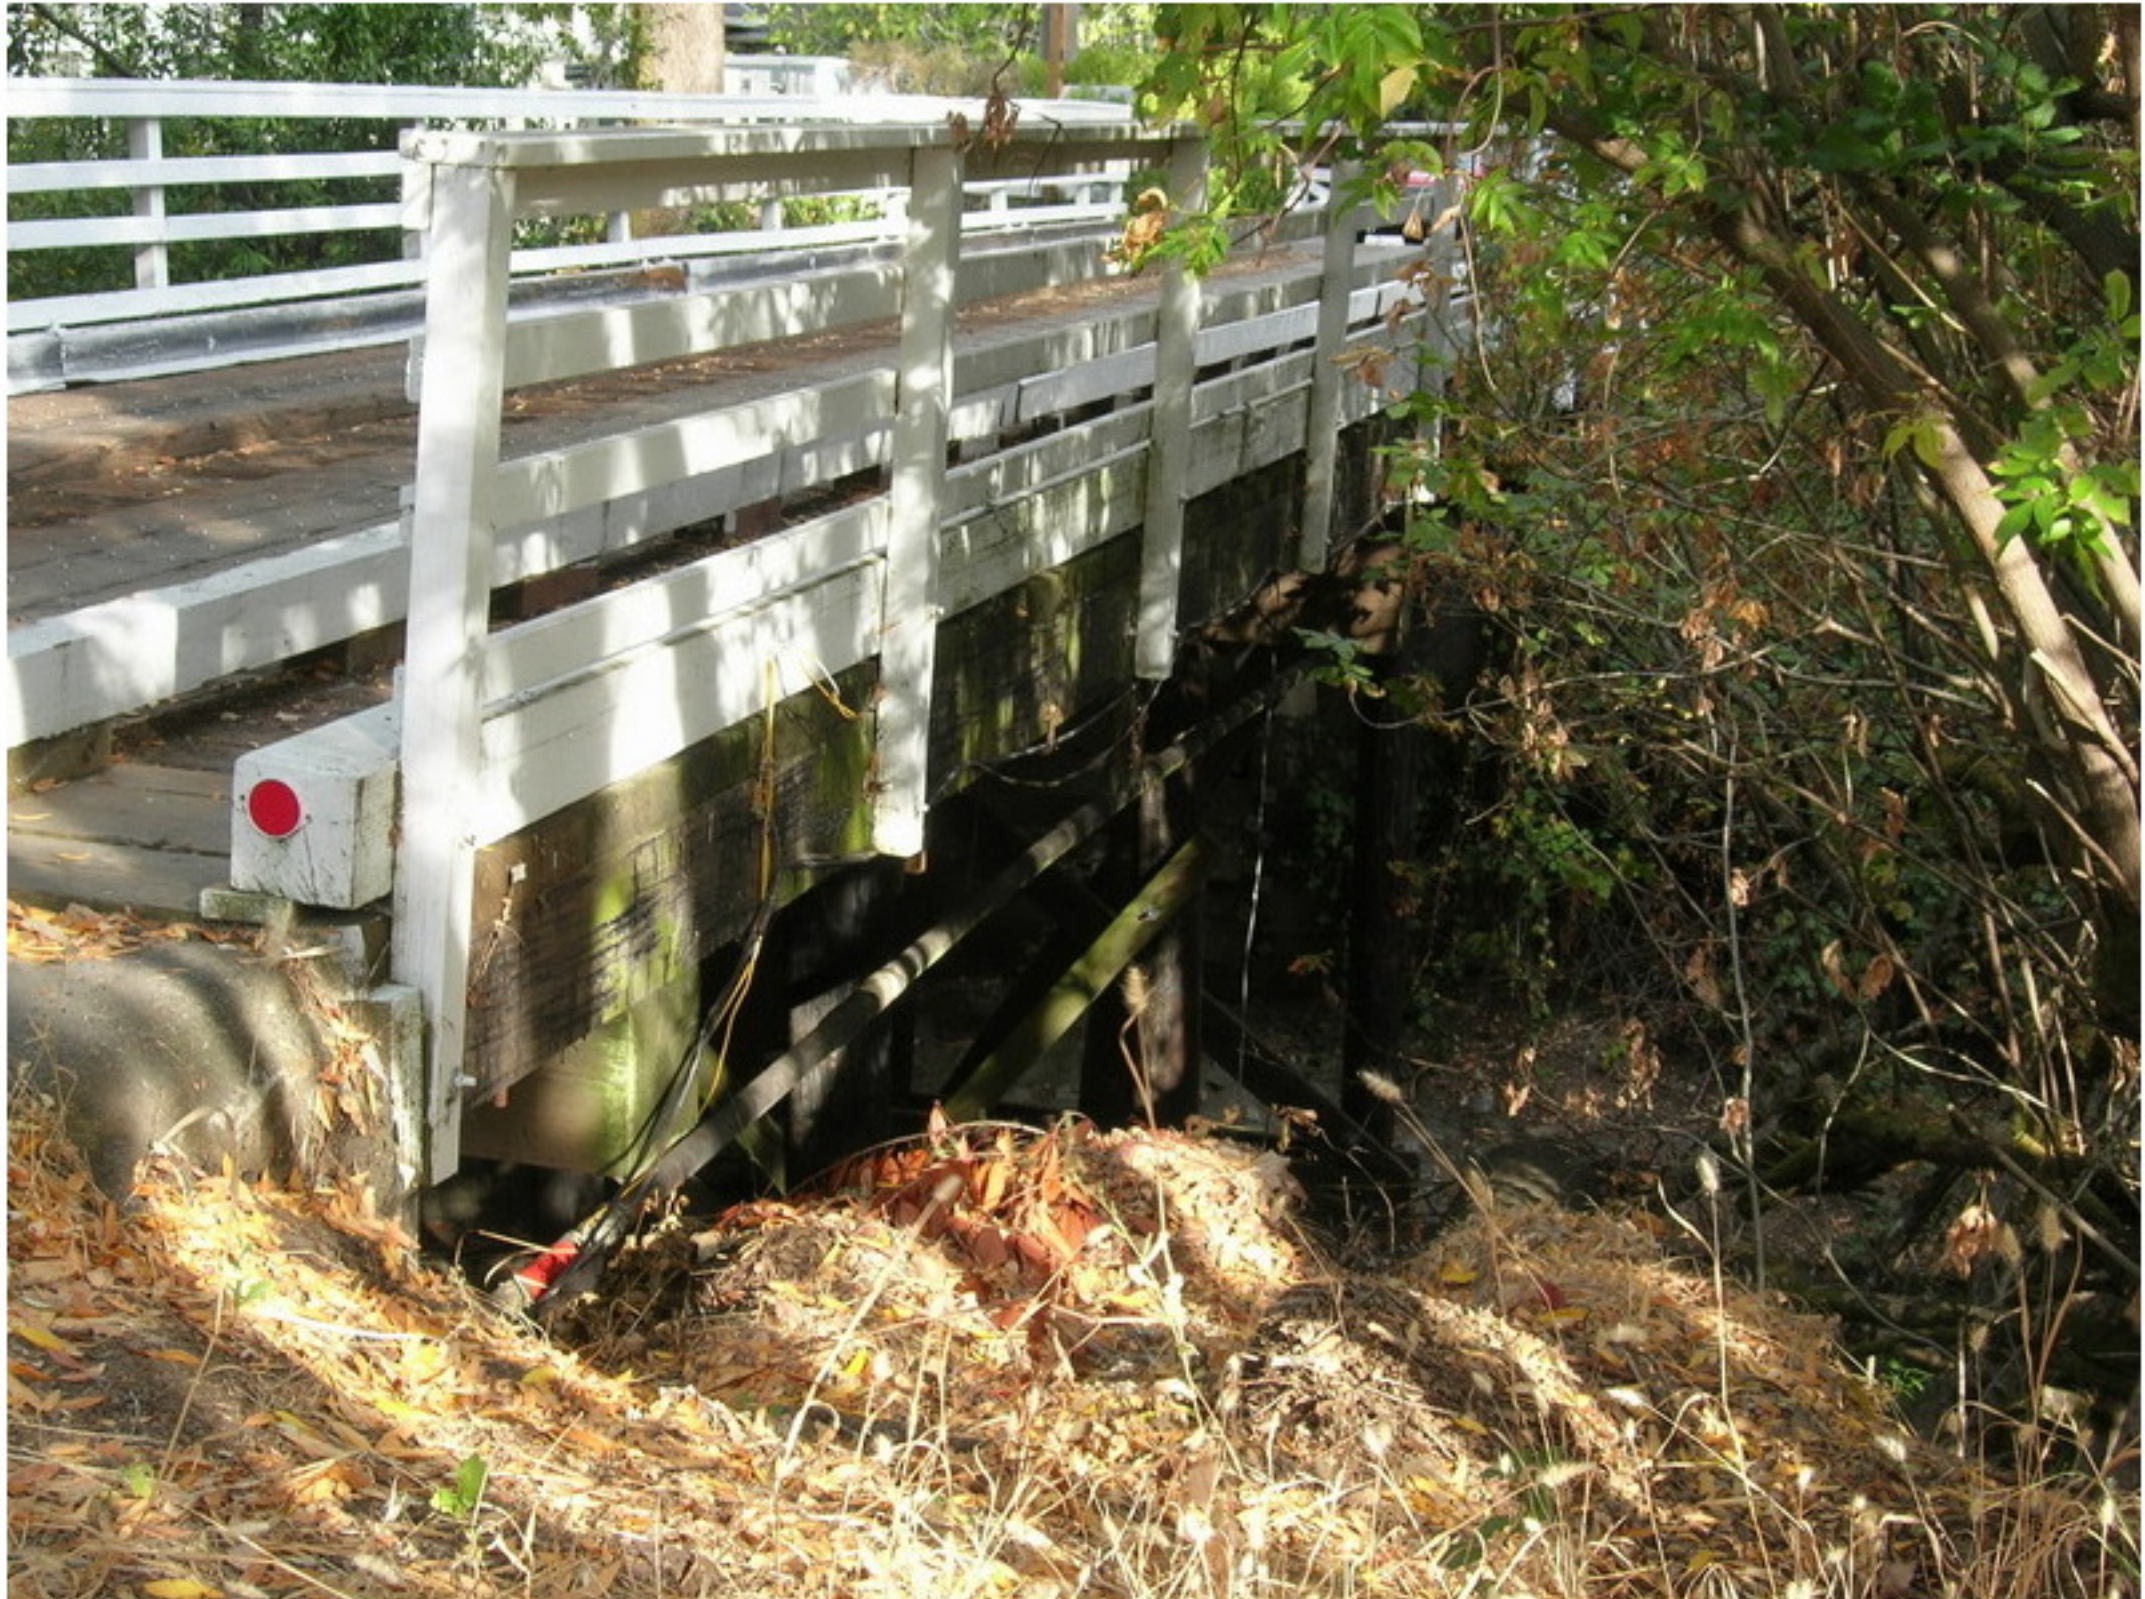
Photo No. 2  
Elevation looking north.

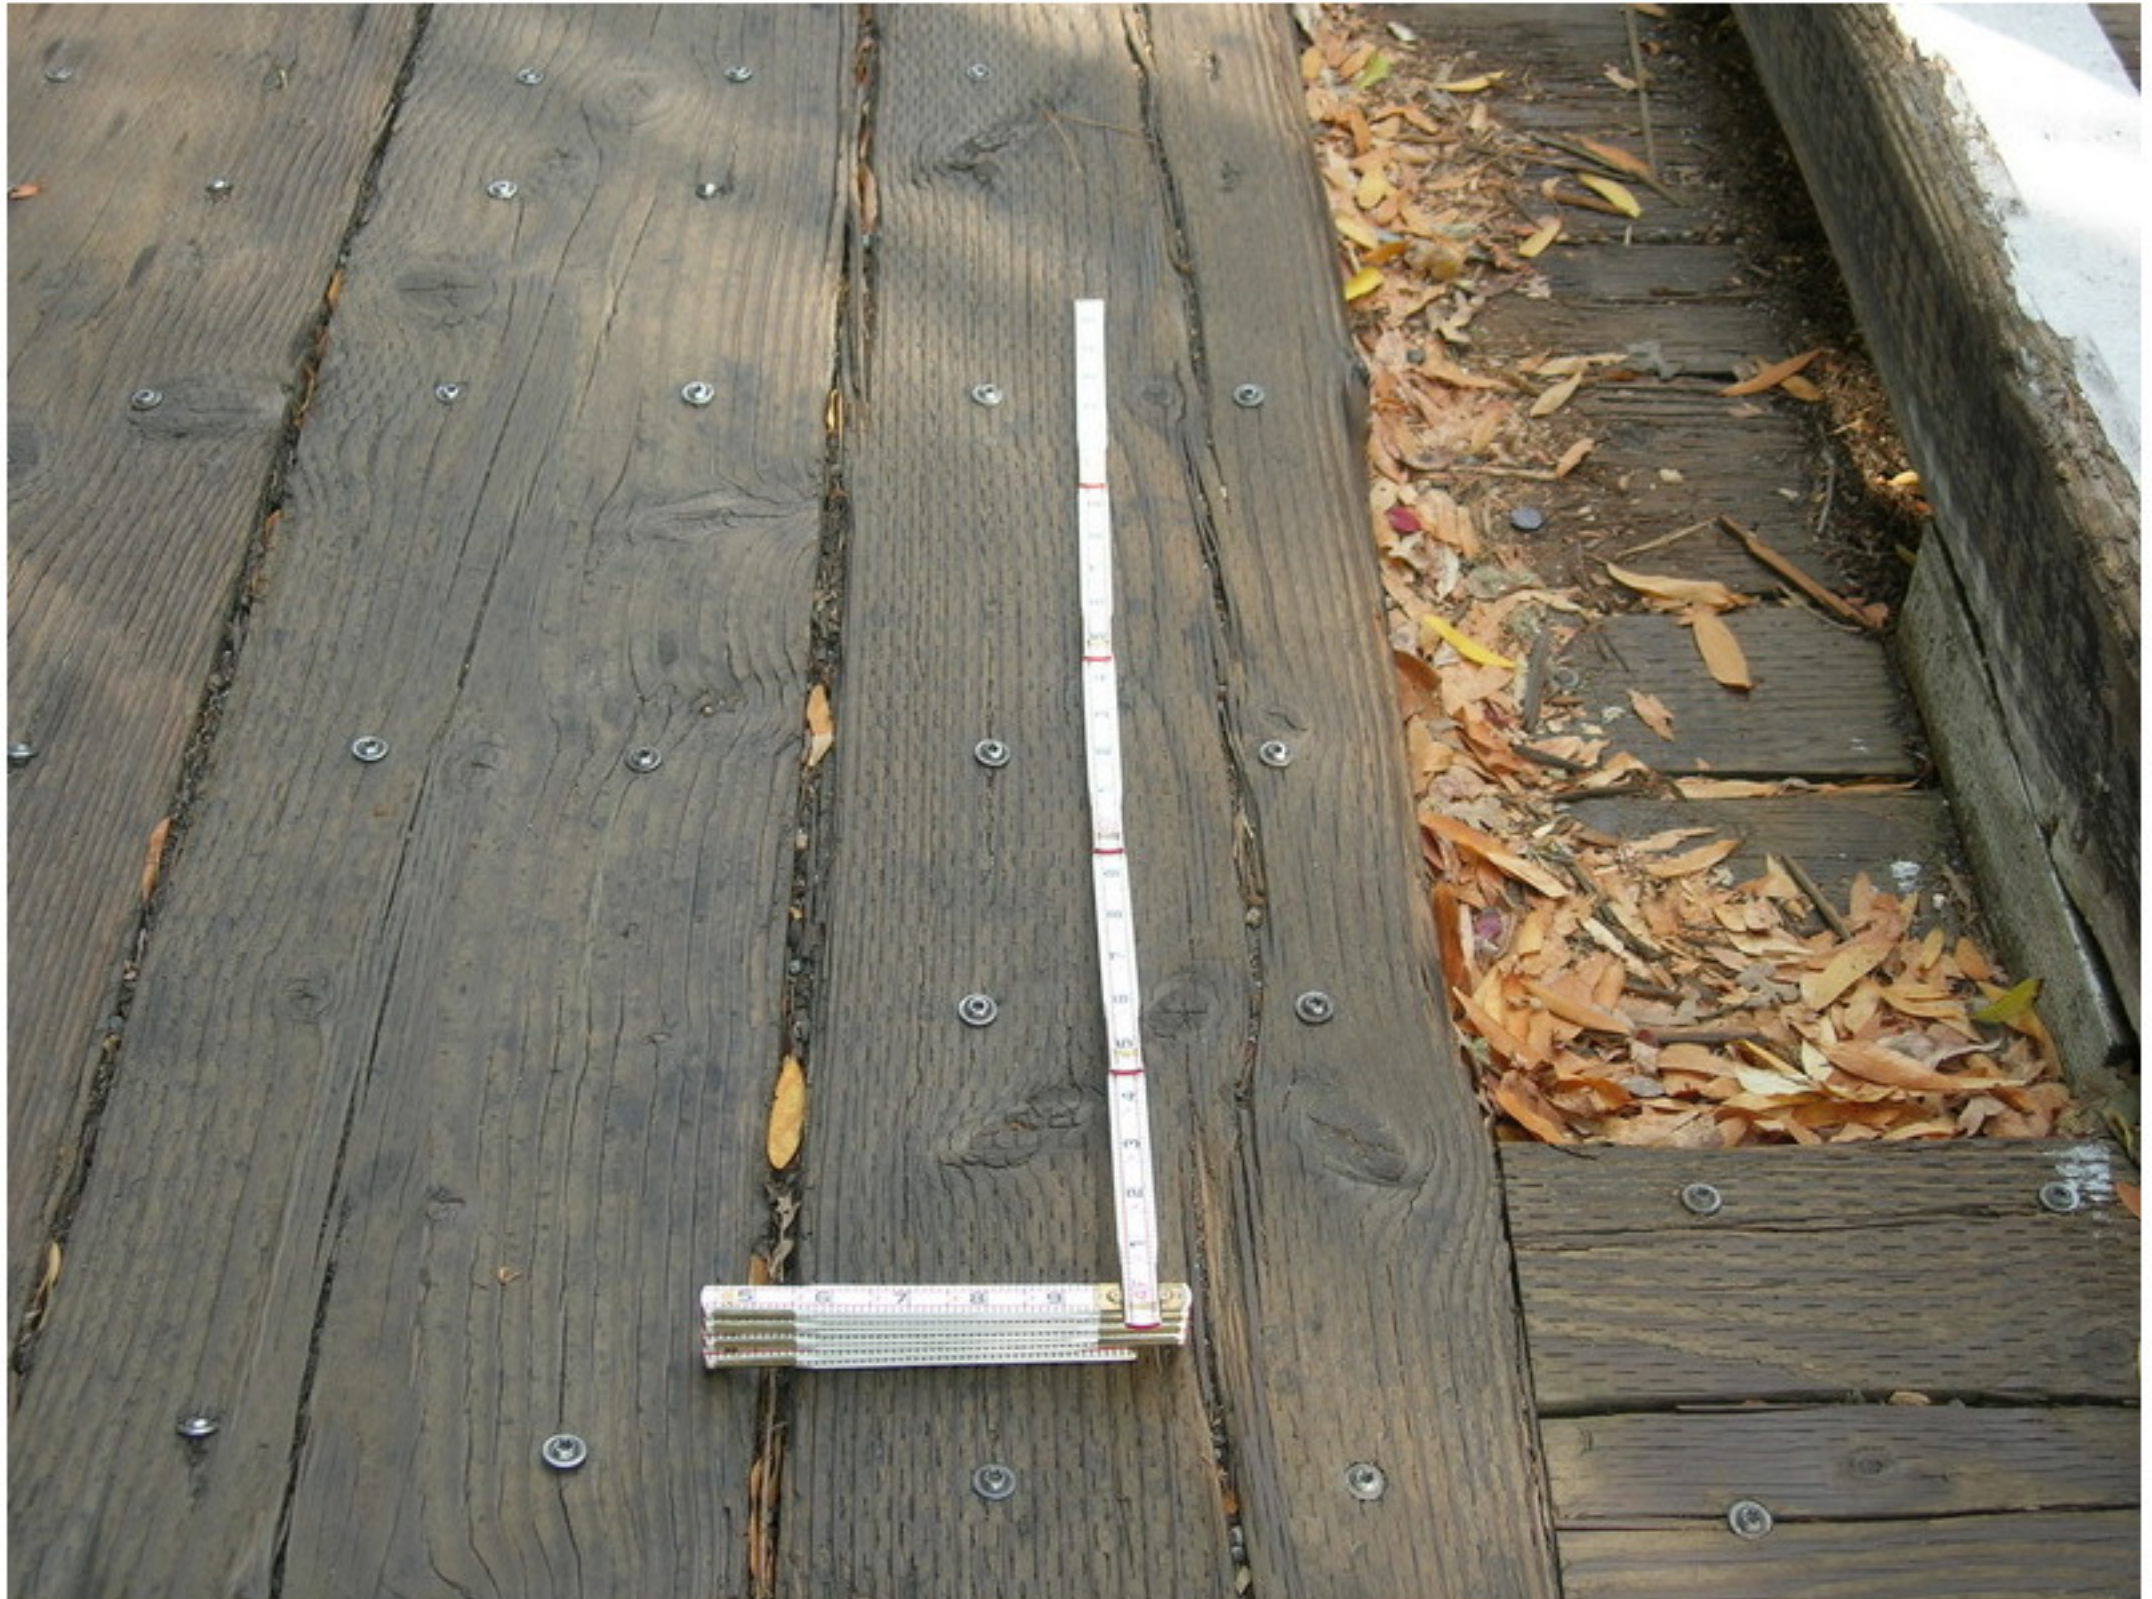
Photo No. 3  
Deck runner planks split.

1. Thirty percent (30%) of the deck runner planks have split. See photo 3.
2. The timber rails were inspected and they are generally in good condition.

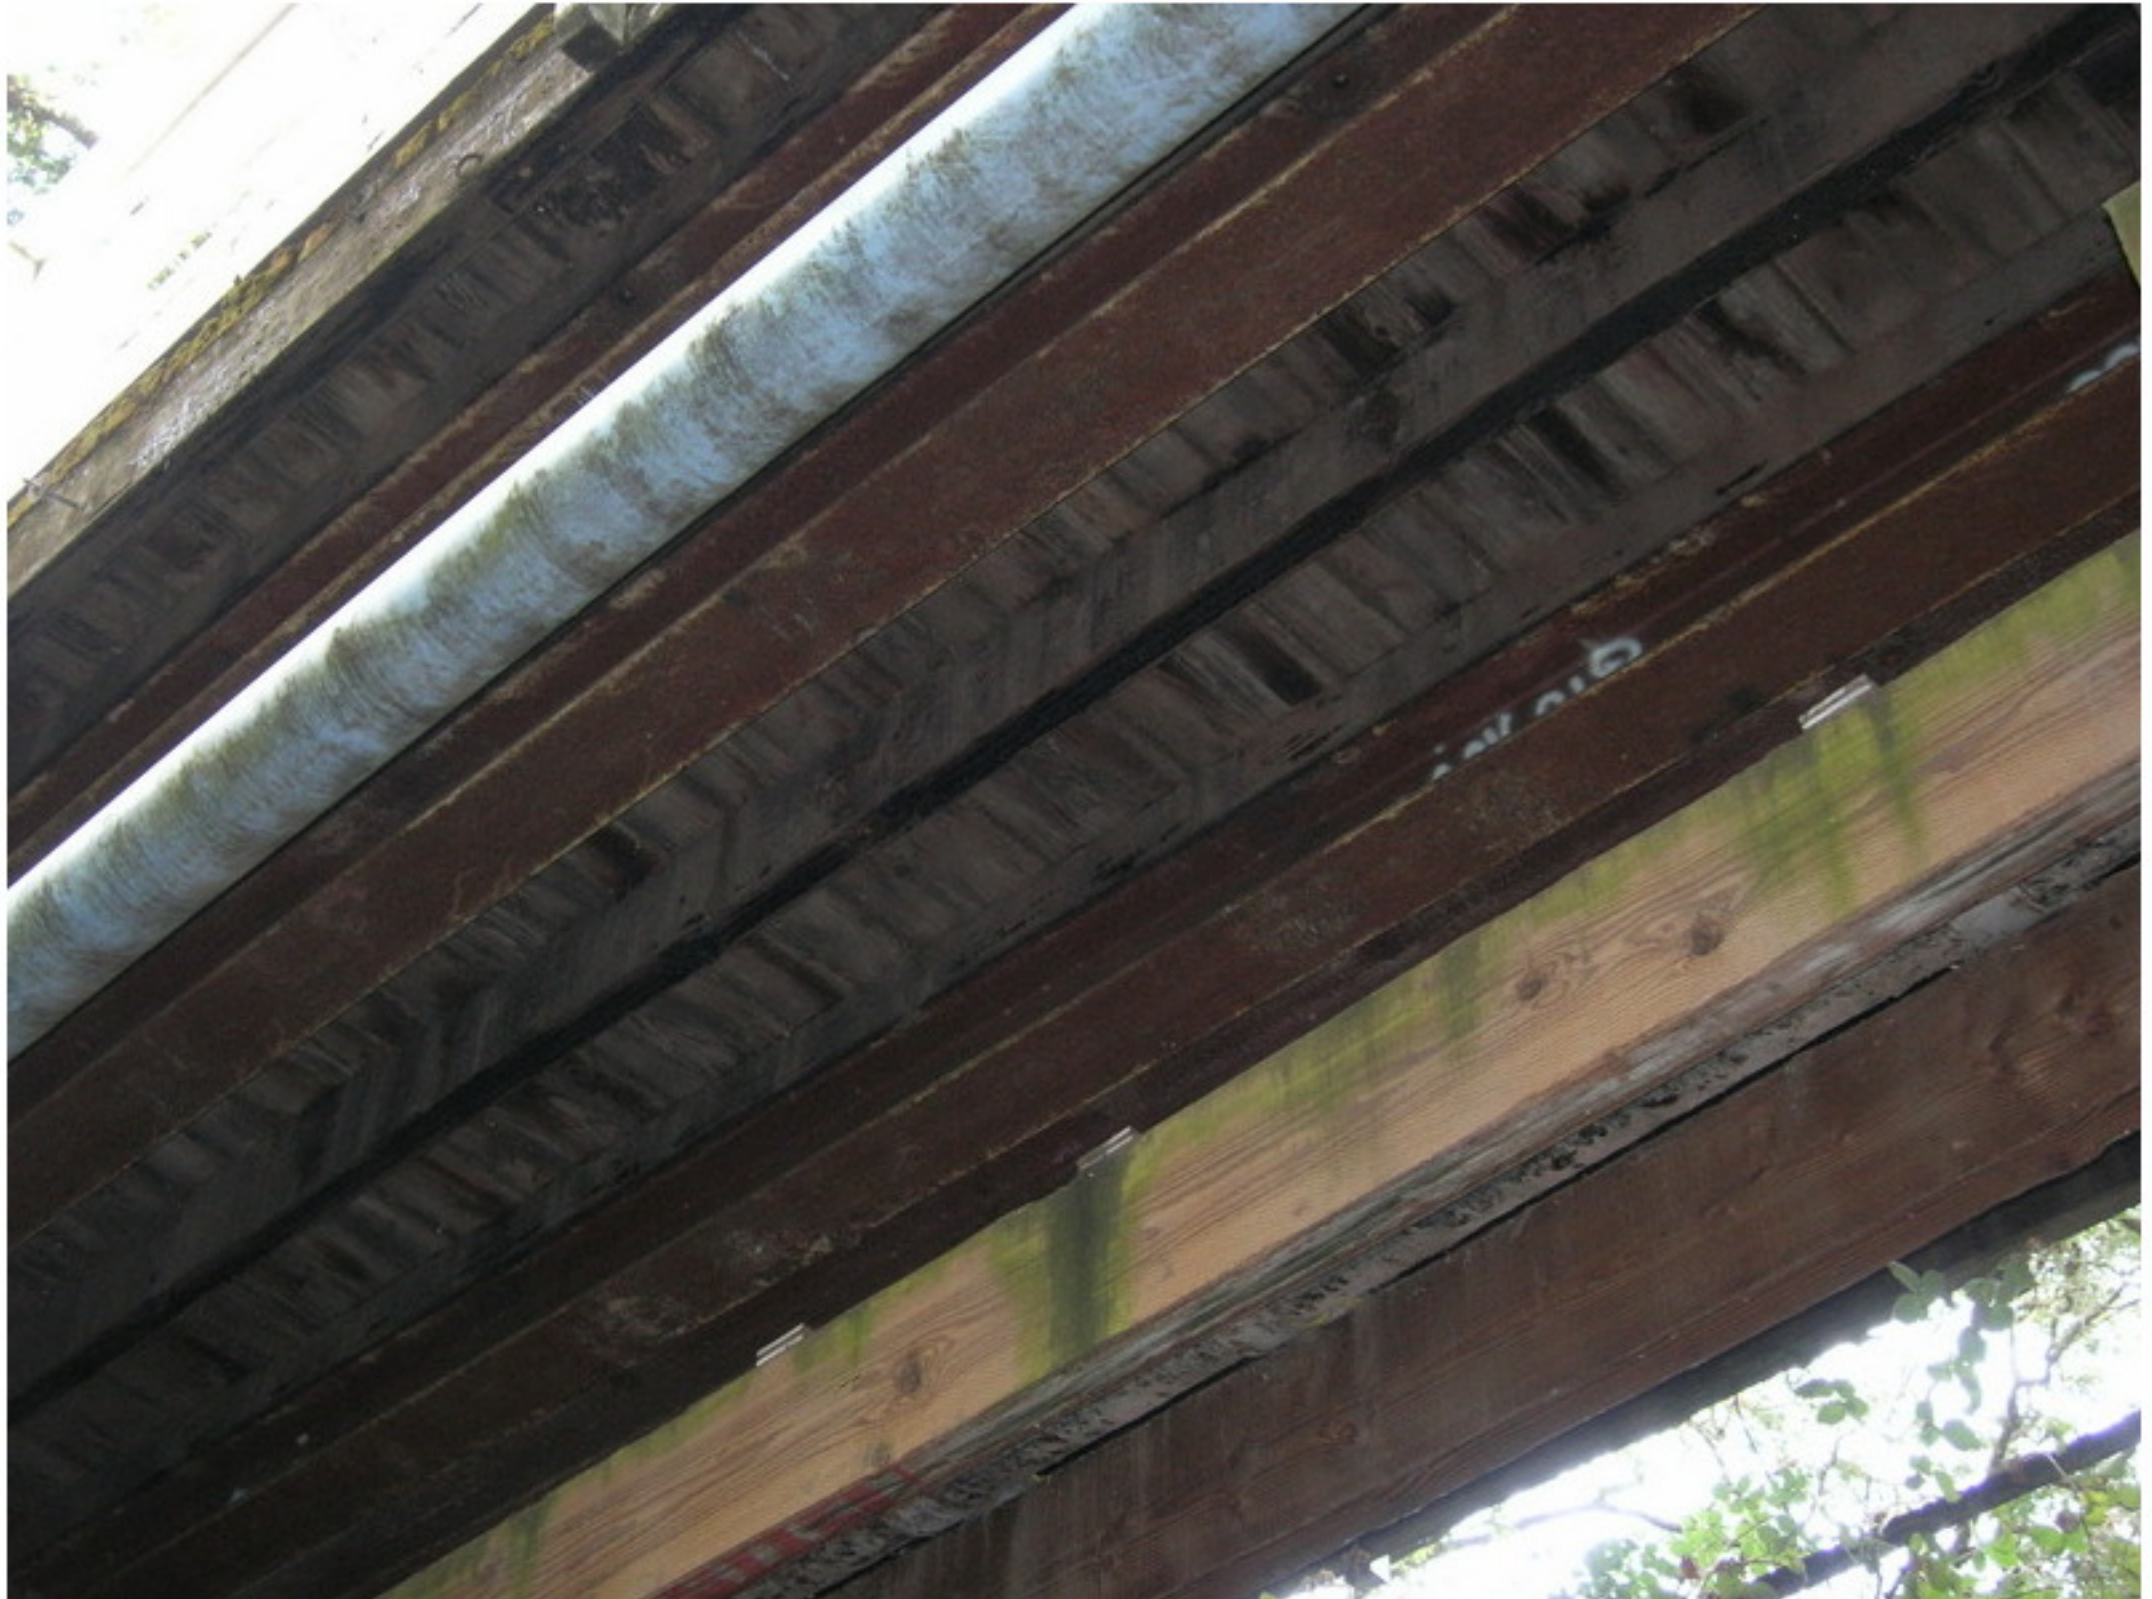
Photo No. 4

All steel girders are covered with blanket rust.

All steel girders are covered with blanket rust. No section loss is observed. See photo 4.

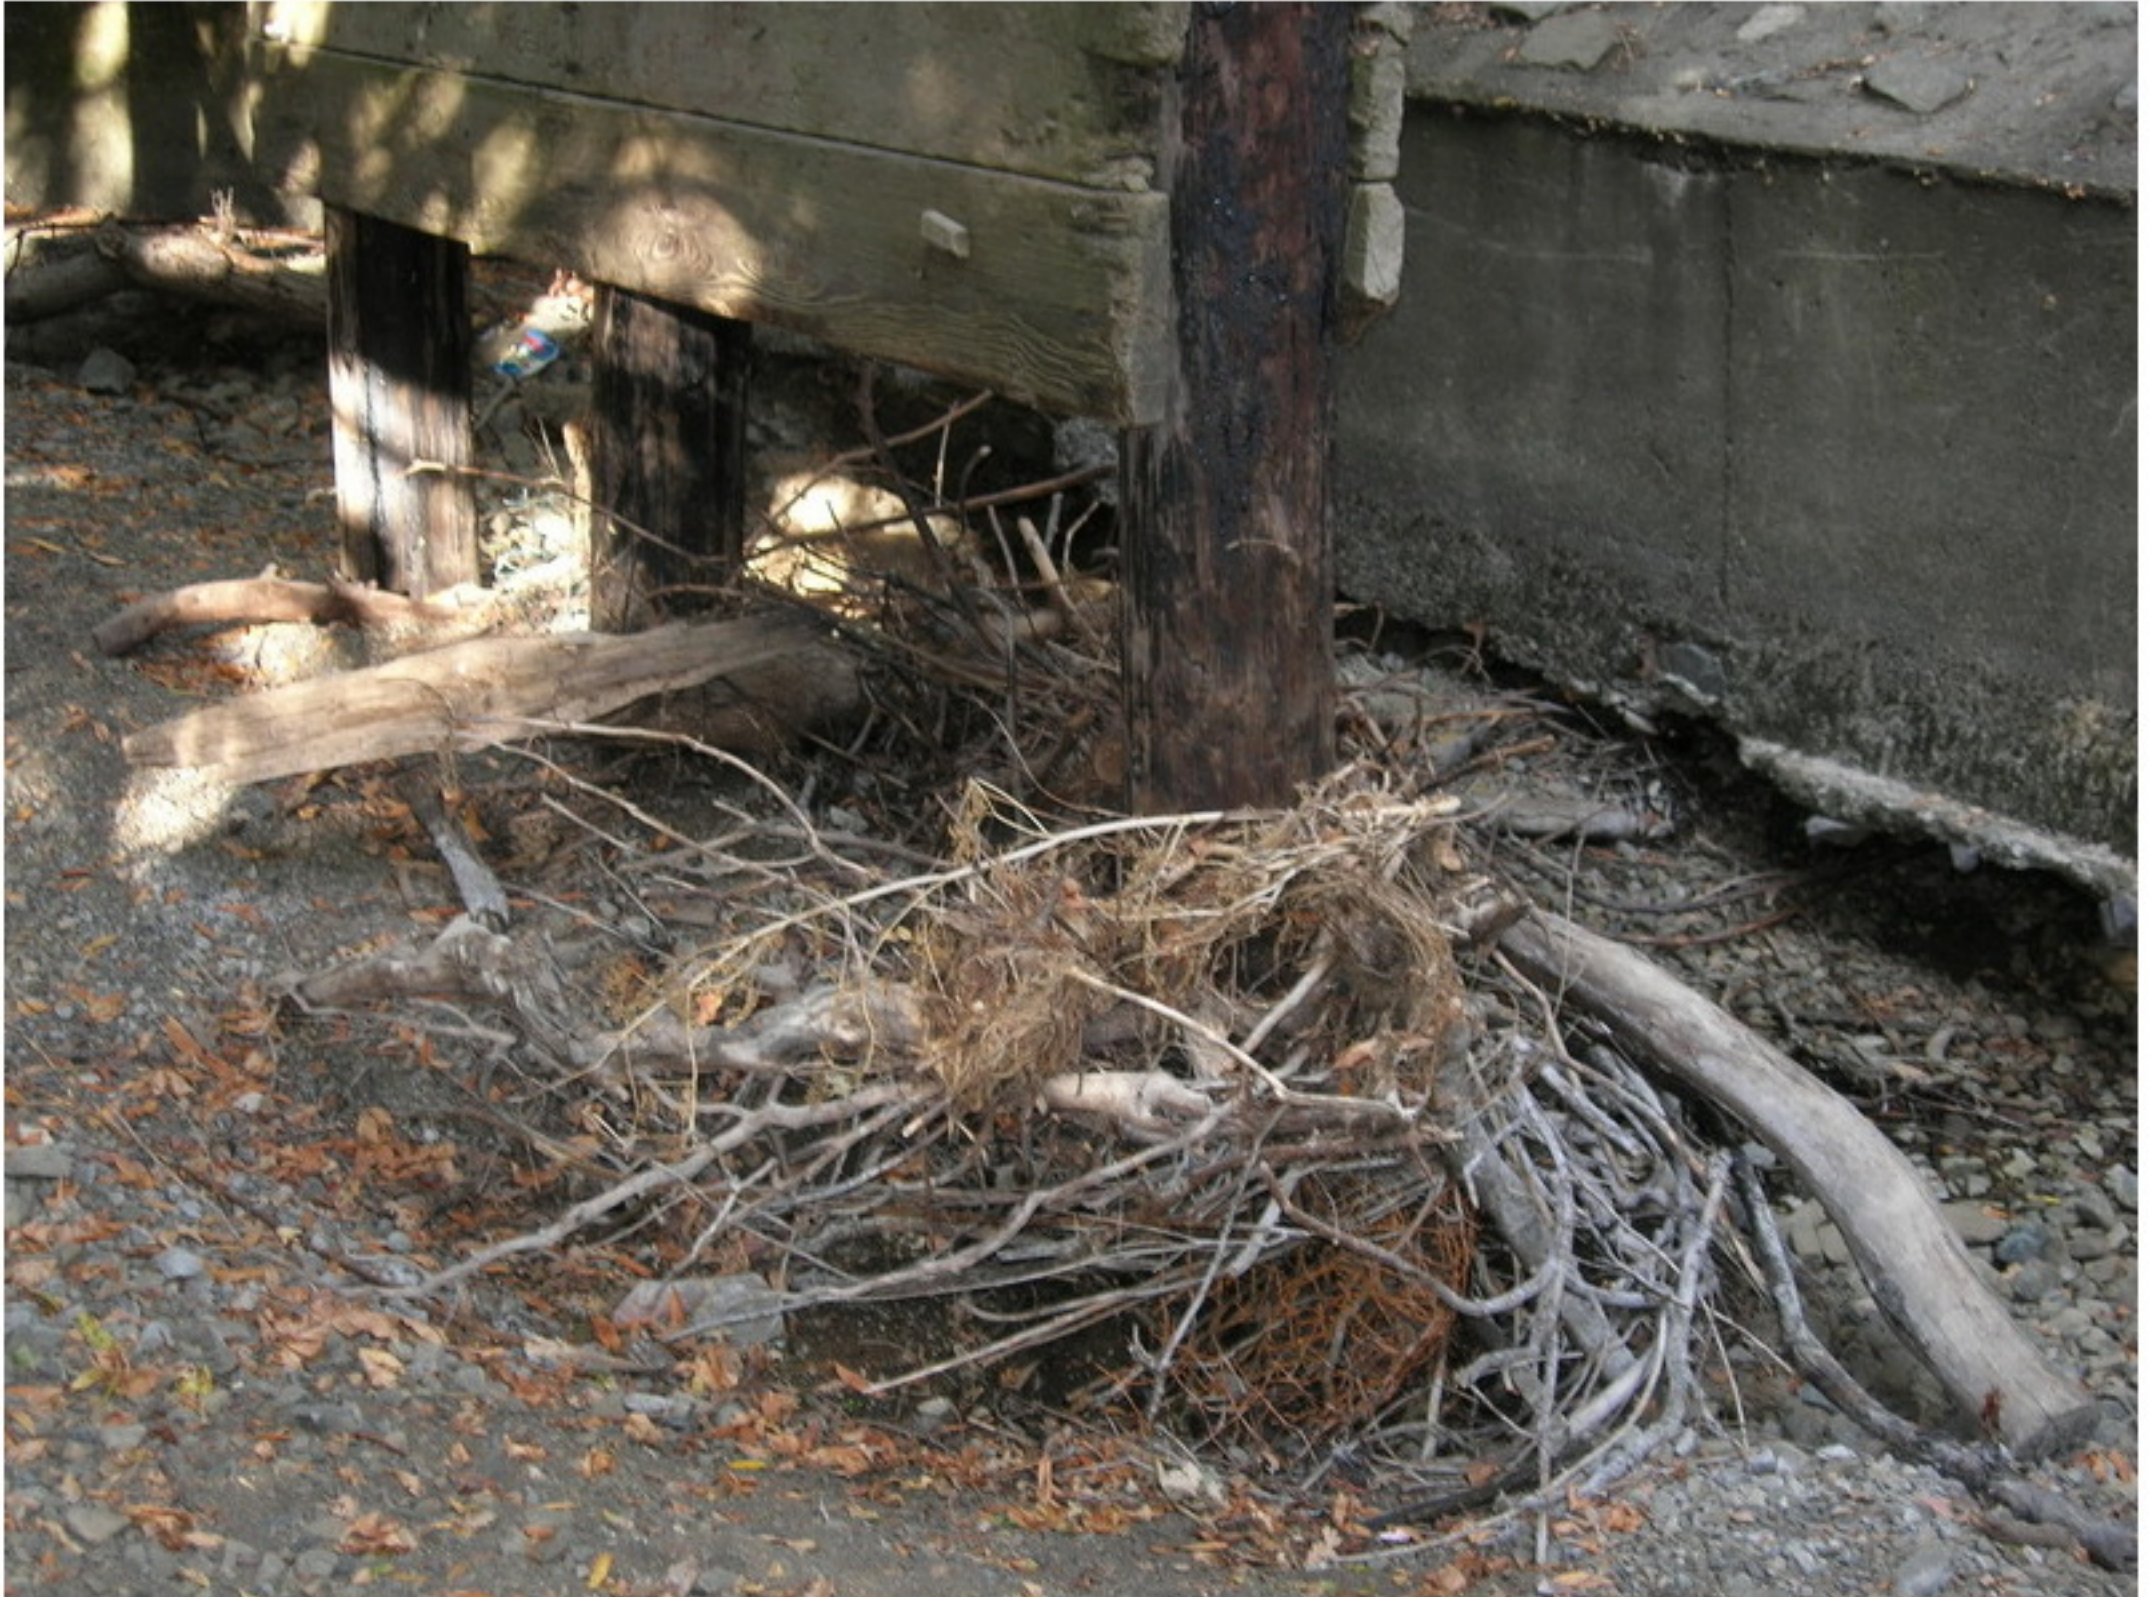
Photo No. 5  
Debris at Pier 4.

1. There is a vertical split in Bent cap 2, which extends from the left end to half length of the bent cap. See photo 7.
2. Bent cap 4 has a horizontal check full length. This condition was first noted in the 8/10/1999 report and has not significantly changed at this time. See photo 6.
3. There are about 5 cu. ft. of debris at Pier 4. See photo 5.

It also appears that the bridge is particularly vulnerable to trapping of woody debris, especially at Pier 4. Trapping of large debris against Pier 4 during floods may cause severe bank erosion at the right bank as might outflank the existing vertical concrete retaining wall immediately downstream from the bridge. It is possible that a large woody debris jam at Pier 4 would create lateral forces that would damage the piers during the flood or subsequent flood. The bridge should be monitored after floods to determine if there is woody debris building up there which should be removed prior to the next flood.

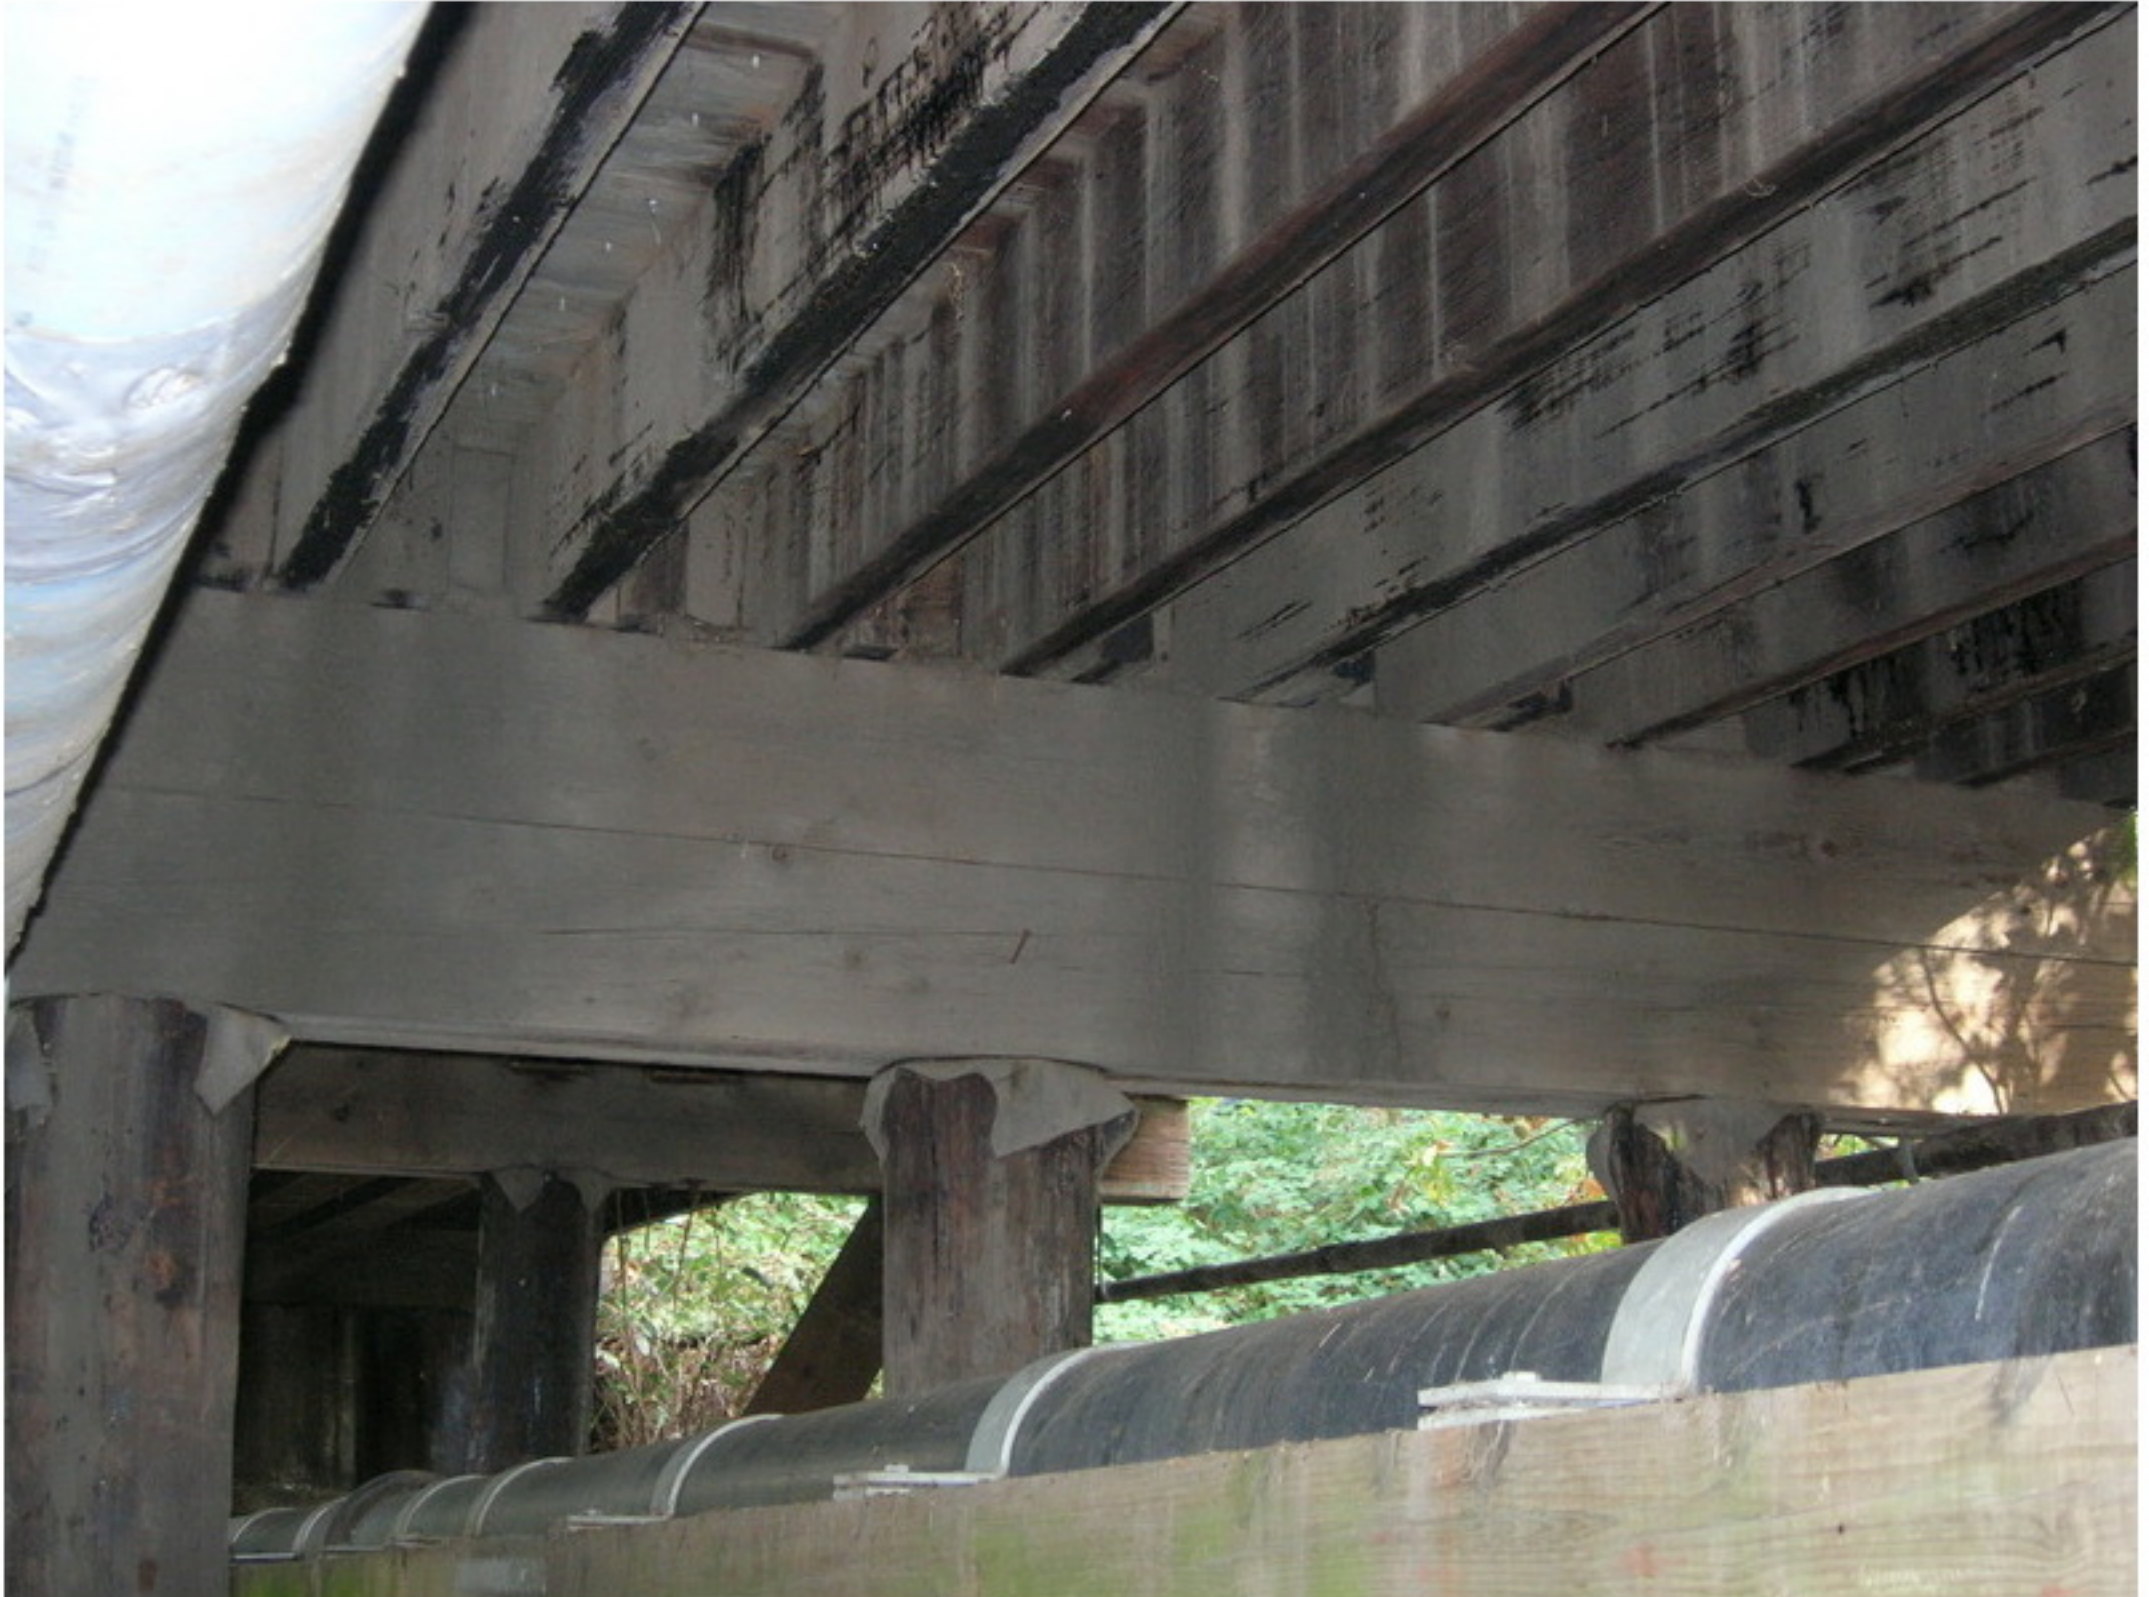
Photo No. 6  
Bent cap 4 has a horizontal check full length.
