# Structure Maintenance & Investigations Load Rating Summary Sheet

Bridge Number: 27C0008  
 Facility Carried: MEADOW WAY  
 Location: IN FAIRFAX  
 City: FAIRFAX

Bridge Name: <u>SAN ANSELMO CREEK</u>						
Structural Element <u>All girders</u>						
Rated:						
Rating Summary						
<b>DESIGN LOADING</b>			<b>Critical Location</b>			
	Rating Factor	Metric Tons	Structure	Control Element	Load Action	Location
Inventory:	0.41	13.3	Span 3,4	Girder	Allowable Moment	0.5pt of Span 3,4 Interior Girders
Operating:	0.57	18.5	Span 3,4	Girder	Allowable Moment	0.5pt of Span 3,4 Interior Girders
<b>LEGAL RATING</b>		Posting U.S. Tons				
Type 3 (25T):	0.72	18	Span 3,4	Girder	Allowable Moment	0.4&0.6pt of Span 3,4 Interior Girders
Type 3S2 (36T):	0.80	28	Span 3,4	Girder	Allowable Moment	0.4&0.6pt of Span 3,4 Interior Girders
Type 3-3 (40T):	0.88	35	Span 3,4	Girder	Allowable Moment	0.4&0.6pt of Span 3,4 Interior Girders
<b>PERMIT RATING</b>		Permit Rating				
5 Axle Truck :	0.53	X	Span 3,4	Girder	Allowable Moment	0.4&0.6pt of Span 3,4 Interior Girders
7 Axle Truck :	0.53	X	Span 3,4	Girder	Allowable Moment	0.4&0.6pt of Span 3,4 Interior Girders

## Bridge Inspection Report

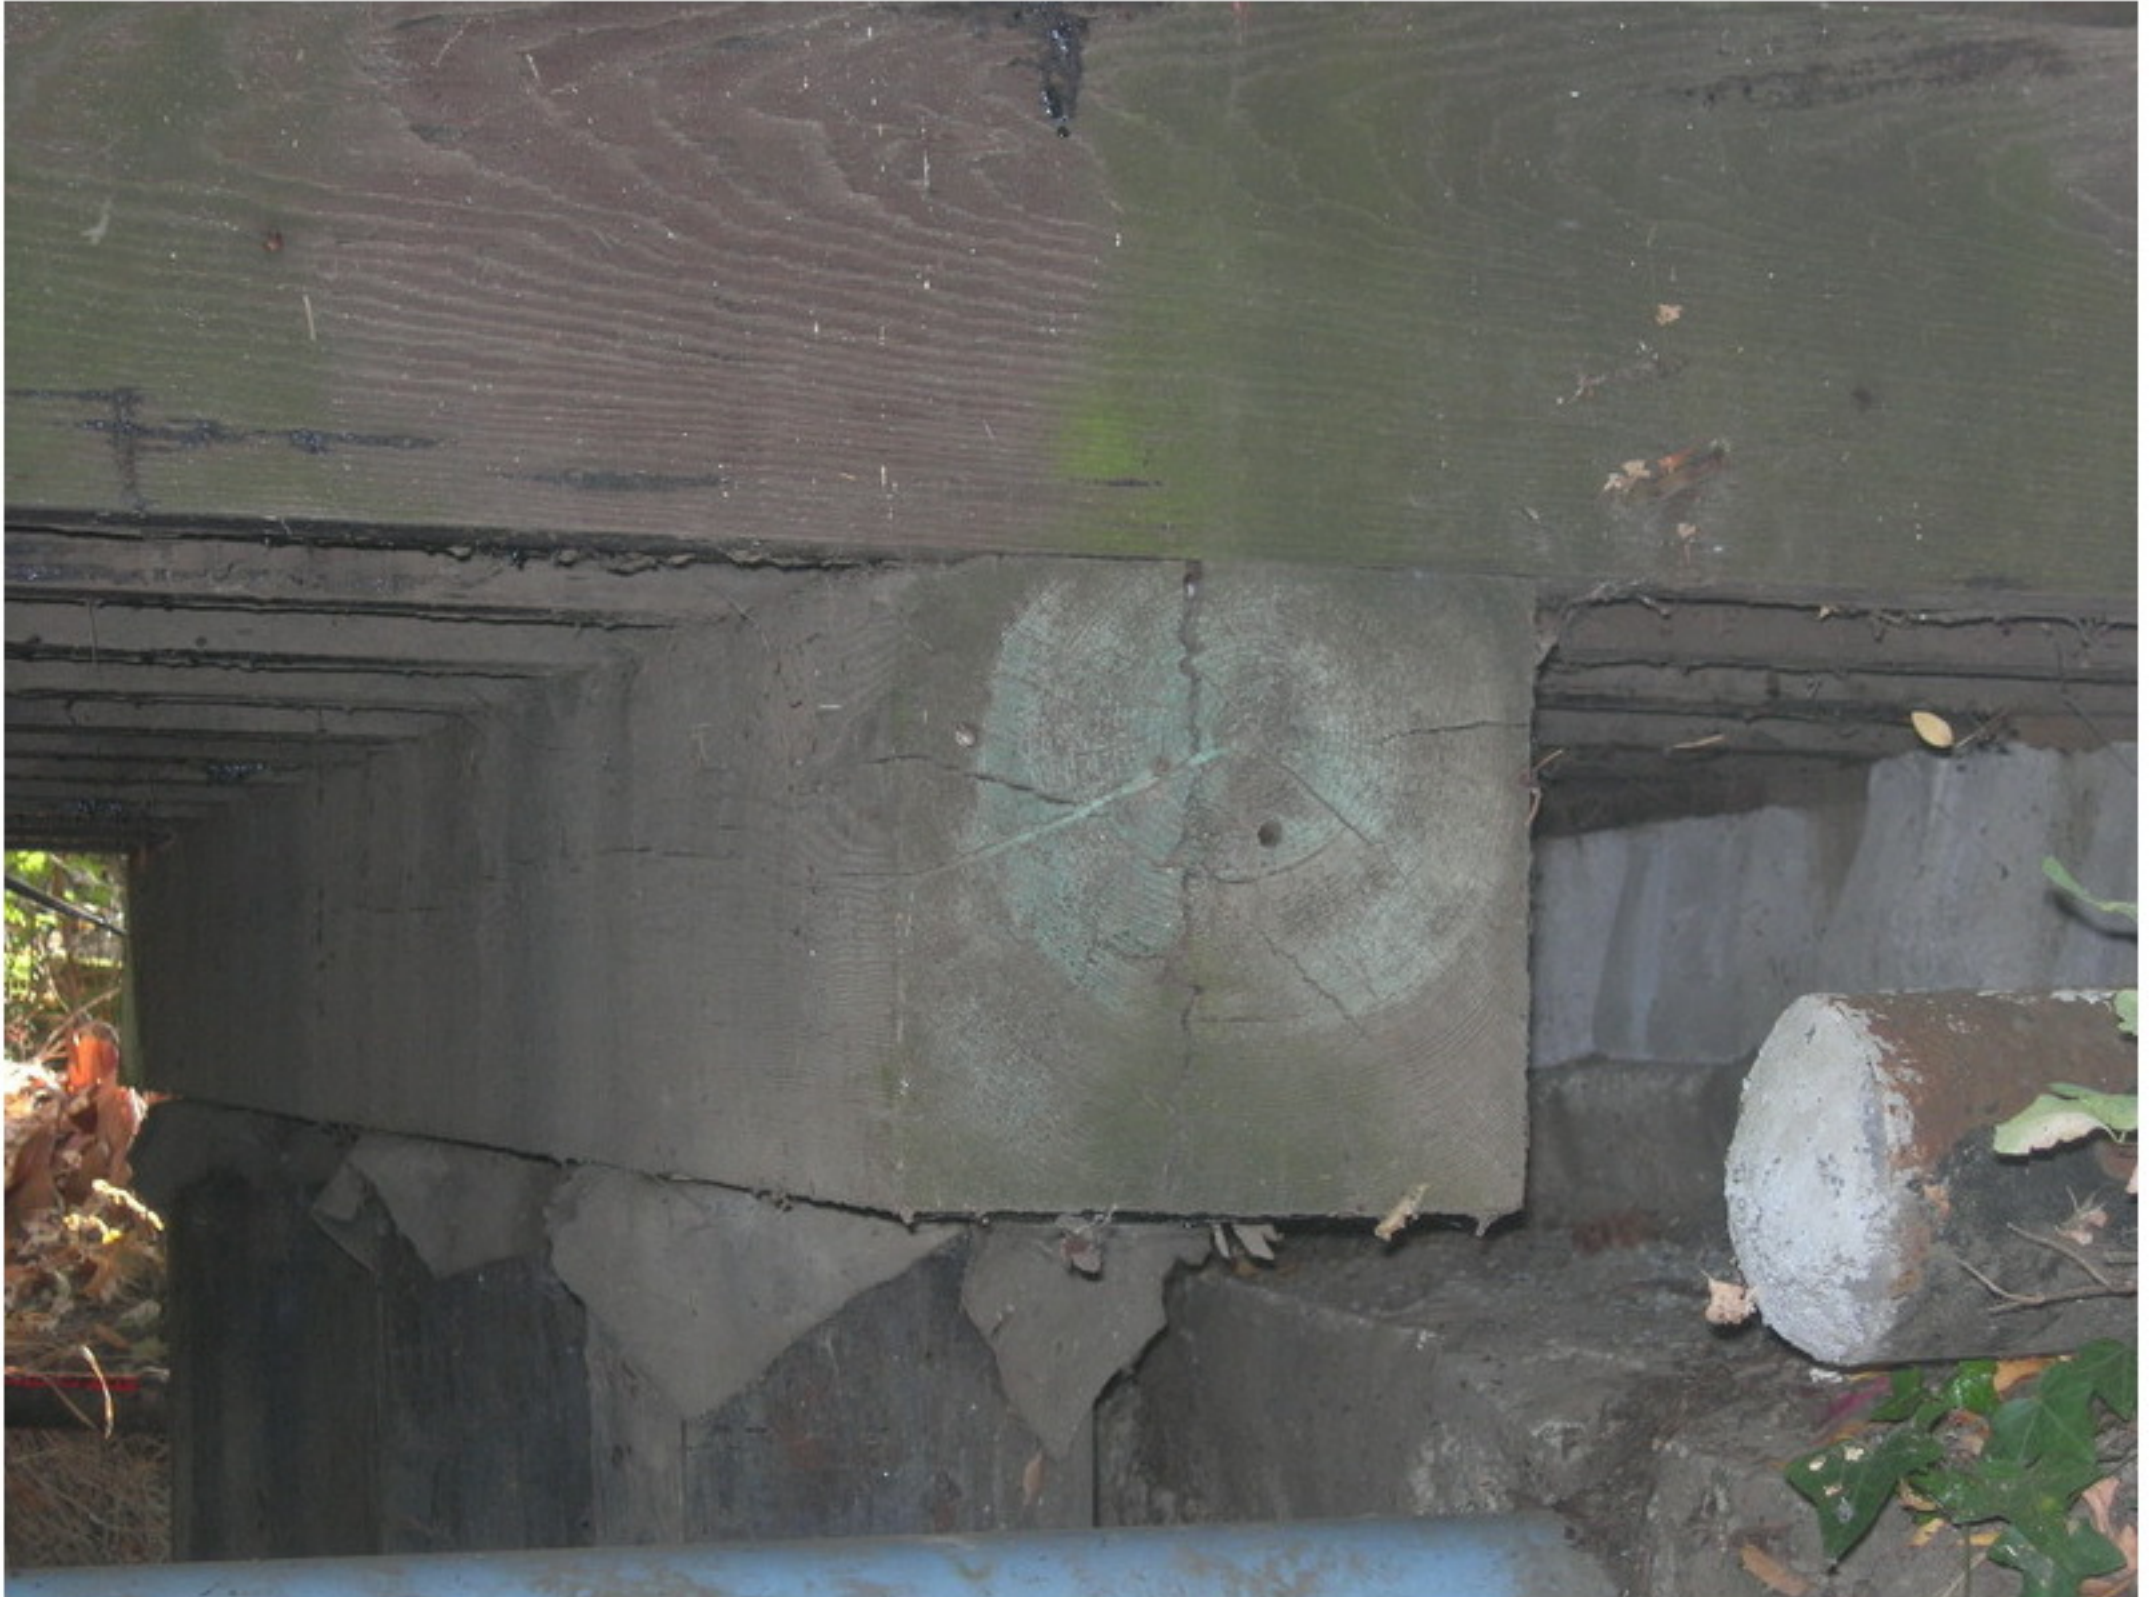
Photo No. 7  
Vertical split in Bent cap 2.

1. There is a vertical split in Bent cap 2, which extends from the left end to half length of the bent cap. See photo 7.
2. Bent cap 4 has a horizontal check full length. This condition was first noted in the 8/10/1999 report and has not significantly changed at this time. See photo 6.
3. There are about 5 cu. ft. of debris at Pier 4. See photo 5.

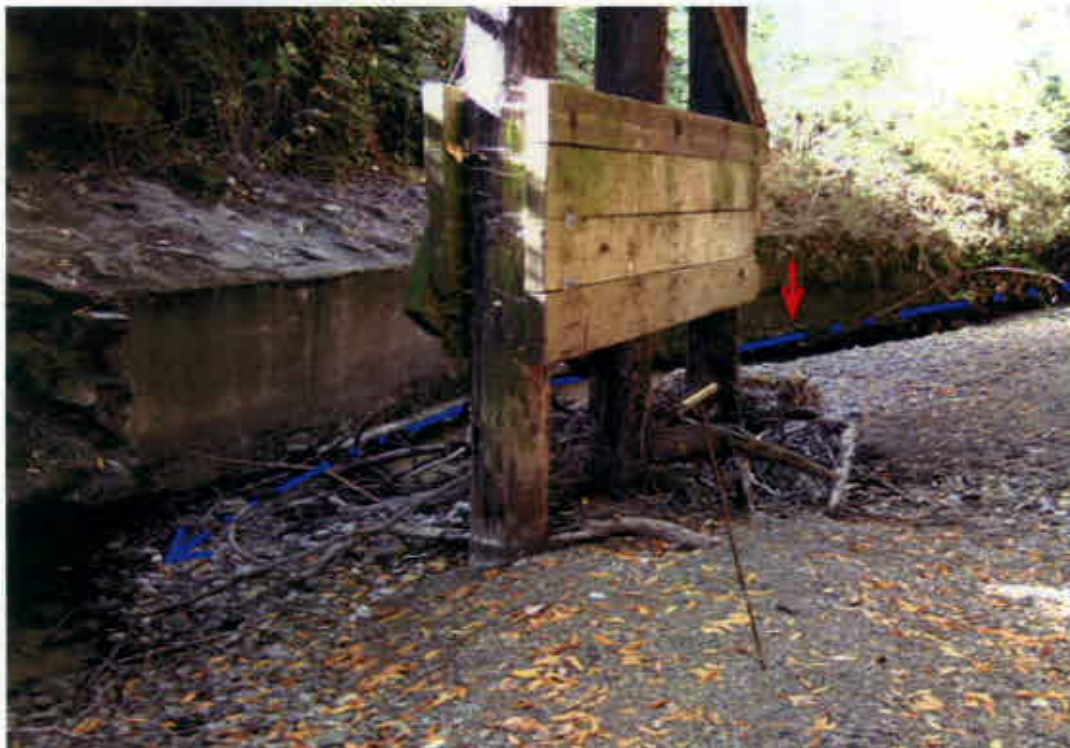
The potential for short-term bed lowering during floods is greatest along the toe of the right bank and near Pier 4. It appears that there is as much as about 3.5 feet of scour during floods along the toe wall upstream from the bridge and between the toe wall and the closest set of piers.

Bed scour is strongly focused along the concrete toe wall and has presently undercut the toe wall over 15 or more lineal feet and by as much as 4 horizontal feet at a location immediately upstream from the upstream face of the bridge. The toe wall does not appear to have a footing and has, therefore, lost much of its foundation support. However, it appears massive and integral enough to continue to span the undercut region without having failed into the channel or cracked. If the wall were to topple into the creek channel, additional erosion and sloughing would likely occur on the slope above the wall, which could impact the southern bridge abutment. Additionally, an old timber bulkhead "deflection" wall upstream of the bridge should be monitored because if this bulkhead failed, significant erosion/sloughing of the steep creek bank could occur. Sloughing could eventually impact the Meadow Way immediately north of the bridge and/or the northern bridge abutment. Support of this wall could be improved with riprap and grout or underpinning with helical anchors or driven mini-piles. As noted above, monitoring of the wood deflection wall upstream of the bridge should also occur and if additional damage is noted, mitigation may be needed.

View upstream to right bank showing area of focused bed scour along the toe of the right bank and near Pier 4. The concrete toe wall bank protection structure at the outside bend channel position is undercut by as much as 4 horizontal feet

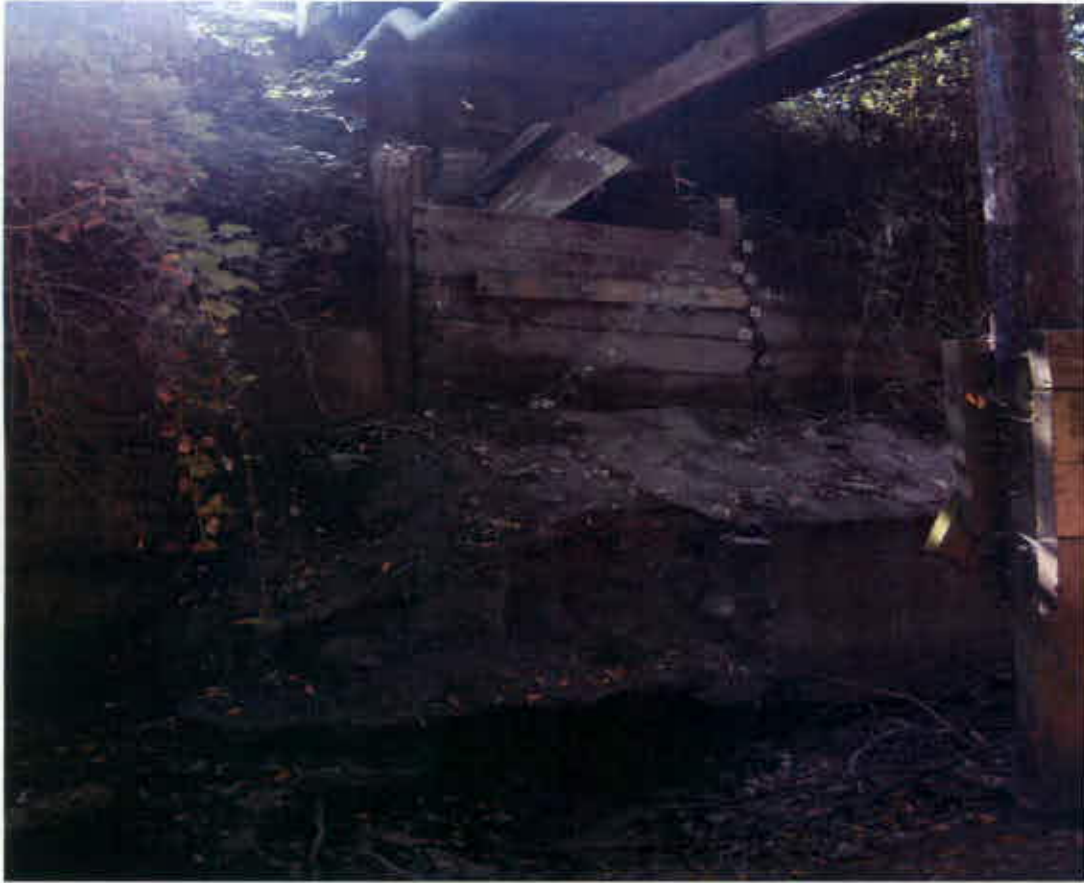
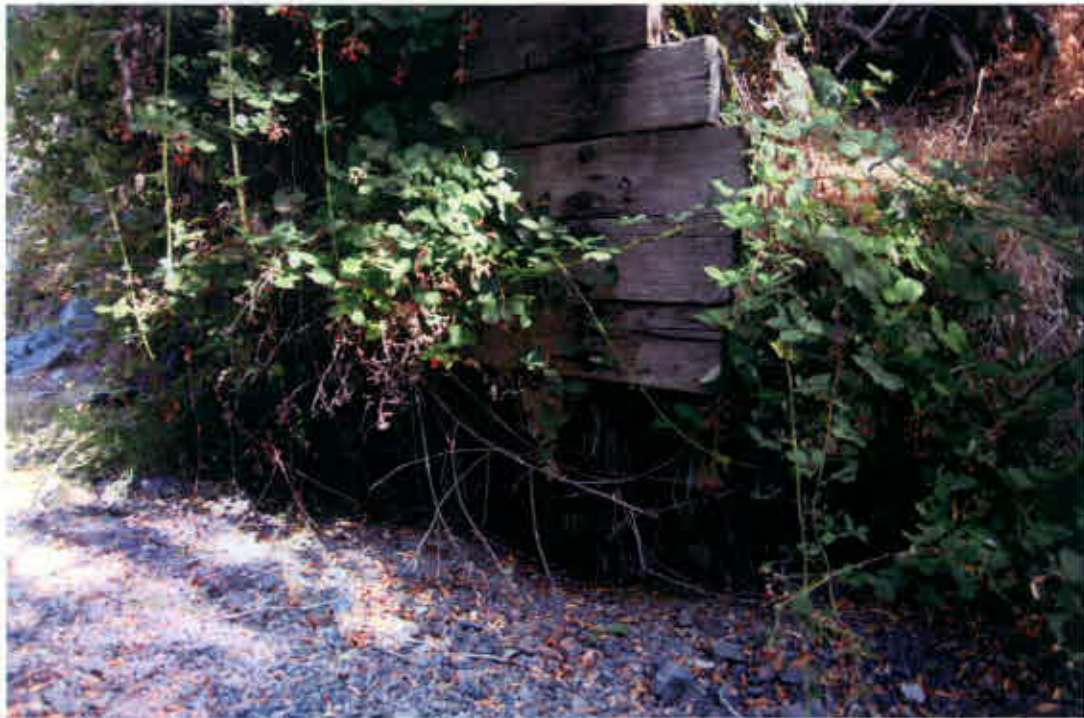
The 4-foot high concrete wall (see photo) at the toe of the south creek bank has been undermined and a void approximately 4 feet wide and 12 inches or more deep is apparent under most of the wall. Additionally, an old timber bulkhead "deflection" wall upstream of the bridge should be monitored because if this bulkhead failed, significant erosion/sloughing of the steep creek bank could occur.

Scour of the timber wall downstream of the bridge

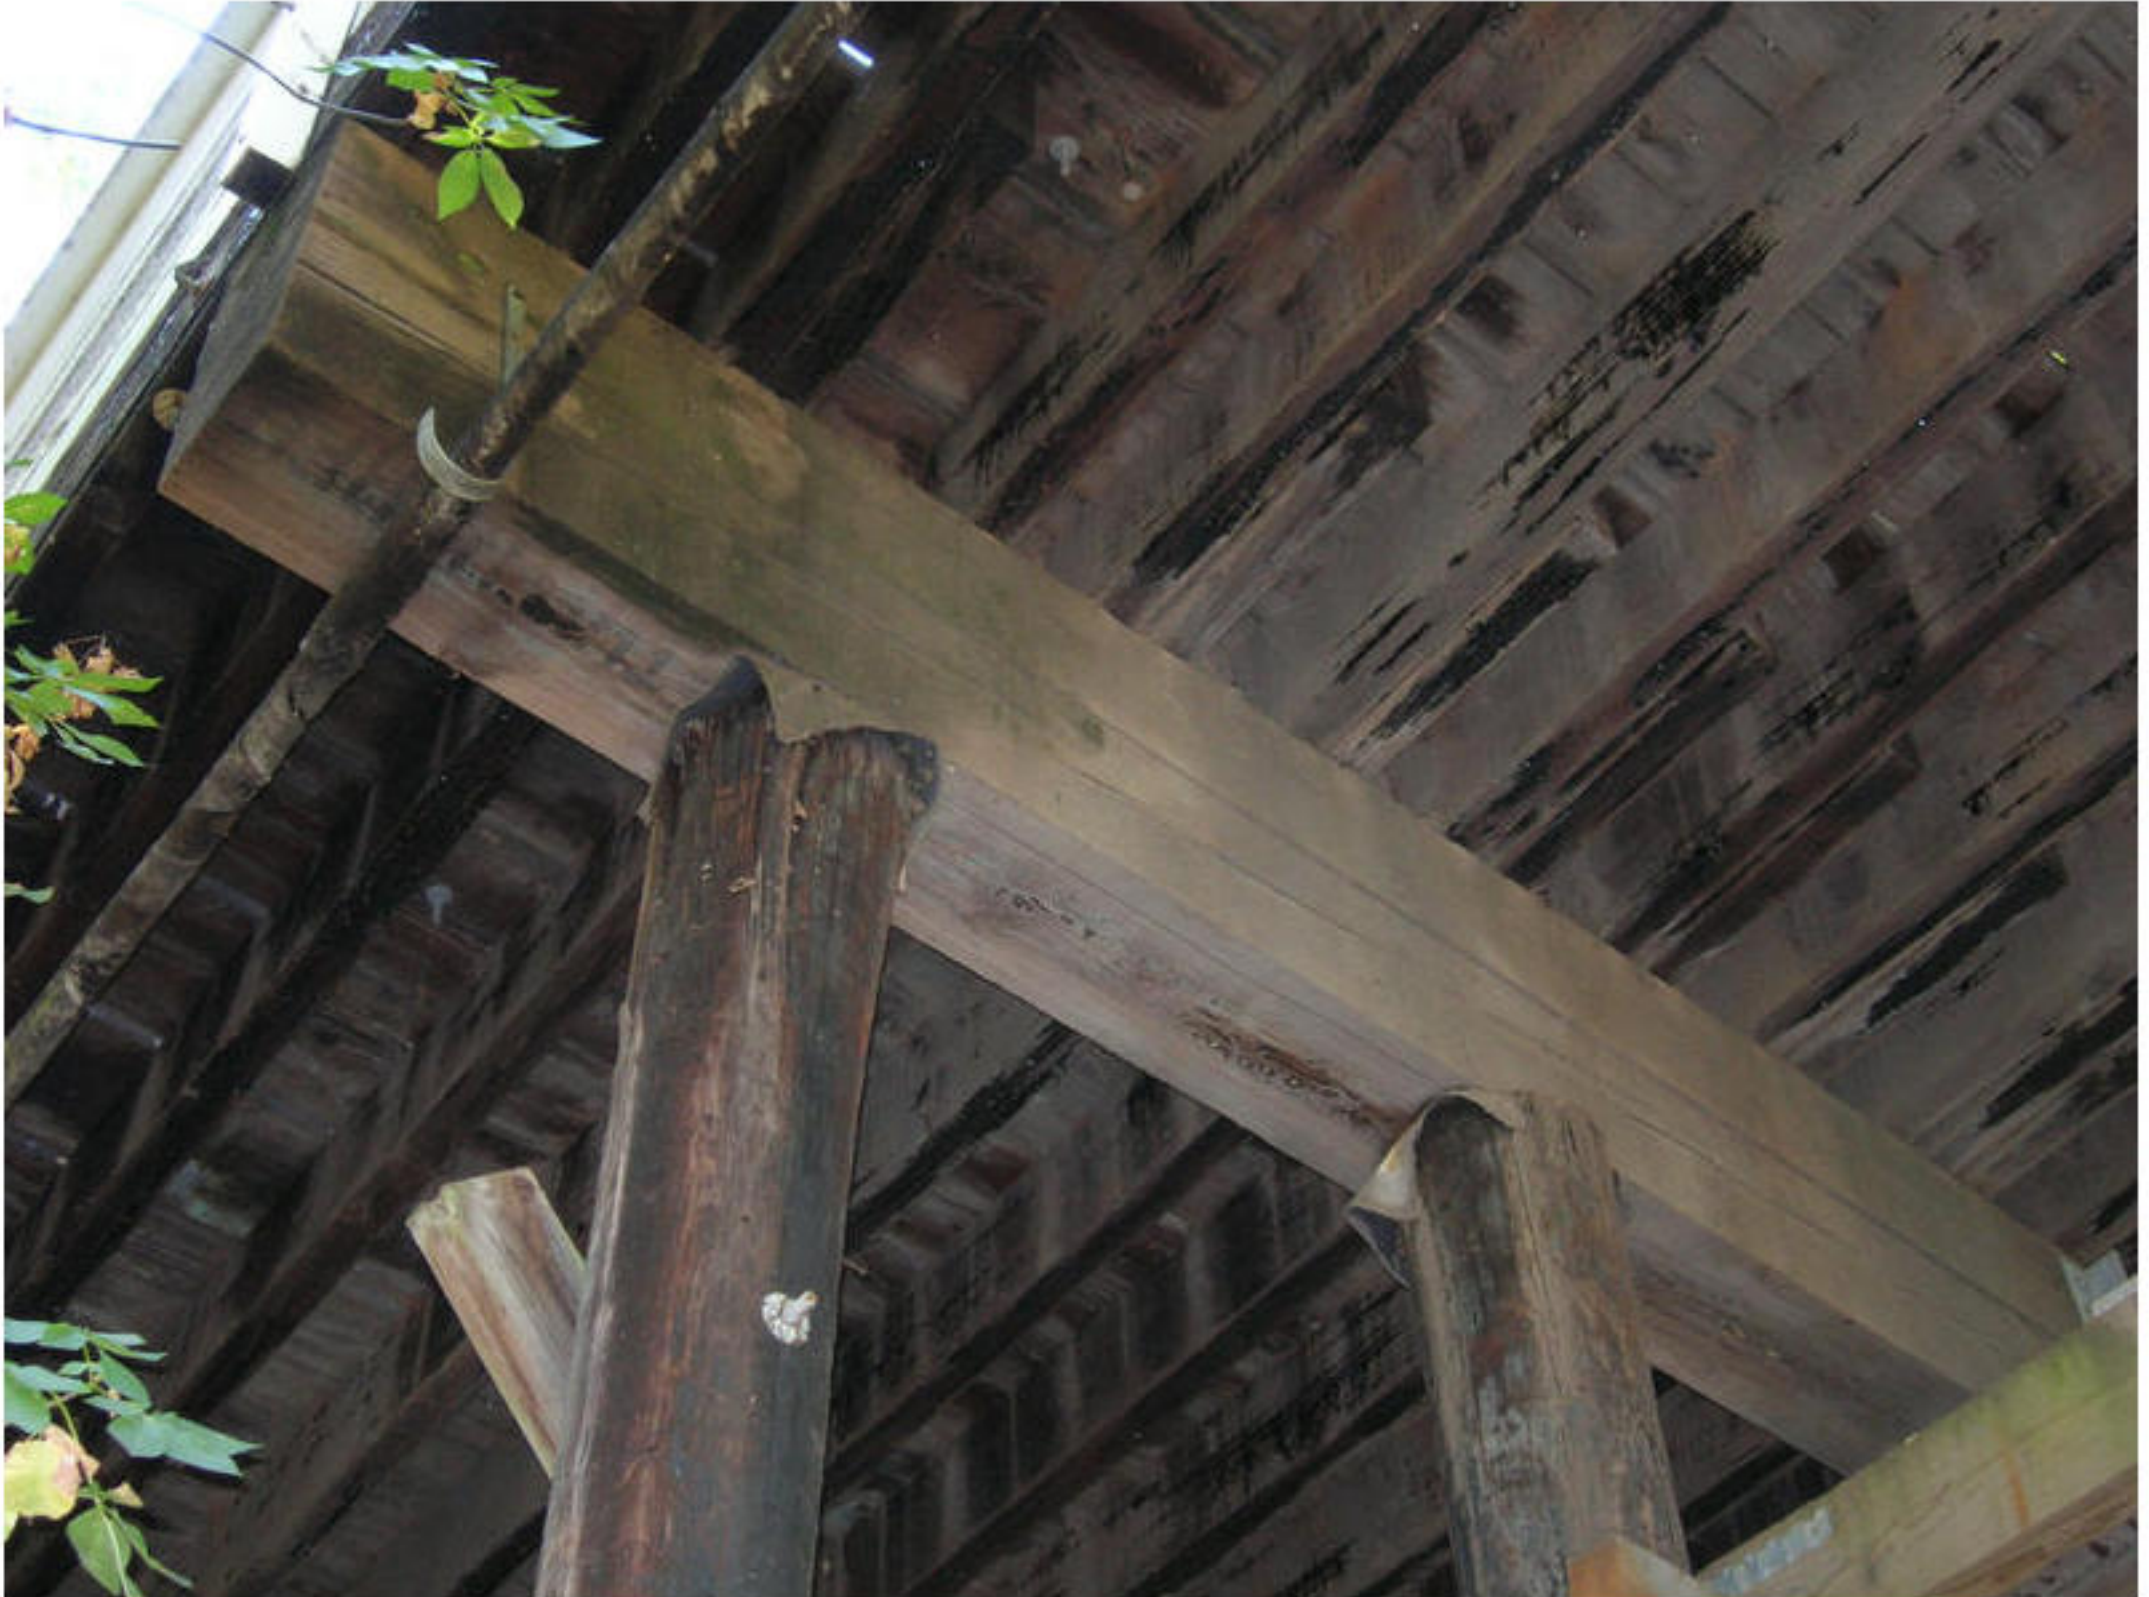
Photo No. 1  
Horizontal check on Bent cap 4.

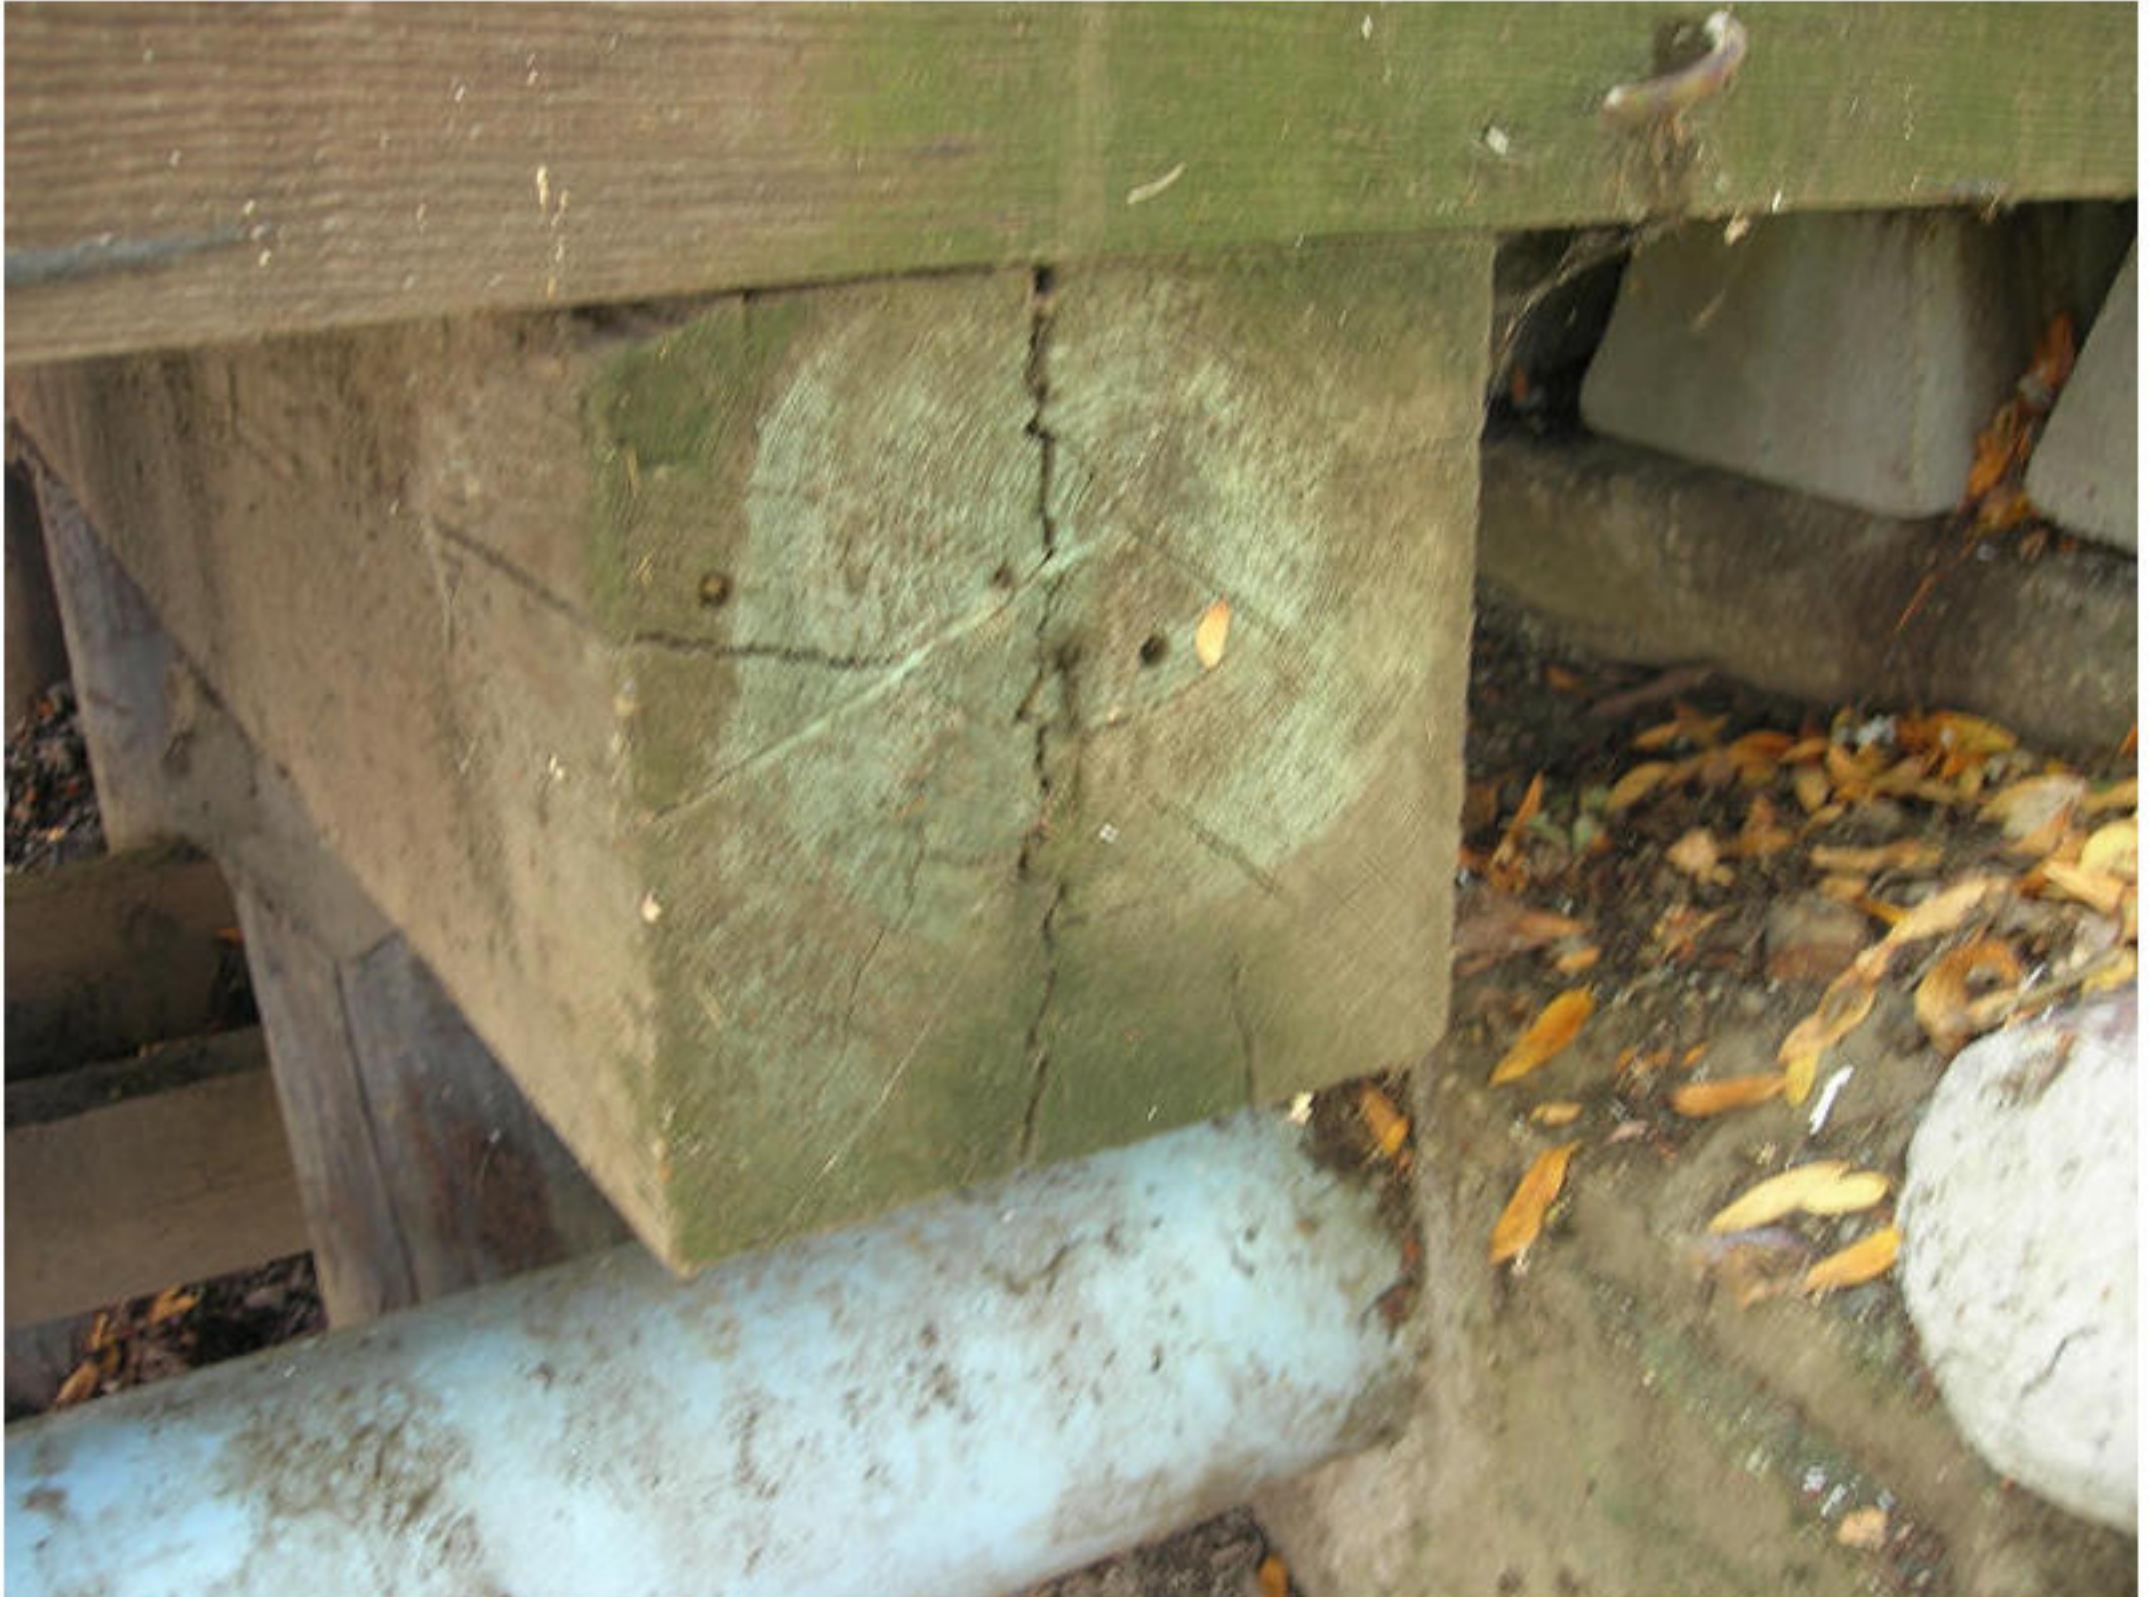
Photo No. 1  
Split on Bent cap 2 left.
