# ASSESSMENT REPORT – FAIRFAX BRIDGE PREVENTIVE MAINTENANCE PROGRAM

Submitted to the Town of Fairfax  
Department of Public Works  
January 14, 2014

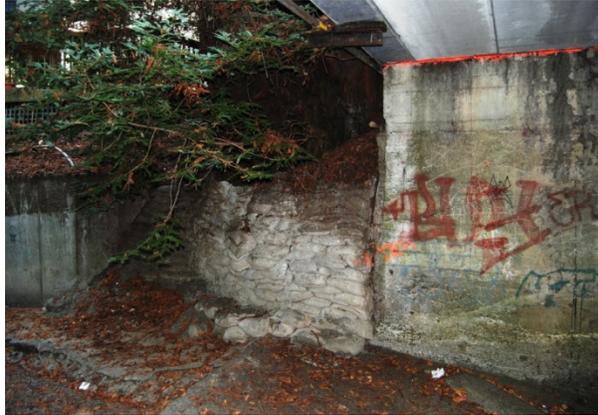
Figure 7 – Stacked concrete bags acting as wing wall

On the upstream side of the northern abutment, growth of a very large redwood tree has bulged out a short section of a sacked concrete slope armoring that also serves as the bridge wingwall. Additional tree growth or water flow in the channel could potentially topple this armoring, which could then result in significant scour risks to the upstream side of the northern abutment. On the downstream side of the northern abutment, an 18-inch RCP storm drain discharges into the channel and a five foot long, eight foot high area of creek bank immediately adjacent to the bridge is eroding and threatening the bridge. The erosive flow forces have also abraded the concrete face of the north abutment.

- Removal of a portion of the north abutment wingwall, both downstream and upstream, to construct new concrete walls with soil nails. For the upstream concrete wall, removal of the existing concrete bags and backfilling with rock and soil is required to contain the redwood tree. A team arborist will be rendering professional opinions as to the proper approach to working around this tree.
- Repair the concrete surface at left abutment (looking downstream) by applying a 4"-thick layer of air-blown concrete (or shotcrete).
- Repair minor superstructure spall located at the northeast rail post.

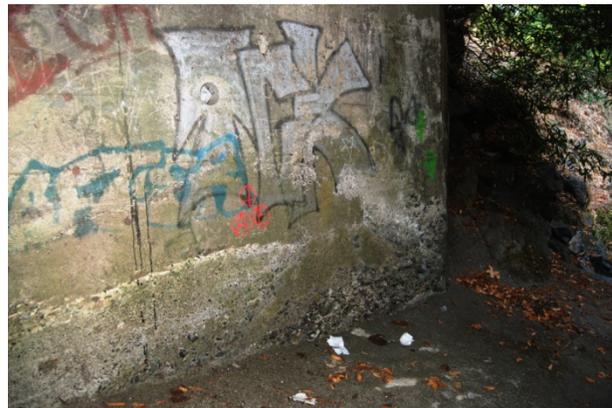
Figure 10 – Flow-induced concrete erosion at north abutment

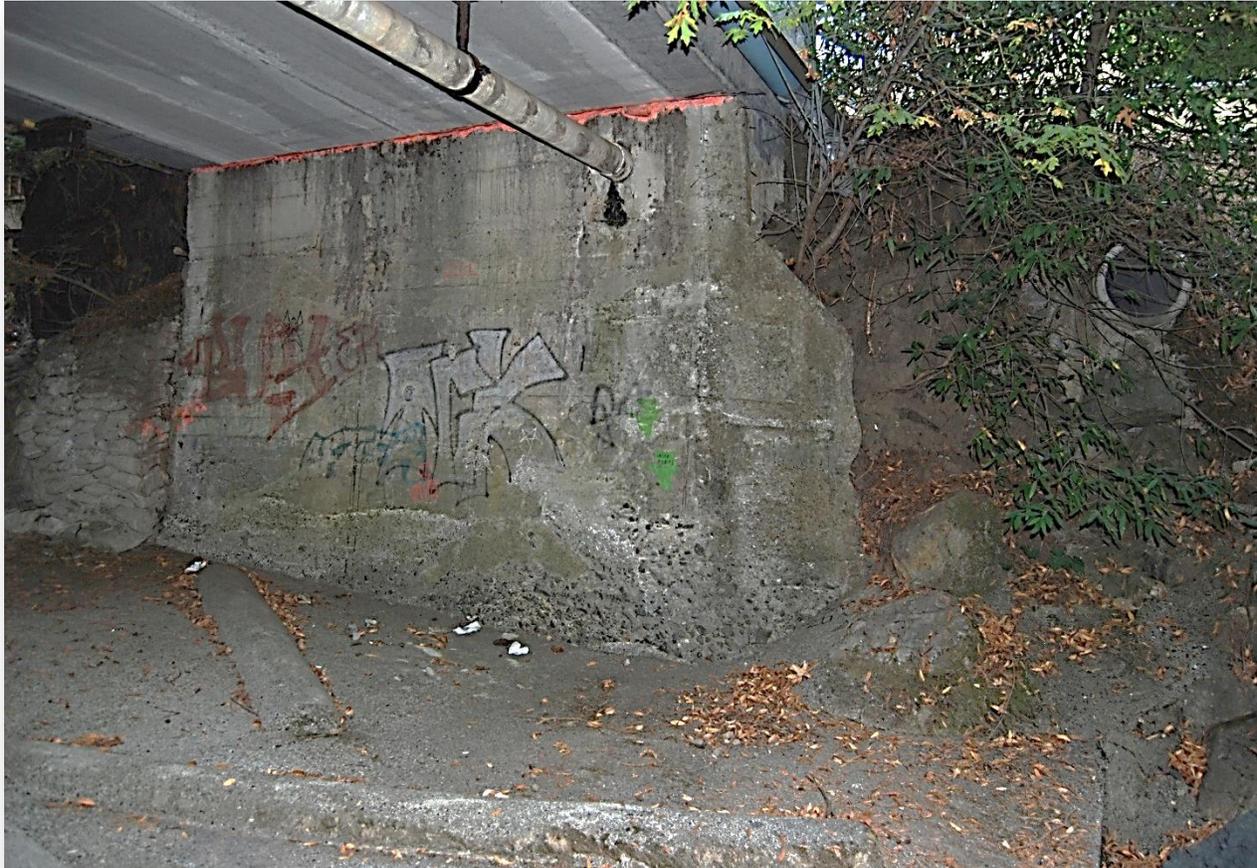
Looking at north abutment of the bridge – Sacked concrete wingwall is on the left and partial wingwall and 18” RCP on the right. Note the erosion of the abutment concrete facing due to abrasive creek flow.

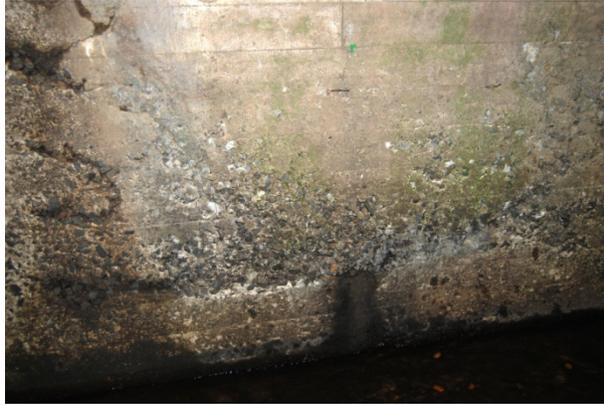
Figure 7 – Abutment concrete erosion due to flows

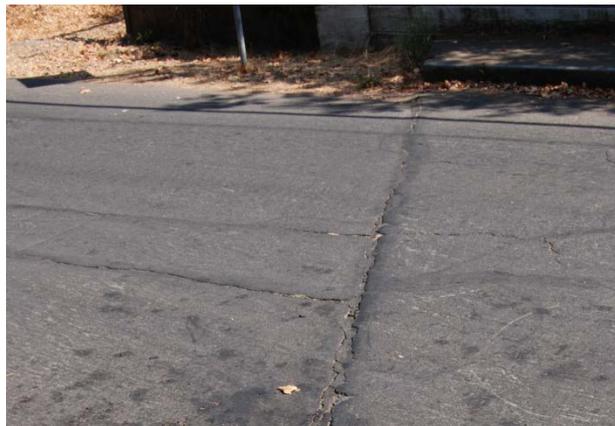
Figure 11 – Pavement cracks at the south end of bridge

- Removal of the 2"-thick AC and placement of 1"-thick polyester concrete to seal the deck and provide a riding surface that will butt up with AC outside the bridge. The AC at the approach to the deck will be partially removed and redone to match the new bridge deck grades since the polyester concrete is 1" thinner.
- The expansion joint between the deck and AC approach roadway will be repaired using Caltrans standard Type A seal.
- Removal of the abandoned exterior utility pipe under the bridge.

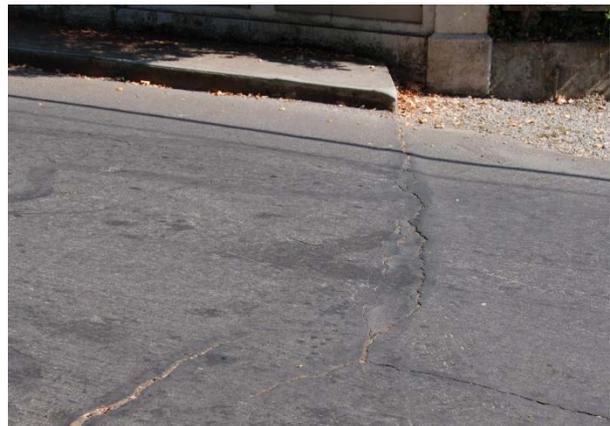
Figure 12 - Pavement cracks at the north end of bridge

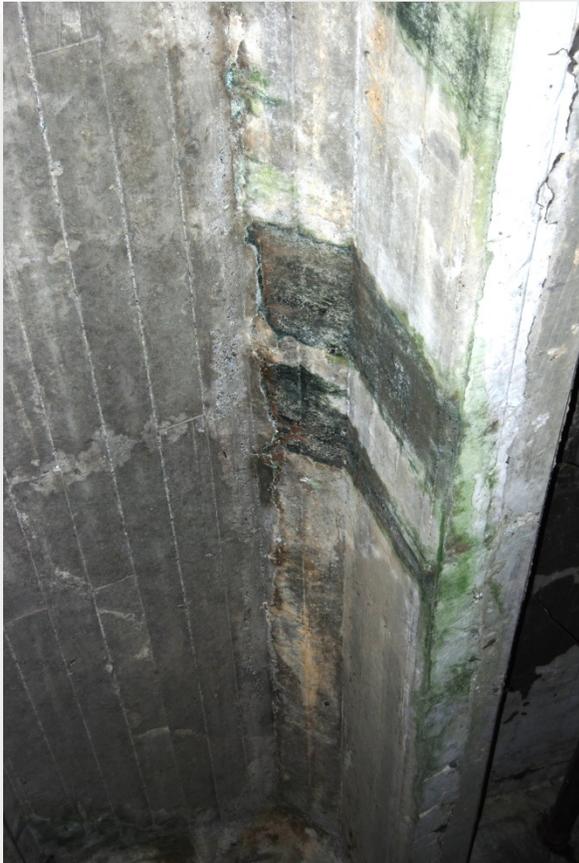
Structurally, the issue qualifying the bridge for preventive maintenance is deck cracks. The topside of the deck is covered by asphalt concrete (AC) covering the cracks. However, the underside of the deck, observable from the creek, shows efflorescence, or the concrete chemicals having leached out of the cracks in the concrete. This condition has been also noted in the Caltrans Bridge Inspection Reports. Since the creek will not be disturbed by the work on this bridge, environmental permits will not be needed. From a

An example of efflorescence in the soffit through cracks in Spruce Road Bridge deck

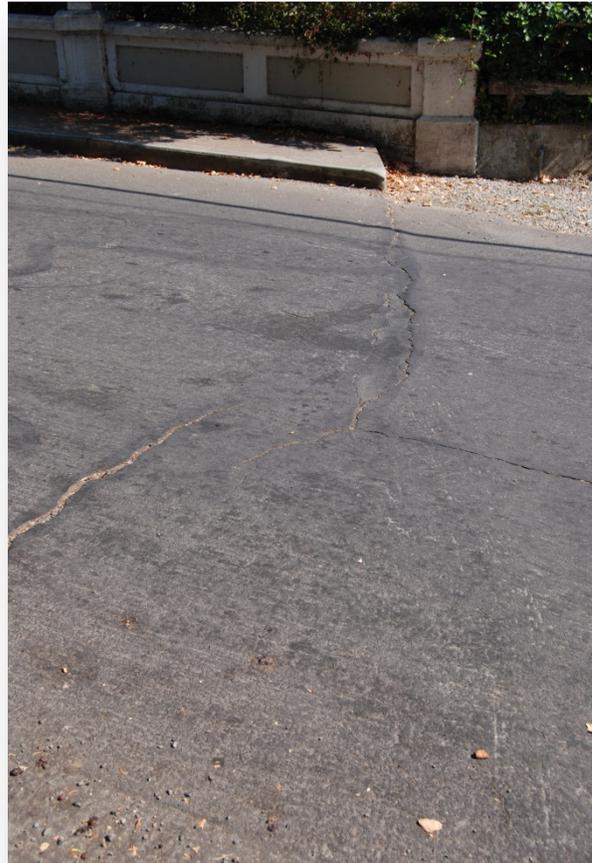
Cracked pavement at transition from concrete deck to asphalt-paved street

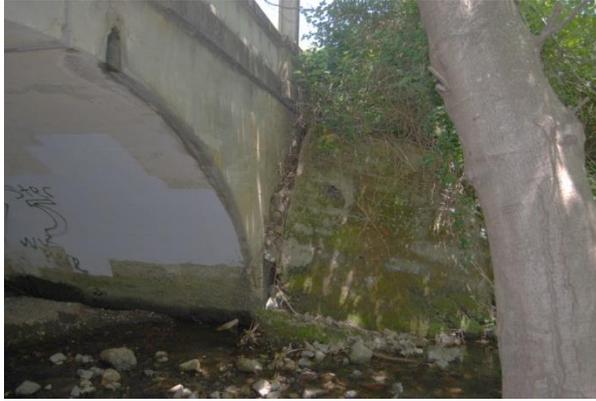
Figure 7 - Looking north at toppled wing wall

1. Repair of the rotated and undermined concrete gravity wall by removing a portion near the structure, extending it flush with and doweling it to the structure, and reinforcing it with a 4 inch gunite wall. The wall will be further stabilized with soil nails. The existing rock riprap around the wall needs to be augmented.
2. Repair of the undermined retaining wall by dry-packing the cracked portion with new concrete and adding a small course of rock riprap to protect it from future scours

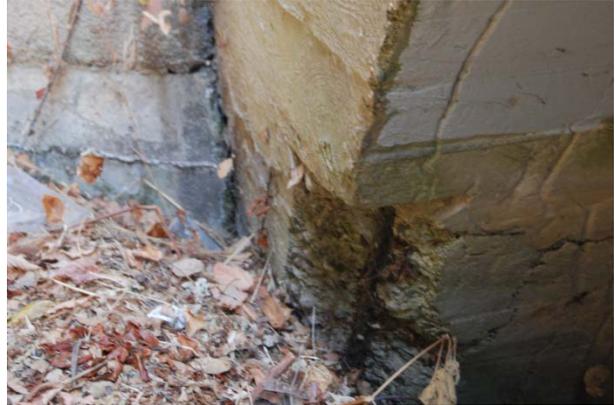
Figure 8 – Spall at southeast arch base

### 3. Repair and patch spall at corners of abutments

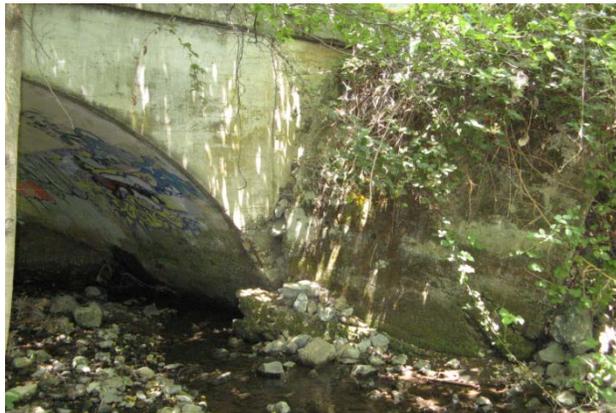
Figure 9 - Looking northwest at toppled wing wall

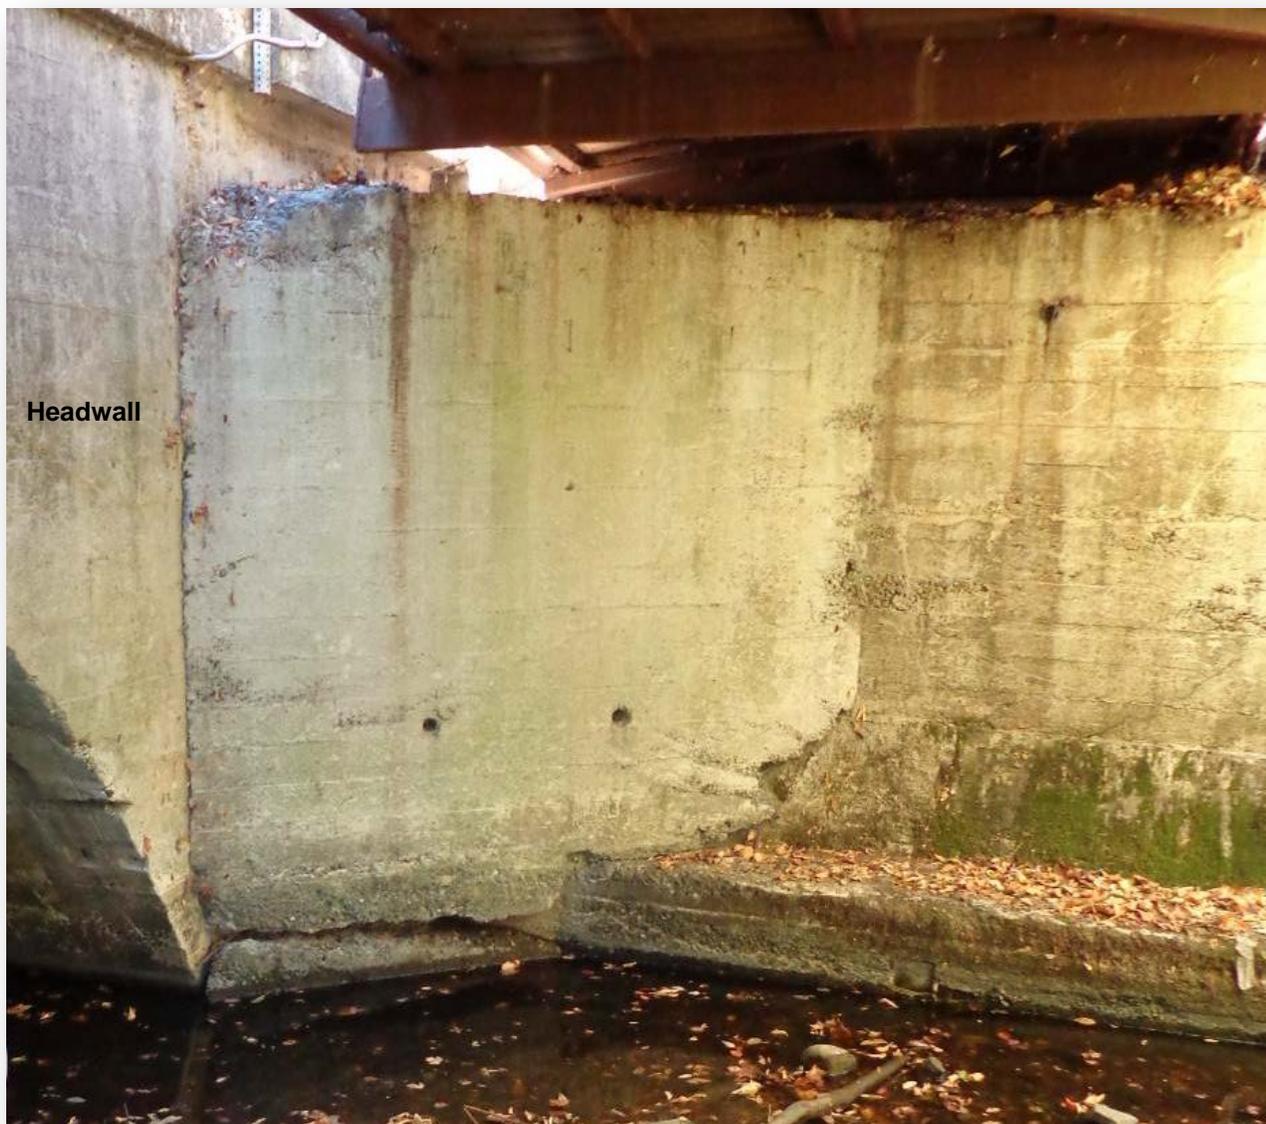
Cracked northwest bridge wingwall, upstream

inspected for scour. However, some scour or undermining of the wall structures at the inlet and outlet of the bridge have been observed in the 2013 and previous visits. The bridge does not have formal integrated wingwalls, but concrete walls have been added at the right side of the inlet and the left side of the outlet. Both of the wingwalls appear to lack adequate foundations, drainage backfill, and structural connection to the bridge structure. Upstream from the inlet an angled concrete wall was added apparently to deflect flow from otherwise impinging directly on the bridge headwall. The angled concrete wall was apparently founded directly on the then existing creek bed and not structurally connected to either the bridge headwall or the right bank vertical concrete retaining wall it joins with. The wall is undermined several inches and cracked, as shown on the photo of the previous page.

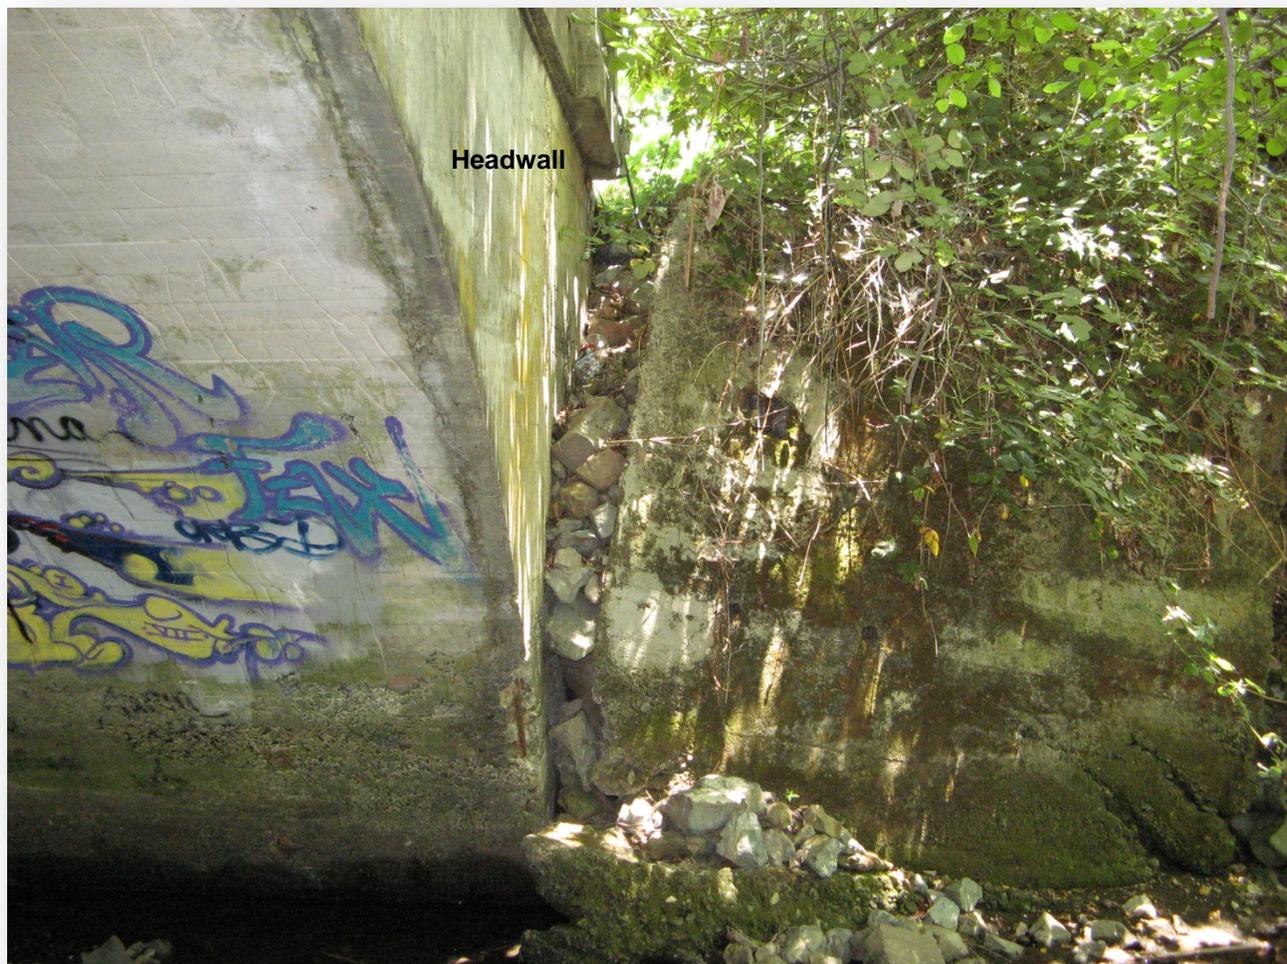
Downstream from the bridge the left bank is aligned straight projecting out from the bridge outlet and erosion pressure is focused at the left toe of arch span at the outlet and the toe of the left bank immediately downstream. A near-vertical concrete wall was added to protect the bank from undermining and erosion pressure. However, the wall is presently severely undermined and rotated out of position.

Toppled Wingwall at southeast corner, downstream

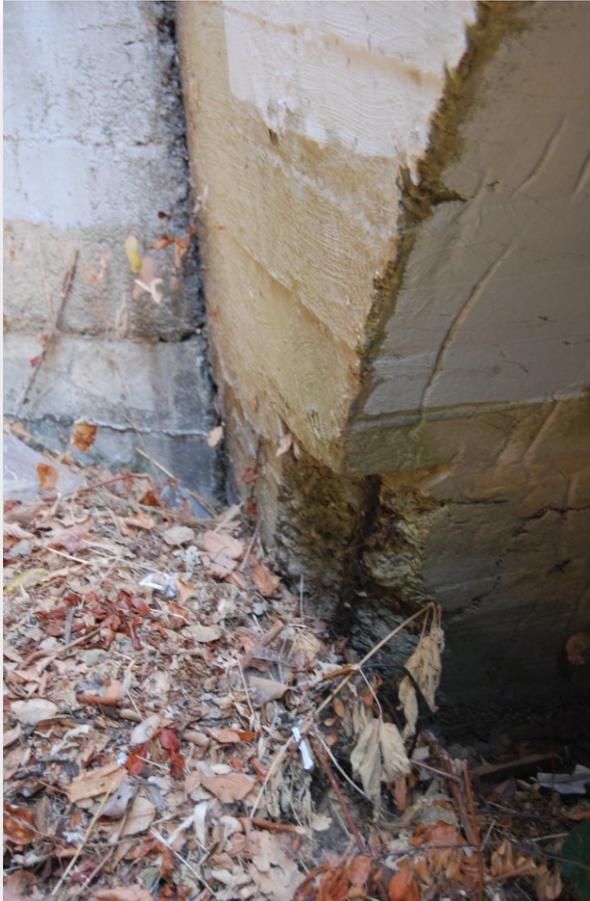
Concrete spall at east abutment
