# Summary of Seismic Retrofit Strategy Report for Creek Road Bridge over San Anselmo Creek

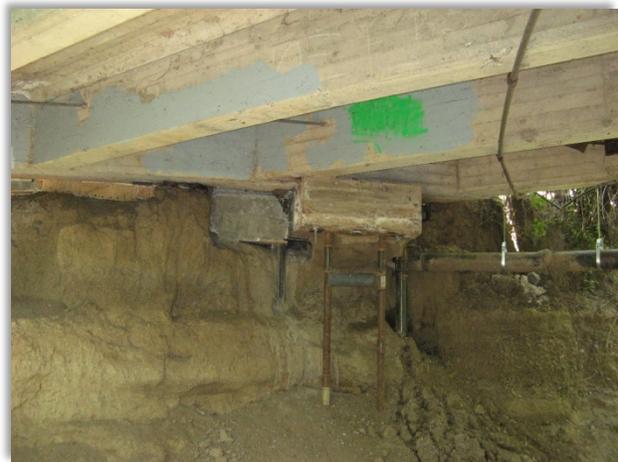
Bridge abutment washout & exposure of New Year's Eve 2005

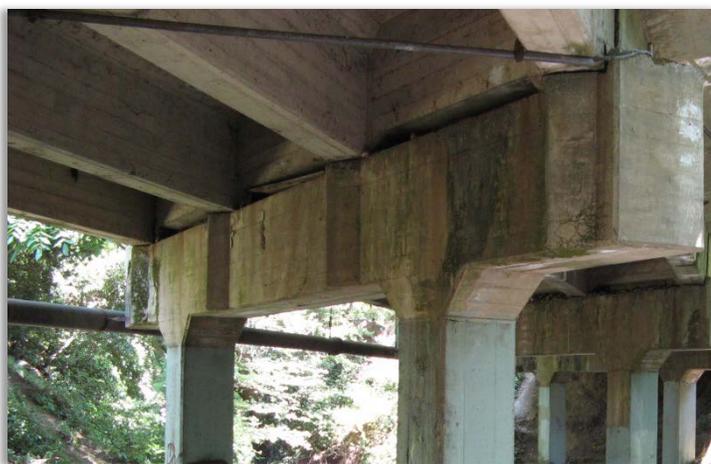
- Being a series of simple spans, the bridge superstructure is not rigidly connected to the substructure to participate in its seismic resistance, and instead sits on the

Lack of connection between girders and bent cap is evident

bent caps and columns as dead weight.

- The lack of connectivity between the super- and substructure, and lack of shear keys acting as stoppers, pose a real danger of the bridge superstructure unseating from the bent caps during a large seismic event and resulting in collapse. The edge of deck is currently offset on each side of the expansion joints, pointing to differential movements of the spans relative to each other due to past seismic events, extreme creek flows, or both. Other distress caused by these movements,

- b. Placement of cable restrainers to tie the superstructure together over the cap beams and a transverse and longitudinal shear key system at each bent to keep the superstructure seated on the bent caps and engage the rest of the substructure.
- c. Construction of seismic approach slabs at the existing bridge abutments. Repairs requiring joint seal replacements at the abutments and the three bent locations on the bridge are also included.

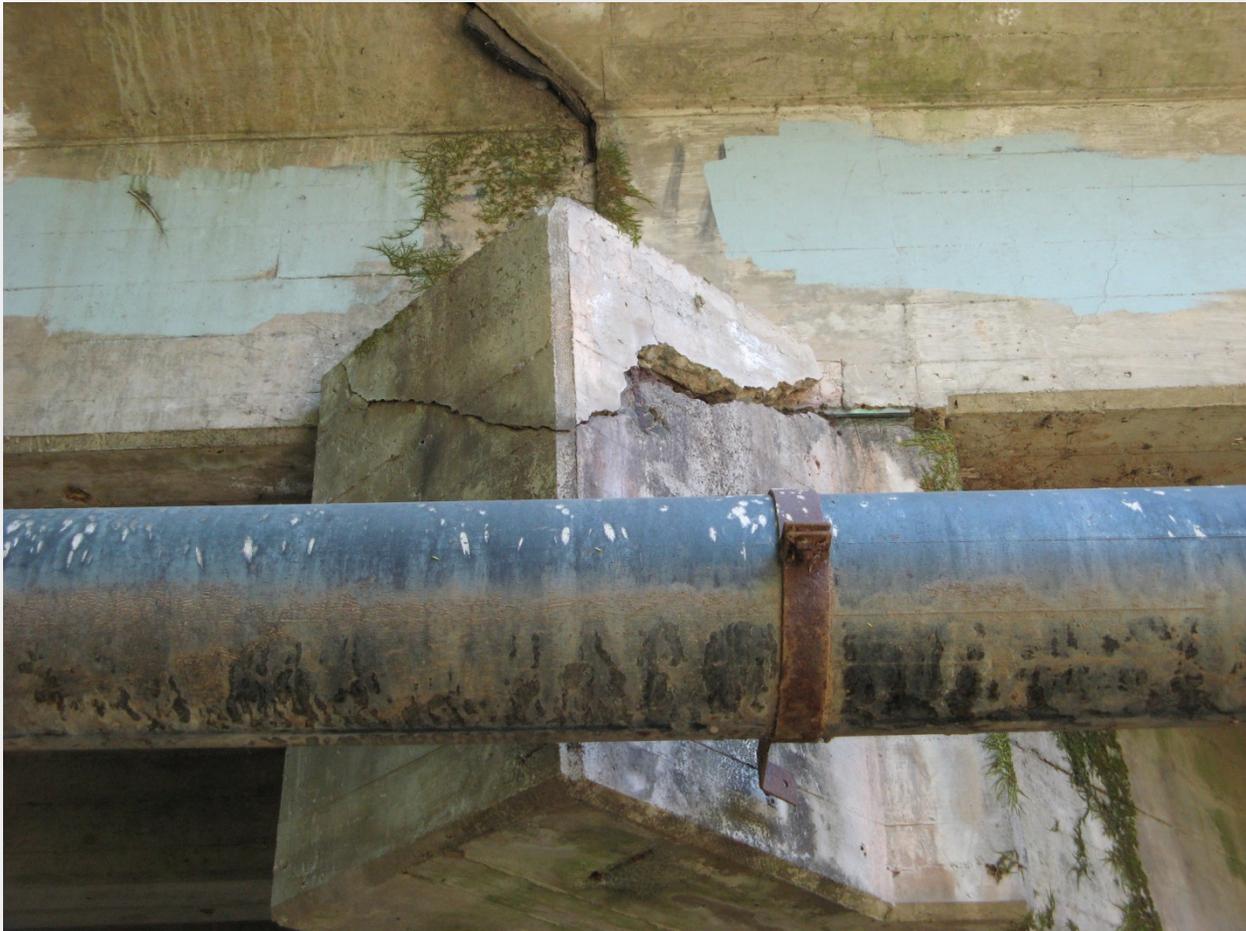
such as a cracked bent cap beam corner caused by grinding from the superstructure, is also evident as shown below.

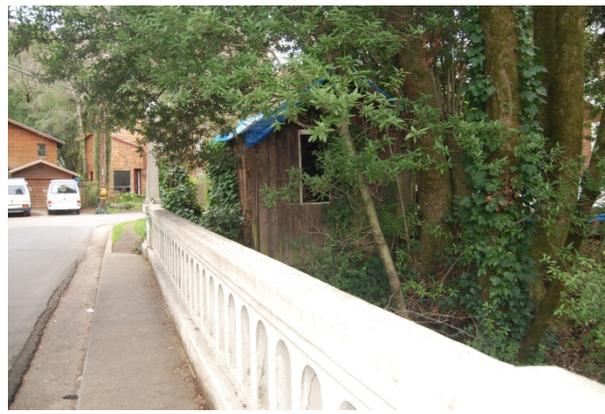
Figure 2 – Close proximity of private parcels to the bridge

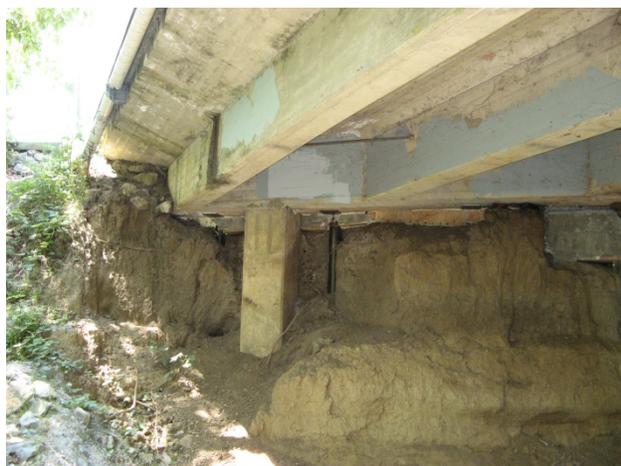
Figure 3 –Abutment washout of New Year's Eve 2005

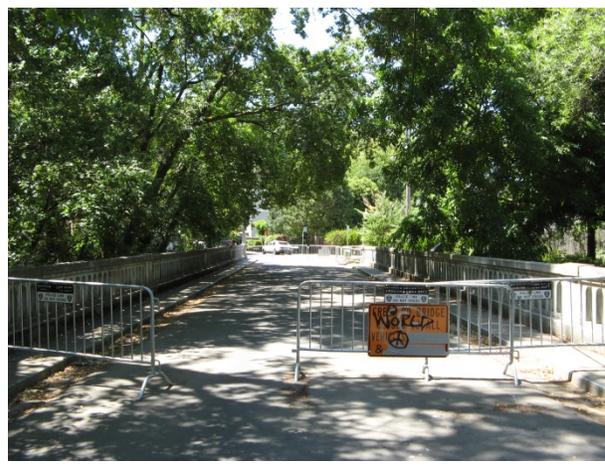
Figure 4 –Bridge closure after flooding of December 2005

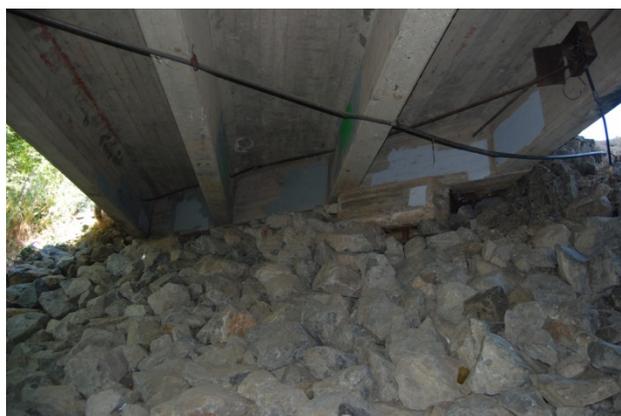
Figure 5 –Abutment fortifications after repairs

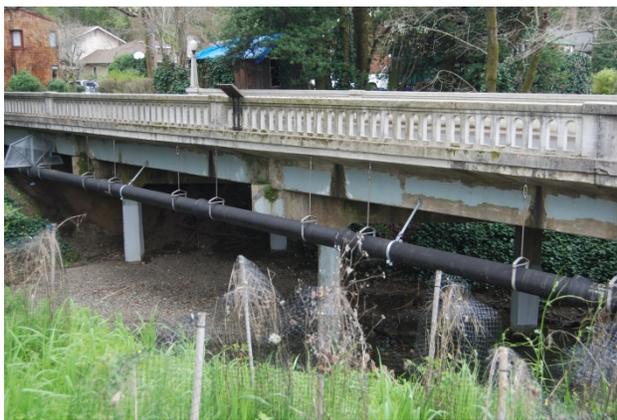
Figure 7- Utility pipe on the bridge

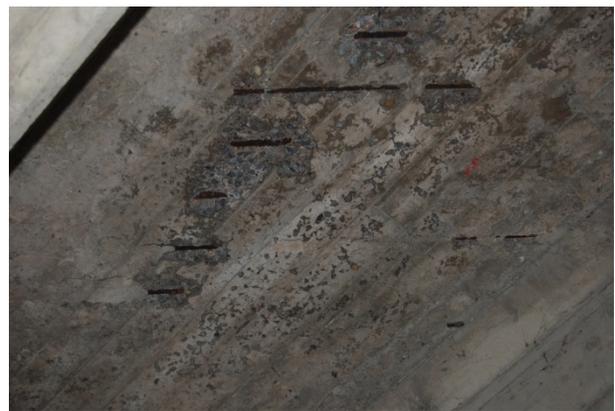
Figure 8 – Exposed rebar due to insufficient concrete cover

The BIR notes numerous concrete spalls (flaking and chipping), exposing the reinforcement and resulting in its rusting. These preventive maintenance needs must be addressed during the construction of any of the four retrofit options presented, and will naturally go away if the bridge is replaced. Funding for these corrections will be included by this federal/State program.

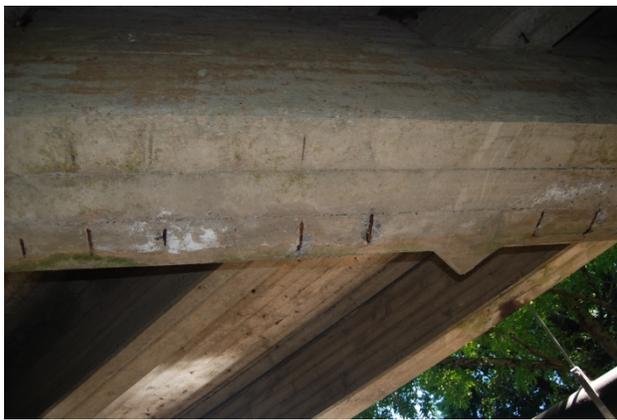
Figure 9 – Exposed rebar on girder

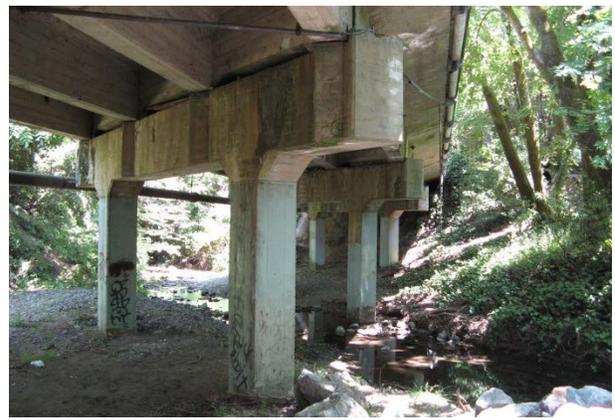
Figure 10 –Retrofit infill wall will be between the columns

exposed and made larger. The infill wall, dowelled into the insides of the columns and the underside of the bent cap, closes the huge rectangular space between the sets of columns at each bent. The columns and caps will no longer be separate entities but act together as a huge diaphragm that will be hard to tip over sideways. Having enlarged the footings, the structure will also resist any longitudinal seismic movements. With this approach, the deficiencies of the concrete cap beams over the columns, potentially leading to their brittle failure, are addressed as well.

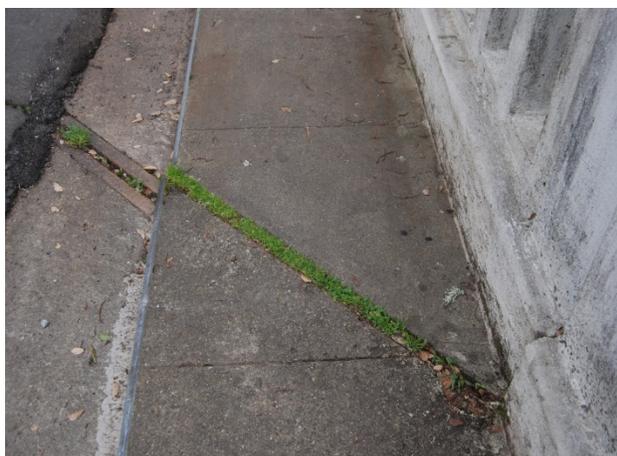
Figure 11 –Filled-in and offset expansion joint

- c. Repairs requiring joint seal replacement at five locations on the existing bridge are also included.

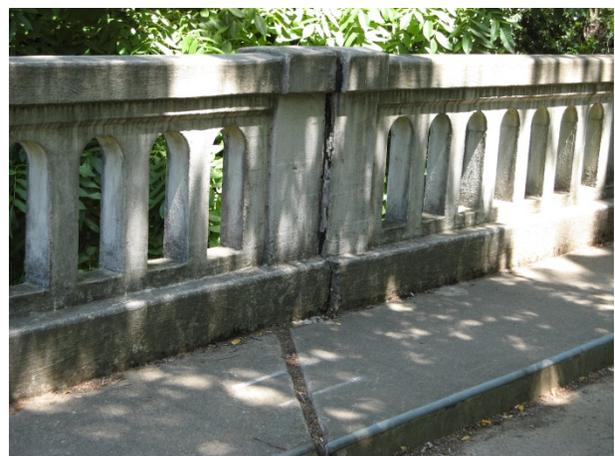
Figure 12 – Offset expansion joint and substandard barrier
