Meadow Way Bridge Repairs Project Description

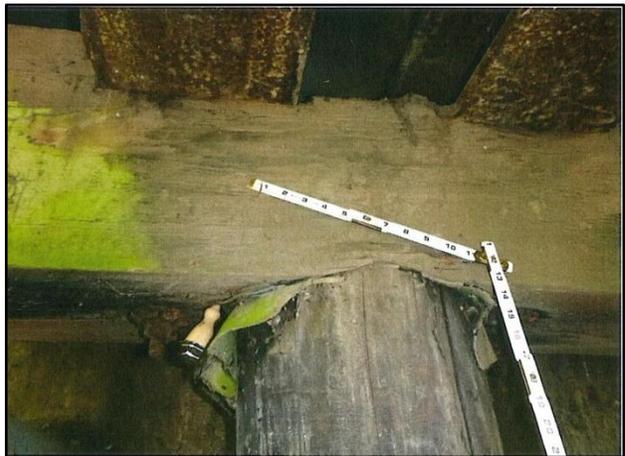
Caltrans returned to the site in July 2015 to re-inspect the bridge as part of the State's quality control program and because of the bridge's condition, age and its timber materials. The 2015 inspection revealed two critical deficiencies that need immediate repairs. First, the wooden 12" x 12" transverse cap beam on top of the piles at Abutment 5, supporting stringers that carry the bridge deck, is dry-rotted. Secondly, one pile head at Pier 3, supporting a similar wooden cap beam, has split. Caltrans has stated the current conditions cannot wait to be addressed when the bridge is replaced several years from now. Caltrans has directed the Town to make these repairs within six months of notification in August 2015, or the bridge will have to be closed.

Cap Beam at Abutment 5 – At this location, the bridge deck and stringers are supported on a 12" x 12" by 14-foot long wooden beam that sits atop three vertical 12" diameter wooden piles. The above-ground lengths of three piles have been encased in a thick concrete platform to within four feet of the bottom of the longitudinal stringers that carry the deck. Access to the abutment concrete platform will be achieved by using ladders placed on the dry creek bed.

Crushed cap Beam at Abutment 5

The repairs will start with standing three pieces of 12' x 12" x 2'-9" long wooden blocks on top of the platform, one next to each existing pile. Each wooden block will be fastened to the platform using two prefabricated galvanized steel brackets that bolt to the block and the platform. To fasten each bracket to the concrete platform a six-inch long hole will be drilled into the concrete (total of six). The holes will be filled with special epoxy cement, an all-thread rod will be placed in each hole and the epoxy is allowed to set up. The three wooden blocks will also be strapped to the existing pile heads above the concrete platform. Next, a new 12" x 12" beam will be placed on top of the wood blocks and attached to them using two L-shaped galvanized brackets at each location (total of six). The new transverse beam will reach the bottom of the steel stringers and any gap remaining between the wood stringers and the beam will be filled with short lengths of wood and wedges until all stringers bear on the beam completely. The dry-rotted beam and the existing pile heads will remain in place and, as the old beam slowly disintegrates, the deck loading transfers to the new auxiliary beam and blocks.

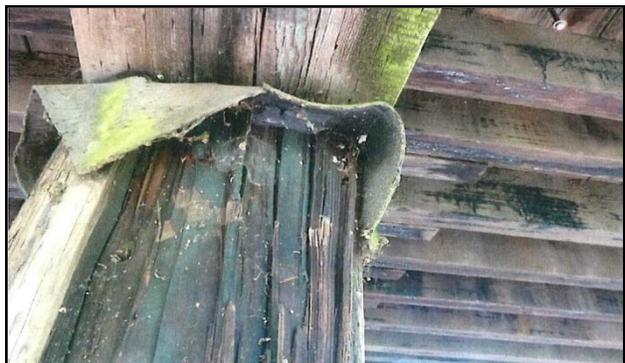
Split Pile Head at Pier 3

Pile Head at Pier 3 – The top of the leftmost pile at this location will be banded to contain the pile head and stop the splitting. Each band will consist of one-inch wide, 3/32-inch thick steel bars formed into two semi-circular fasteners clamped around the top of the split pile head with two sets of bolts, nuts and washers. Three sets of such bands will be used next to each other at the top. The location of the repair is approximately 18 feet above the creek bed and will be accessed using ladders.
