Bridge Number: **27C0008**Bridge Name: **SAN ANSELMO CREEK**

Bridge Number : 27C0008
Facility Carried: MEADOW WAY
Location : IN FAIRFAX
City : FAIRFAX
Inspection Date : 09/28/2016

Bridge Inspection Report

STRUCTURE NAME: SAN ANSELMO CREEK

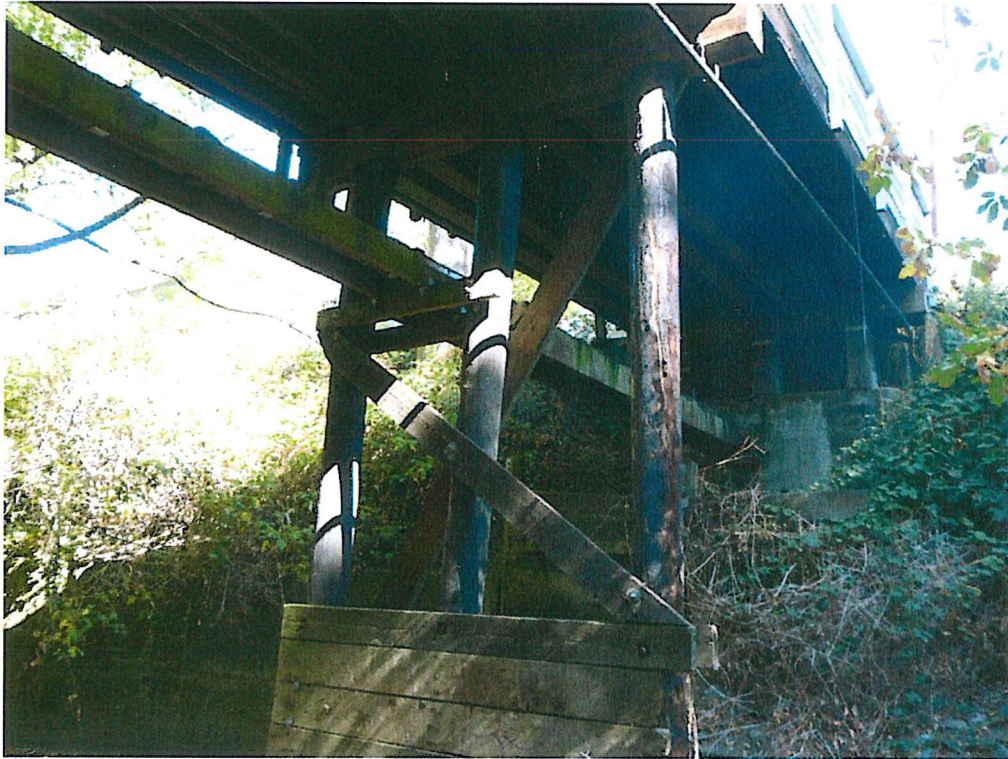
Photo No. 1

Routine underside view, looking northeast.

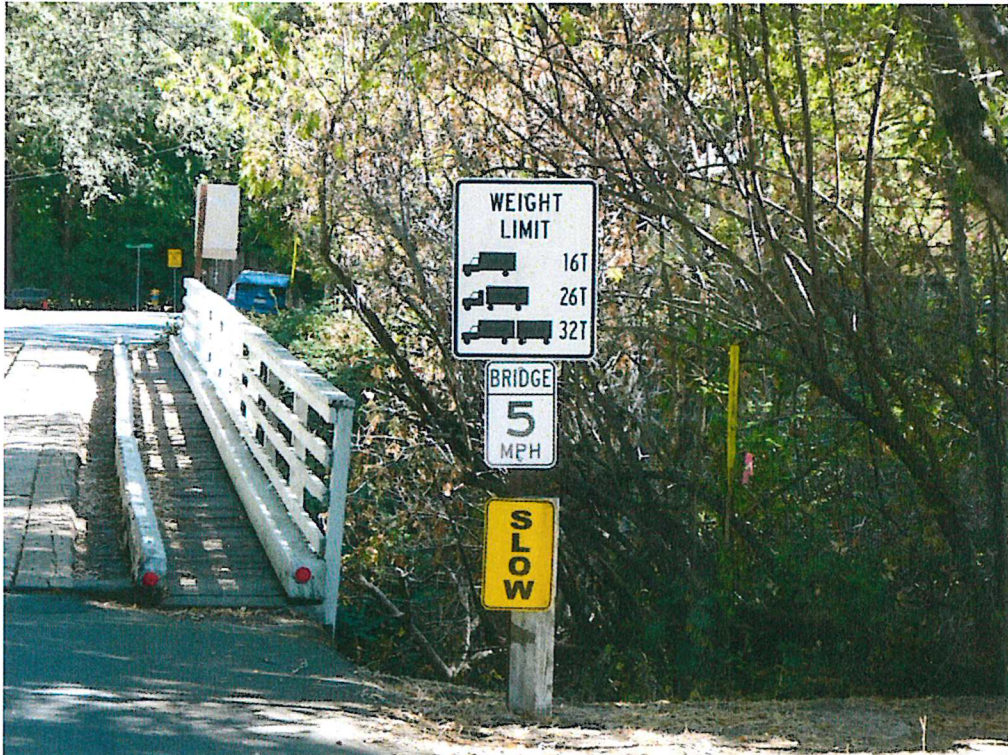
Photo No. 2

"5 MPH"
"SLOW"
WEIGHT LIMIT
16 TONS PER VEHICLE
26 TONS PER SEMI-TRAILER COMBINATION
32 TONS PER TRUCK AND FULL TRAILER

Weight Limit and Speed Reduction signs, looking east (typ).

RecDate: 09/28/2016	EstCost:	Replace weight limit signs at bridge per
Action : Bridge-Install Sign	StrTarget: 2 YEARS	the upgraded safe load capacity
Work By: LOCAL AGENCY	DistTarget:	calculations as follows:
Status : PROPOSED	EA:	18 TONS (Type 3)
		28 TONS (Type 3S2)
		35 TONS (Type 3-3)
RecDate: 07/16/2015	EstCost:	Replace timber bent cap at Pier 5 and
Action : Sub-Misc.	StrTarget: 6 MONTHS	Column 3 of Pier 3.
Work By: LOCAL AGENCY	DistTarget:	
Status : PROPOSED	EA:

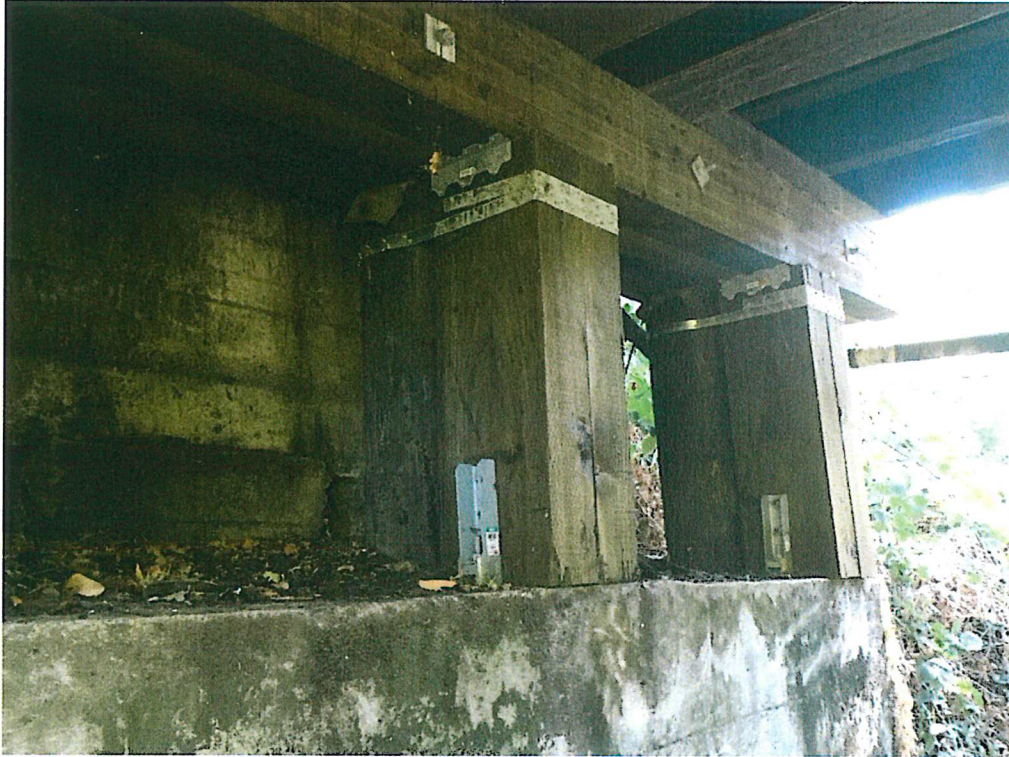
Photo No. 3

Bent Cap 5 exhibits a vertical split along its full length and has crushed approximately 1 inch vertically over Column 1. The interior of the cap exhibits decay (primarily along the vertical split) which affects approximately 50% of the cross section of the cap.

An auxiliary timber bent has been constructed adjacent to Bent 5 with columns and bent cap longitudinally connected to the original bent. This auxiliary bent was constructed of built-up timber members and utilizes light-weight connection hardware typically used for wood frame building construction. This repair is considered a "Temporary repair" and thus does not upgrade the condition state for the bent cap. Refer to Photograph No. 3.

Abutment 5 repairs, looking southeast.

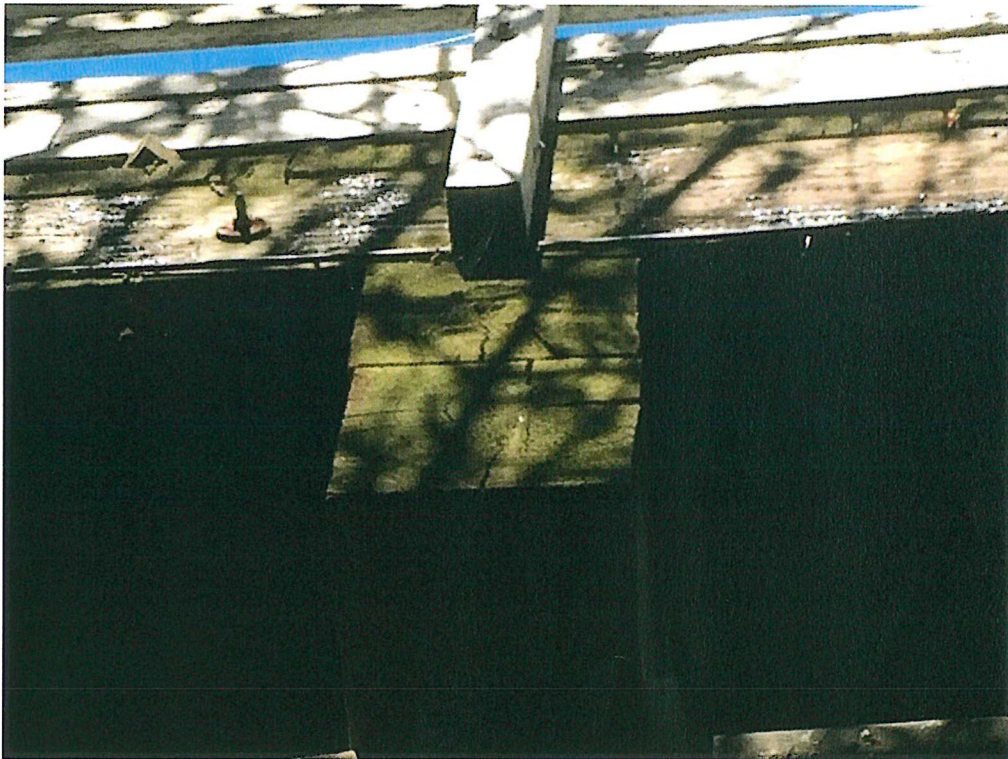
Photo No. 4

Bent Caps 2, 3 and 4 each exhibit full-length checks

Widespread checking in Bent Cap 3, looking north.

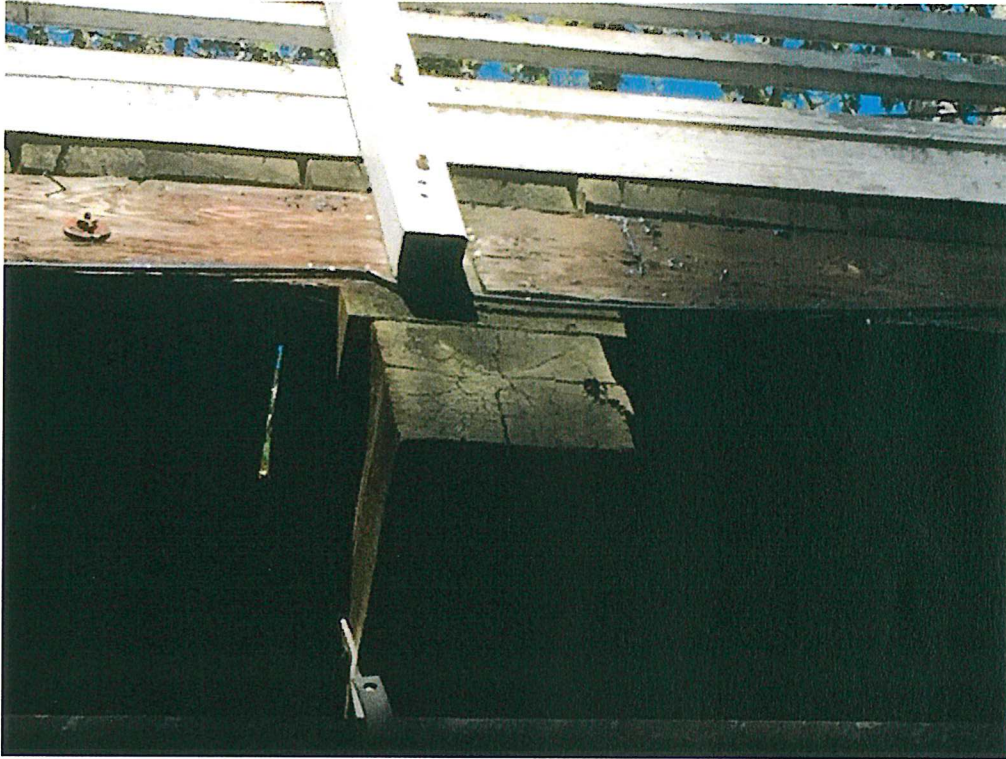
Photo No. 5

Bent cap 4 has a full-length horizontal check up to 0.25 inches wide and with up to 2 inches of penetration. Based upon field comparison with the archived report photographs, no significant changes are noted since it was initially reported on 8/10/1999.

Widespread checking and shaking in Bent Cap 4, looking north.

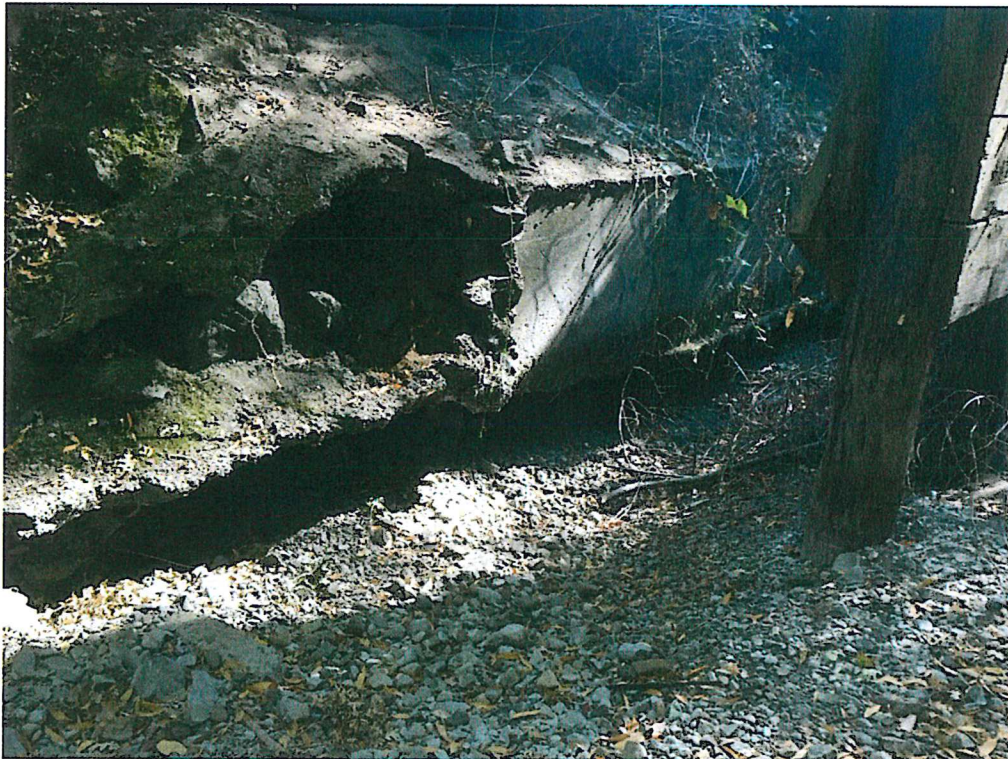
Photo No. 6

of scour countermeasures as well as visual monitoring during high flow events and measuring the channel cross sections after high flow events and during routine bridge inspections. There is also extensive lateral scour upstream of Abutment 5 which remains relatively unchanged as compared to the description from the scour plan of action

The Abutment 5 concrete slope protection is undermined approximately 12 linear feet, up to 1.5 feet vertically with up to 3.5 feet of penetration. Based upon field comparison with the archived report photographs, no significant changes are noted over the previous inspection interval.

Concrete slope protection scour and undermining at the Abutment 5 embankment, looking south
