April 23, 2020

Bridge Number : 27C0008
Facility Carried: MEADOW WAY
Location : 0.1 MI SE OF CASCADE DR
City : FAIRFAX
Inspection Date : 10/22/2019

Bridge Inspection Report

STRUCTURE NAME: SAN ANSELMO CREEK

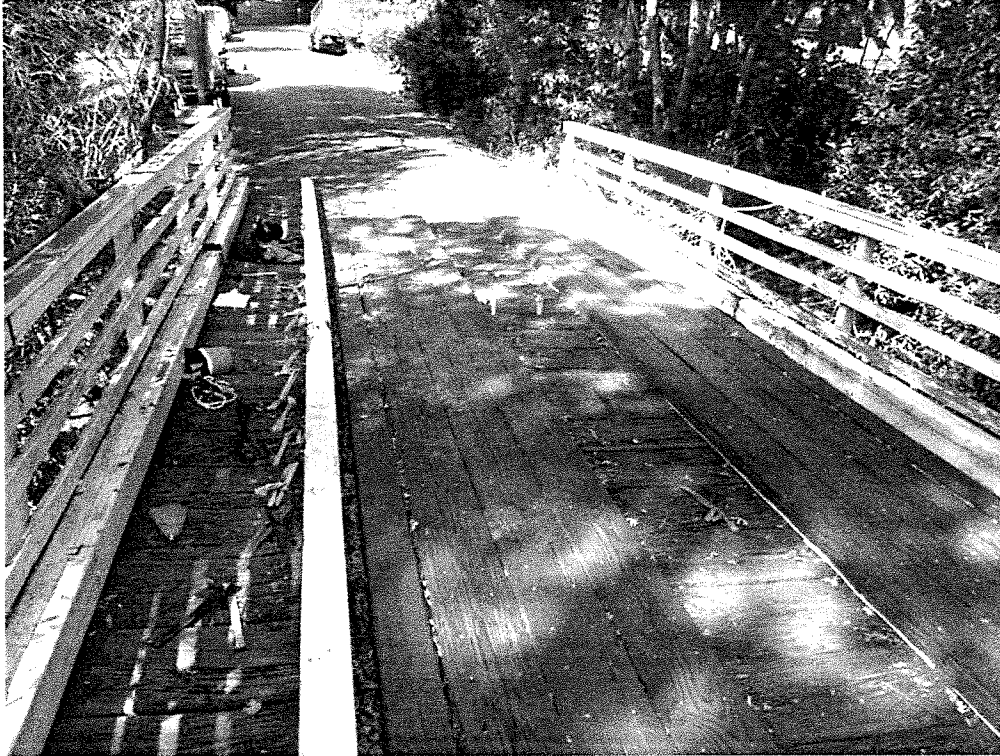
Photo No. 1

techniques. Performing the inspection were Area Bridge Maintenance Engineers Mark Efe, Rachel Donovan, Roman Granados, and Edward Thometz. Use of an awl secured to a telescoping pole was utilized to investigate the integrity of the timber elements. See Photos 1 and 2.

Tubular webbing wrapped over deck planks for aid climbing.

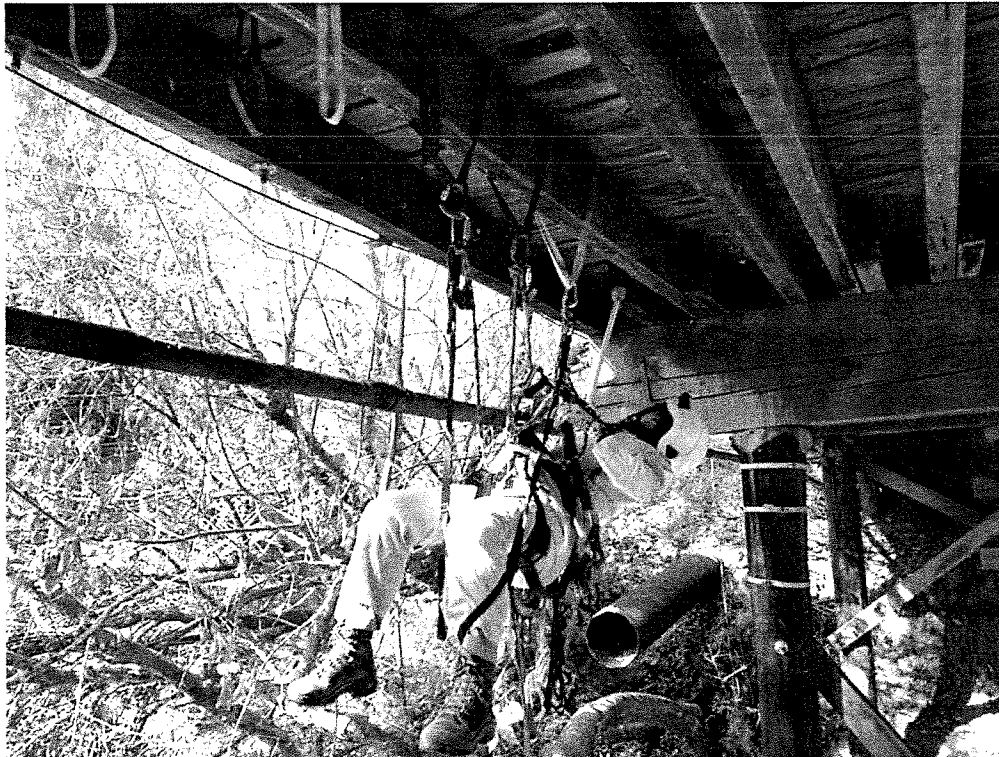
Photo No. 2

Climber using horizontal aid technique and awl on telescoping pole to assess timber.
