## INTRODUCTION

**SPECIFICS OF MEADOW WAY BRIDGE**

## **ALTERNATIVE OPTIONS**

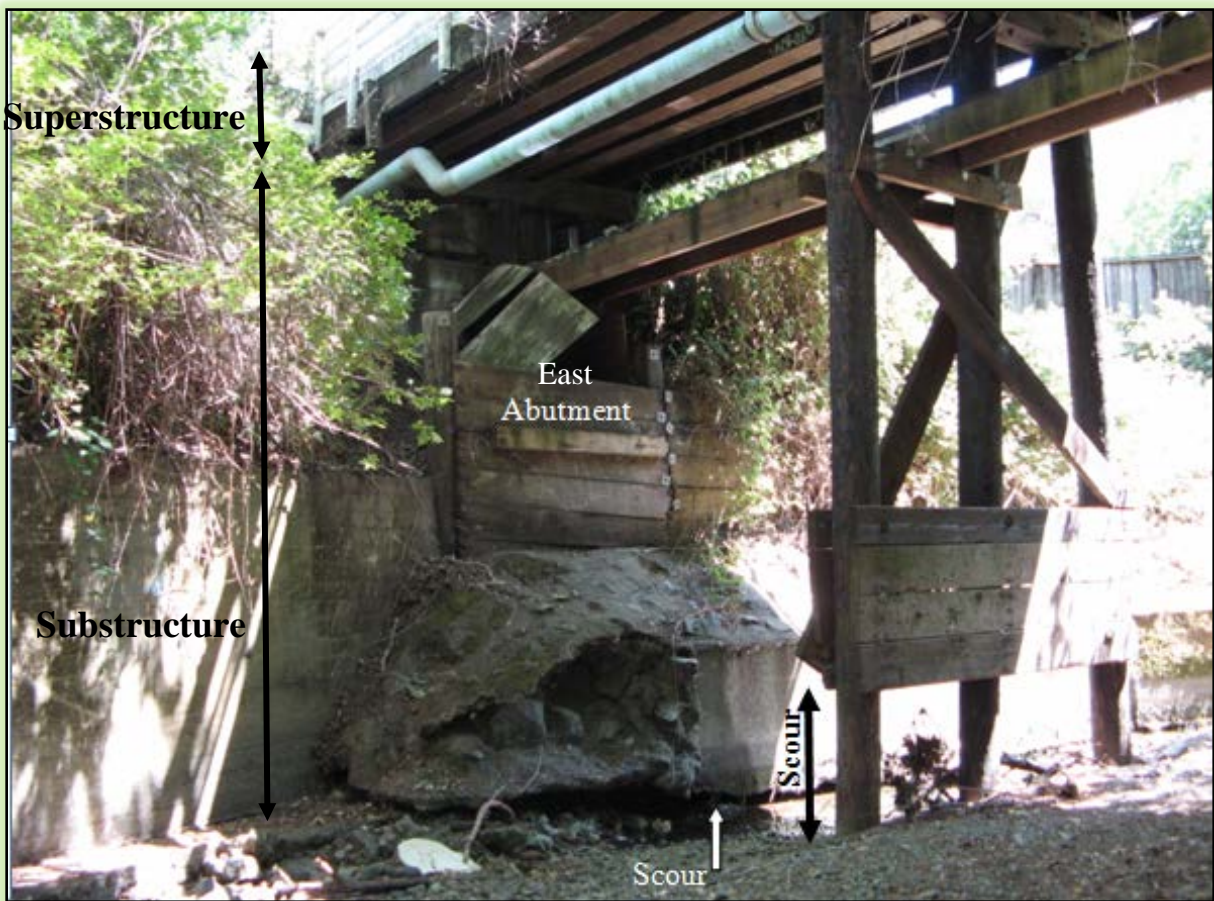
Below are definitions of some of the bridge terms used in this response:

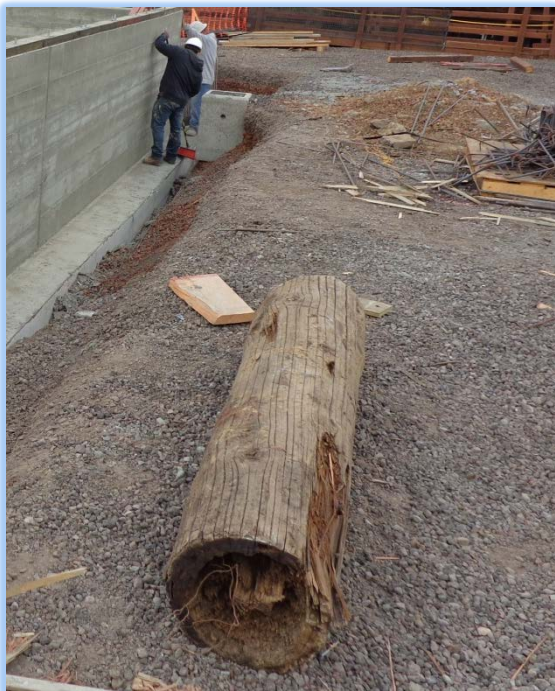
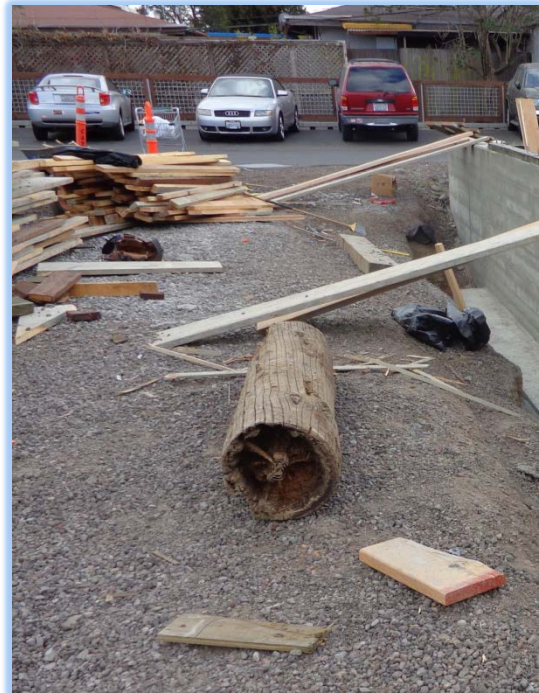
- The repairs cannot rid the structure of its creosote contamination.
- The depth of the driven timber pilings in the ground cannot be determined. The ground around the pilings has eroded 3-4 feet since they were installed over 60 years ago and has reduced their safe embedment lengths by that much. The remaining depth, whatever it is, will likely not meet today's engineering criteria.
- The condition of the piles underground cannot be determined. The underground segments of the pilings may be entirely rotted and hollowed out beyond the one inch or so of creosote penetration. Below are a couple of photos of similar pilings recently extracted from a site in Sausalito by CIC's geotechnical subconsultant. The piles at Meadow Way may be in similar condition and the structure will need to be propped up with auxiliary pilings.

Caltrans. This report found scour present as deep as 3.5 feet at the bridge pile extensions and dangerous undermining of the easterly bridge abutment, classified the bridge as scour-critical and recommended scour countermeasures. These conditions are depicted in the photo on page 2. This report was filed after the funding application for bridge replacement had already been approved. In response, Caltrans stated that the scour condition would be addressed with bridge replacement and did not agree to a separate fix before the bridge was replaced.

Two other important conditions, also specific to Meadow Way Bridge, are the creosote coating on the timbers and the underground condition of the wood pilings. The former will make any kind of repair work hazardous, requiring special and costly precautionary work conduct and disposal measures. After all is said and done, creosote will still be around. As far as the underground segments of the timber piles are concerned, their soundness cannot be accurately determined without invasive testing, but based on our experience they are most likely in a deteriorated condition (see page 5 for example). However, their embedded lengths are impossible to surmise without plans.

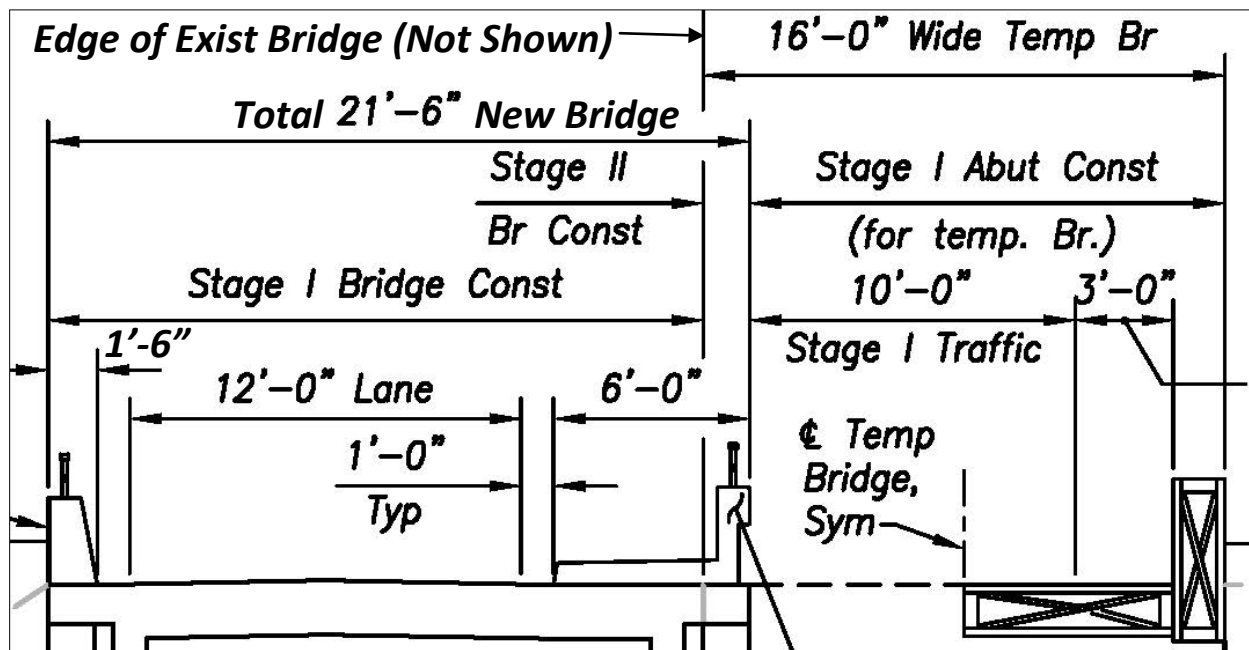
**Cross Section of the New and Temporary Bridges**

The CIC team has performed preliminary studies and cost analysis of three bridge concepts made from wood, concrete or steel. Each bridge will clear-span the creek. The new bridge may have one standard 12' lane, a 1' shy-away strip on each side of the lane, a 5'-wide sidewalk on the south side and safety rails on each side of the deck, as shown below:

Response – any bridge constructed will have one lane, a 5’ sidewalk and safety railing on both sides. Currently, our concepts show a section through the bridge being comprised of a 1.5-foot wide railing on the north side, a 1-foot shy-away strip, a 12’ lane, another 1-foot shy-away, a 5-foot sidewalk and a 1-foot railing on the south edge, producing a total edge-to-edge width of 21.5 feet. This is shown on cross section view on page 7. We can delete the two 1-foot shy-away strips, which are there for additional safety, to reduce the width to 19.5 feet, which is the minimum width Caltrans may approve. As noted earlier, the total width of the existing bridge is 14 feet.

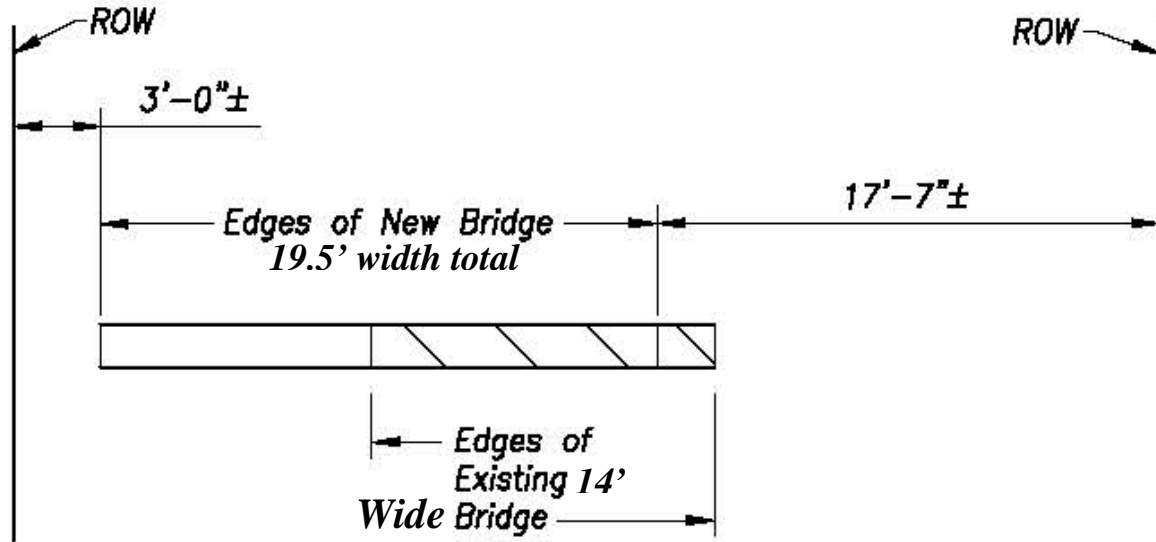
### Relative Locations of New and Existing Bridges

The one-lane provision will still need to be approved by Caltrans as a "Design exception," but we believe the existing conditions would support such a request. In comparison, the existing bridge is 14 feet wide with a 10-foot lane for traffic, 2.5 feet for pedestrian walkway, and 1.5 total feet for railings and a separator strip. The minimum Caltrans standard for a new bridge is 19.5 feet wide with 12 feet for traffic lane, 5 feet for pedestrians/bikes, and 2.5 feet total for safety rails on both sides. The diagram below shows the dimensions and relative locations of the existing bridge and a new bridge of minimum width,

as well as public right-of-way (ROW). Since the traffic has come closer to the public ROW on the north side, CIC can consider switching the location of the sidewalk to that side to bring the cars closer to the middle of the street and farther away from the homes on the north side.

The existing bridge is assumed to be in the middle of the presumed 40’-wide street right-of-way. (Right-of-way information will be researched and verified for this project in the next phase.) The center of the new bridge will be approximately 5.75 feet offset to the north from the center of street. In other words, if the 21.5-foot wide bridge is selected, the north edge of the bridge will be 16.5 feet north of the centerline and the south edge of the bridge will be 5 feet south of the street centerline. If the 19.5-foot wide bridge is selected, the north edge will be 14.5 offset from the street centerline and the south edge remains 5 south of the street center. Considering the fact that each half of the public right-of-way is 20’(to be confirmed), the bridge will remain within the street boundaries.
