# Seismic Retrofit Report for Creek Road Bridge over San Anselmo Creek (Bridge No. 27C-0144)

## Executive Summary

## Summary of Analyses, Findings, Issues, Retrofit Alternates and Recommendations

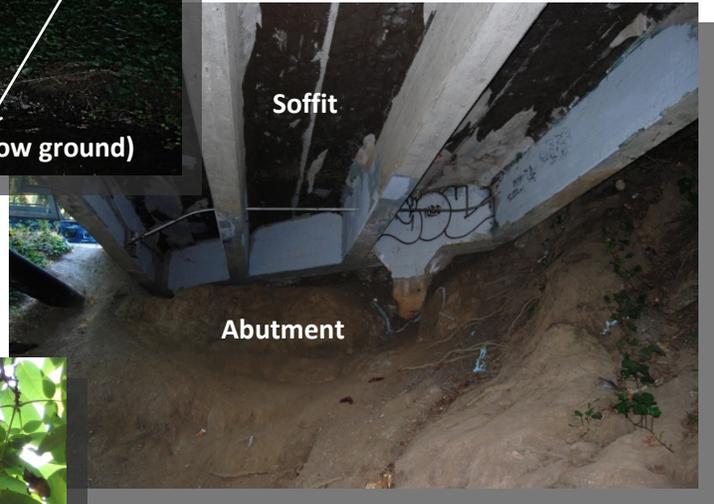
Substructure Area

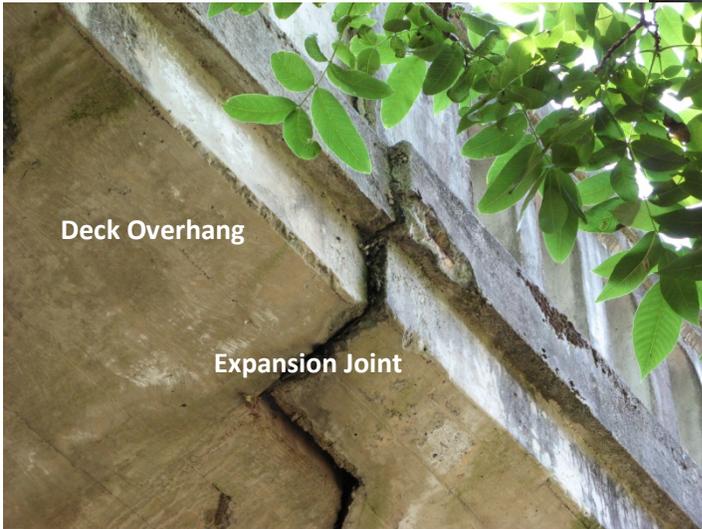
Overhang Area at the edge of deck

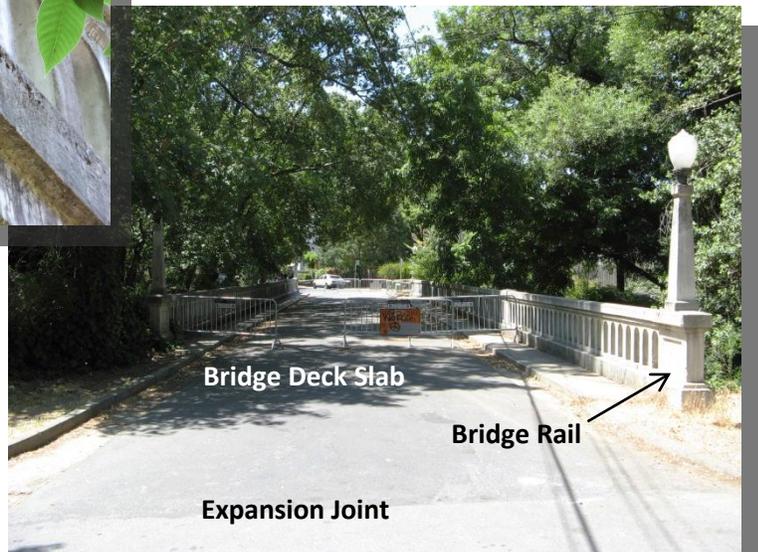
Superstructure Area

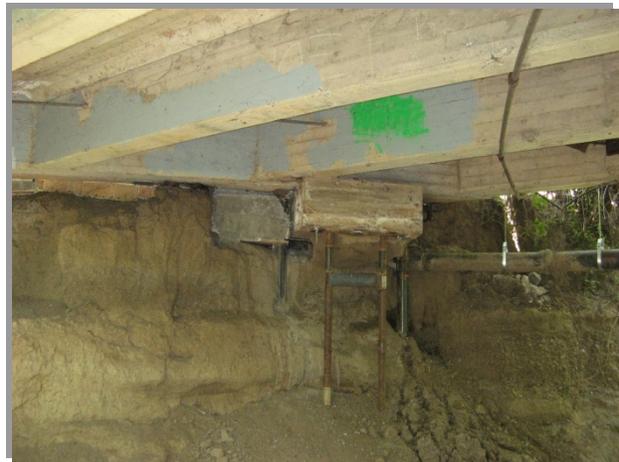
This bridge is located on a wide section of San Anselmo Creek. It experienced a significant washout and undermining of its west abutment during the floods of New Year's eve, 2005, although the water never exceeded a 7-8 feet height above the creek bed nor did it impinge on the girders. The washout may be attributed to not only the forces of the flow and soil conditions, but the unusual abutment configuration described earlier. The bridge was closed to vehicular traffic due to its gaping abutment exposure while the Town obtained funds and implemented repairs for it. During that time, motorists used a detour around the bridge via other streets. The abutment was underpinned and protected with a substantial course of rock riprap in 2008 and the bridge reopened after the repairs.

Bridge abutment washout & exposure of New Year's Eve 2005

Subsequently, a September 2010 bridge scour Plan of Action (POA) report by CIC team members found no signs of new significant bridge foundation scour. None of the bridge footings were exposed during the field investigations. The riprap has, however, had the effect of reducing scour potential at the bent adjacent to this abutment (Bent 2) and slightly increasing scour potential at Bent 3 near the creek center. From field visits and probings it is surmised that each bridge column sits on 6' x 6' spread footings approximately 5 feet below the creek bed. The thickness of the footings cannot be determined without extensive excavations.

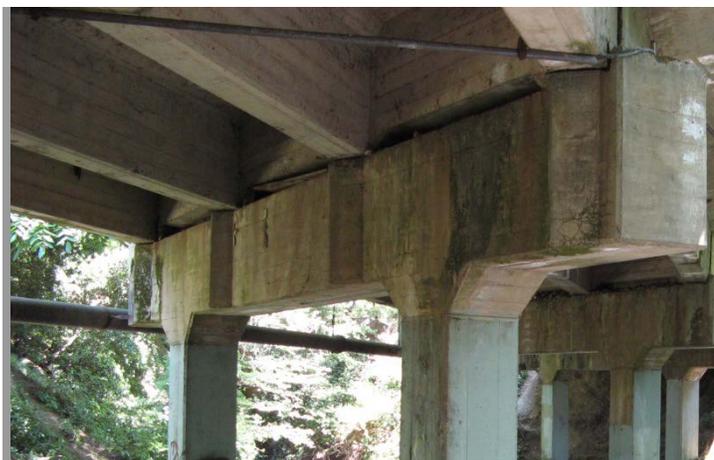
- Being a series of simple spans, the bridge superstructure is not rigidly connected to the substructure to participate in its seismic resistance, and instead sits on the bent caps and columns as dead weight.
- The lack of connectivity between the super- and substructure, and

Lack of connection between girders and bent cap is evident

lack of shear keys acting as stoppers, pose a real danger of the bridge superstructure unseating from the bent caps during a large seismic event and resulting in collapse. The edge of deck is currently offset on each side of the expansion joints, pointing to differential movements of the spans relative to each other due to past seismic events, extreme creek flows, or both. Other distress caused by these movements, such as a cracked bent cap beam corner caused by grinding from the superstructure, is also evident as shown below.

1. The girders and substructure are not tied together and there are no longitudinal or transverse shear keys on the bent caps to stop the girders from unseating, leading to collapse of the bridge.

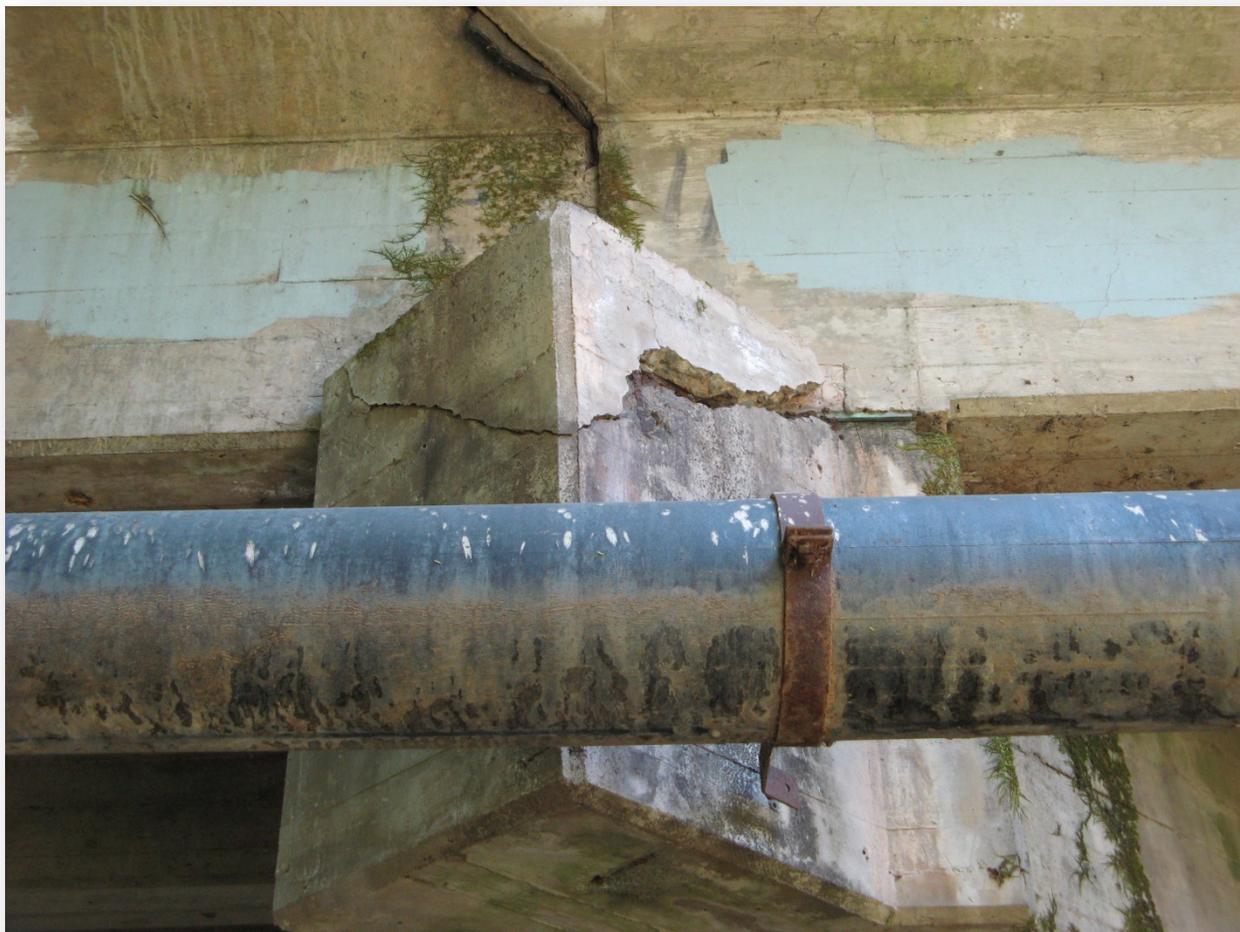
- If the superstructure doesn't unseat itself during a large seismic event, its dead inertia will sway back and forth and laterally and puts extreme bending and compressive loads on the base of the columns and on the footings. The concrete columns cores in the bridge lack adequate steel rebar to confine them and will collapse under the extreme cyclic seismic loads predicted.
- The bent caps are poorly reinforced. The analysis showed them failing in bending, caused by the columns' ultimate plastic moments under the seismic loads plus the structure's dead weight.
- The bridge is founded on relatively small spread footings, which are also seismically inadequate. The footings fail due to bearing and overturning plastic moments from the columns. Additionally, they are expected to break up due to their thin depth and typically sparse reinforcement before even reaching bearing thresholds.

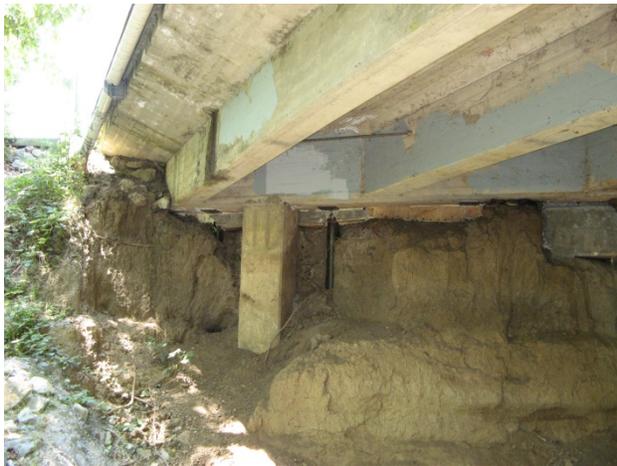
Figure 3 –Abutment washout of New Year's Eve 2005

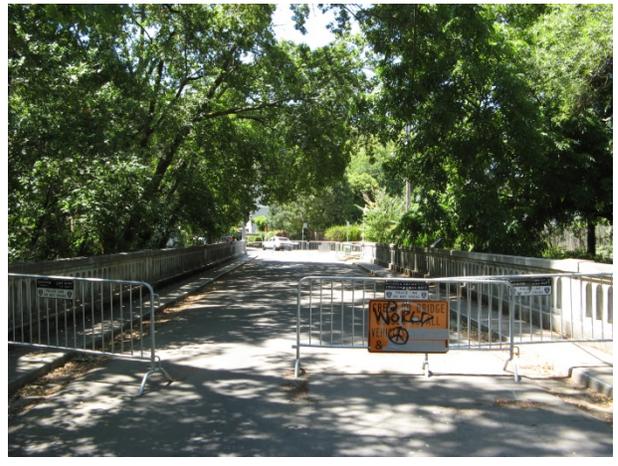
Figure 4 –Bridge closure after flooding of December 2005

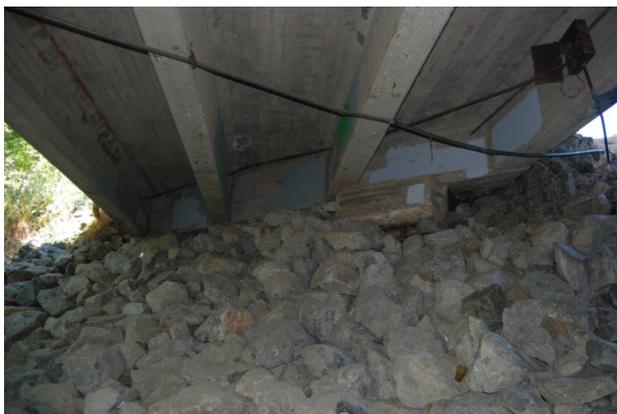
Figure 5 –Abutment fortifications after repairs

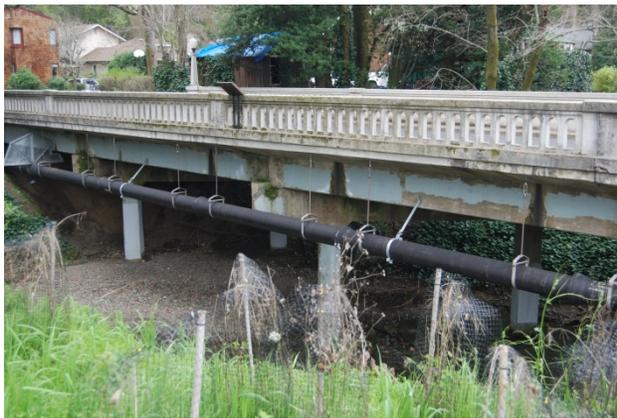
Figure 7- Utility pipe on the bridge

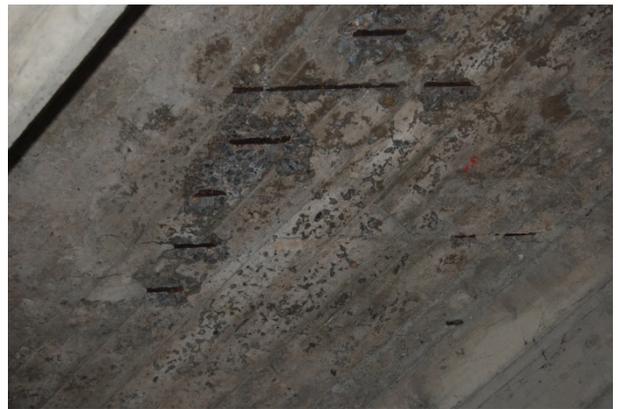
Figure 8 – Exposed rebar due to insufficient concrete cover

The BIR notes numerous concrete spalls (flaking and chipping), exposing the reinforcement and resulting in its rusting. These preventive maintenance needs must be addressed during the construction of any of the four retrofit options presented, and will naturally go away if the bridge is replaced. Funding for these corrections will be included by this federal/State program

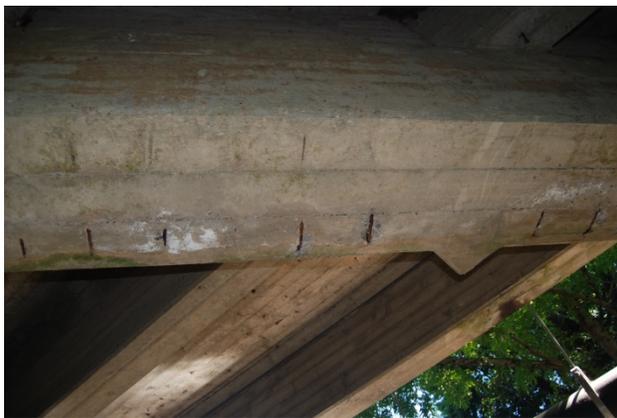
Figure 9 – Exposed rebar on girder

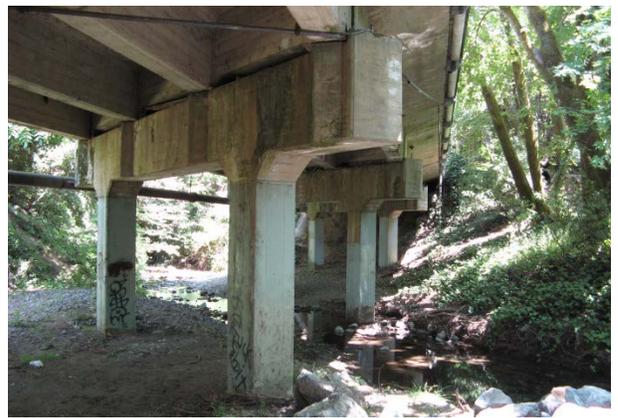
Figure 10 –Retrofit infill wall will be between the columns

- a. Enlarging its bent foundation footings and strengthening the columns by casting concrete infill walls between each pair. To do this, each of the six bridge footings in the creek will need to be exposed and made larger. The infill wall, dowelled into the insides of the columns and the underside of the bent cap, closes the huge rectangular space between the sets of columns at each bent. The columns and caps will no longer be separate entities but act together as a huge diaphragm that will be hard to tip over sideways. Having enlarged the footings, the structure

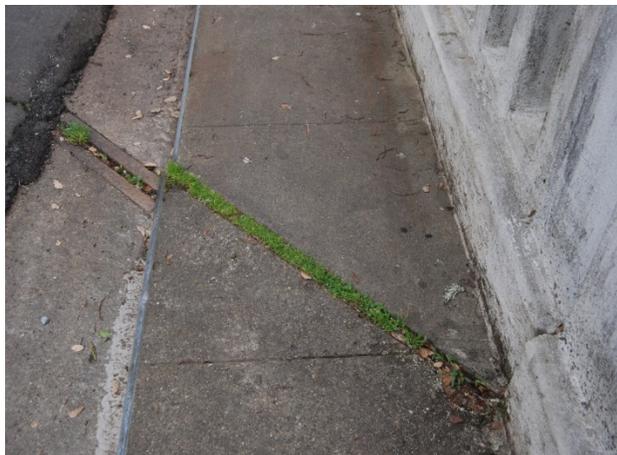
Figure 11 –Filled-in and offset expansion joint

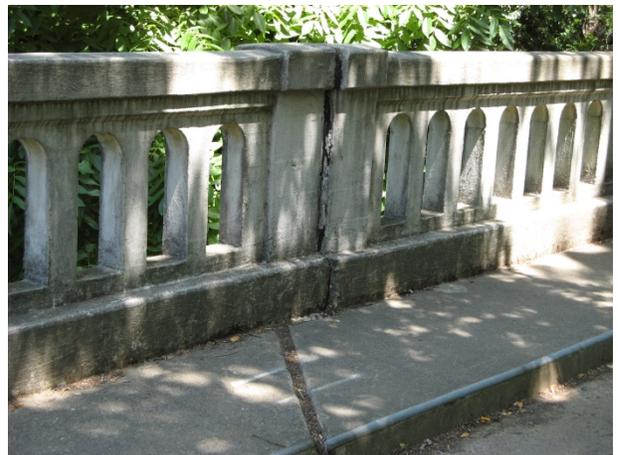
Figure 12 – Offset expansion joint and substandard barrier

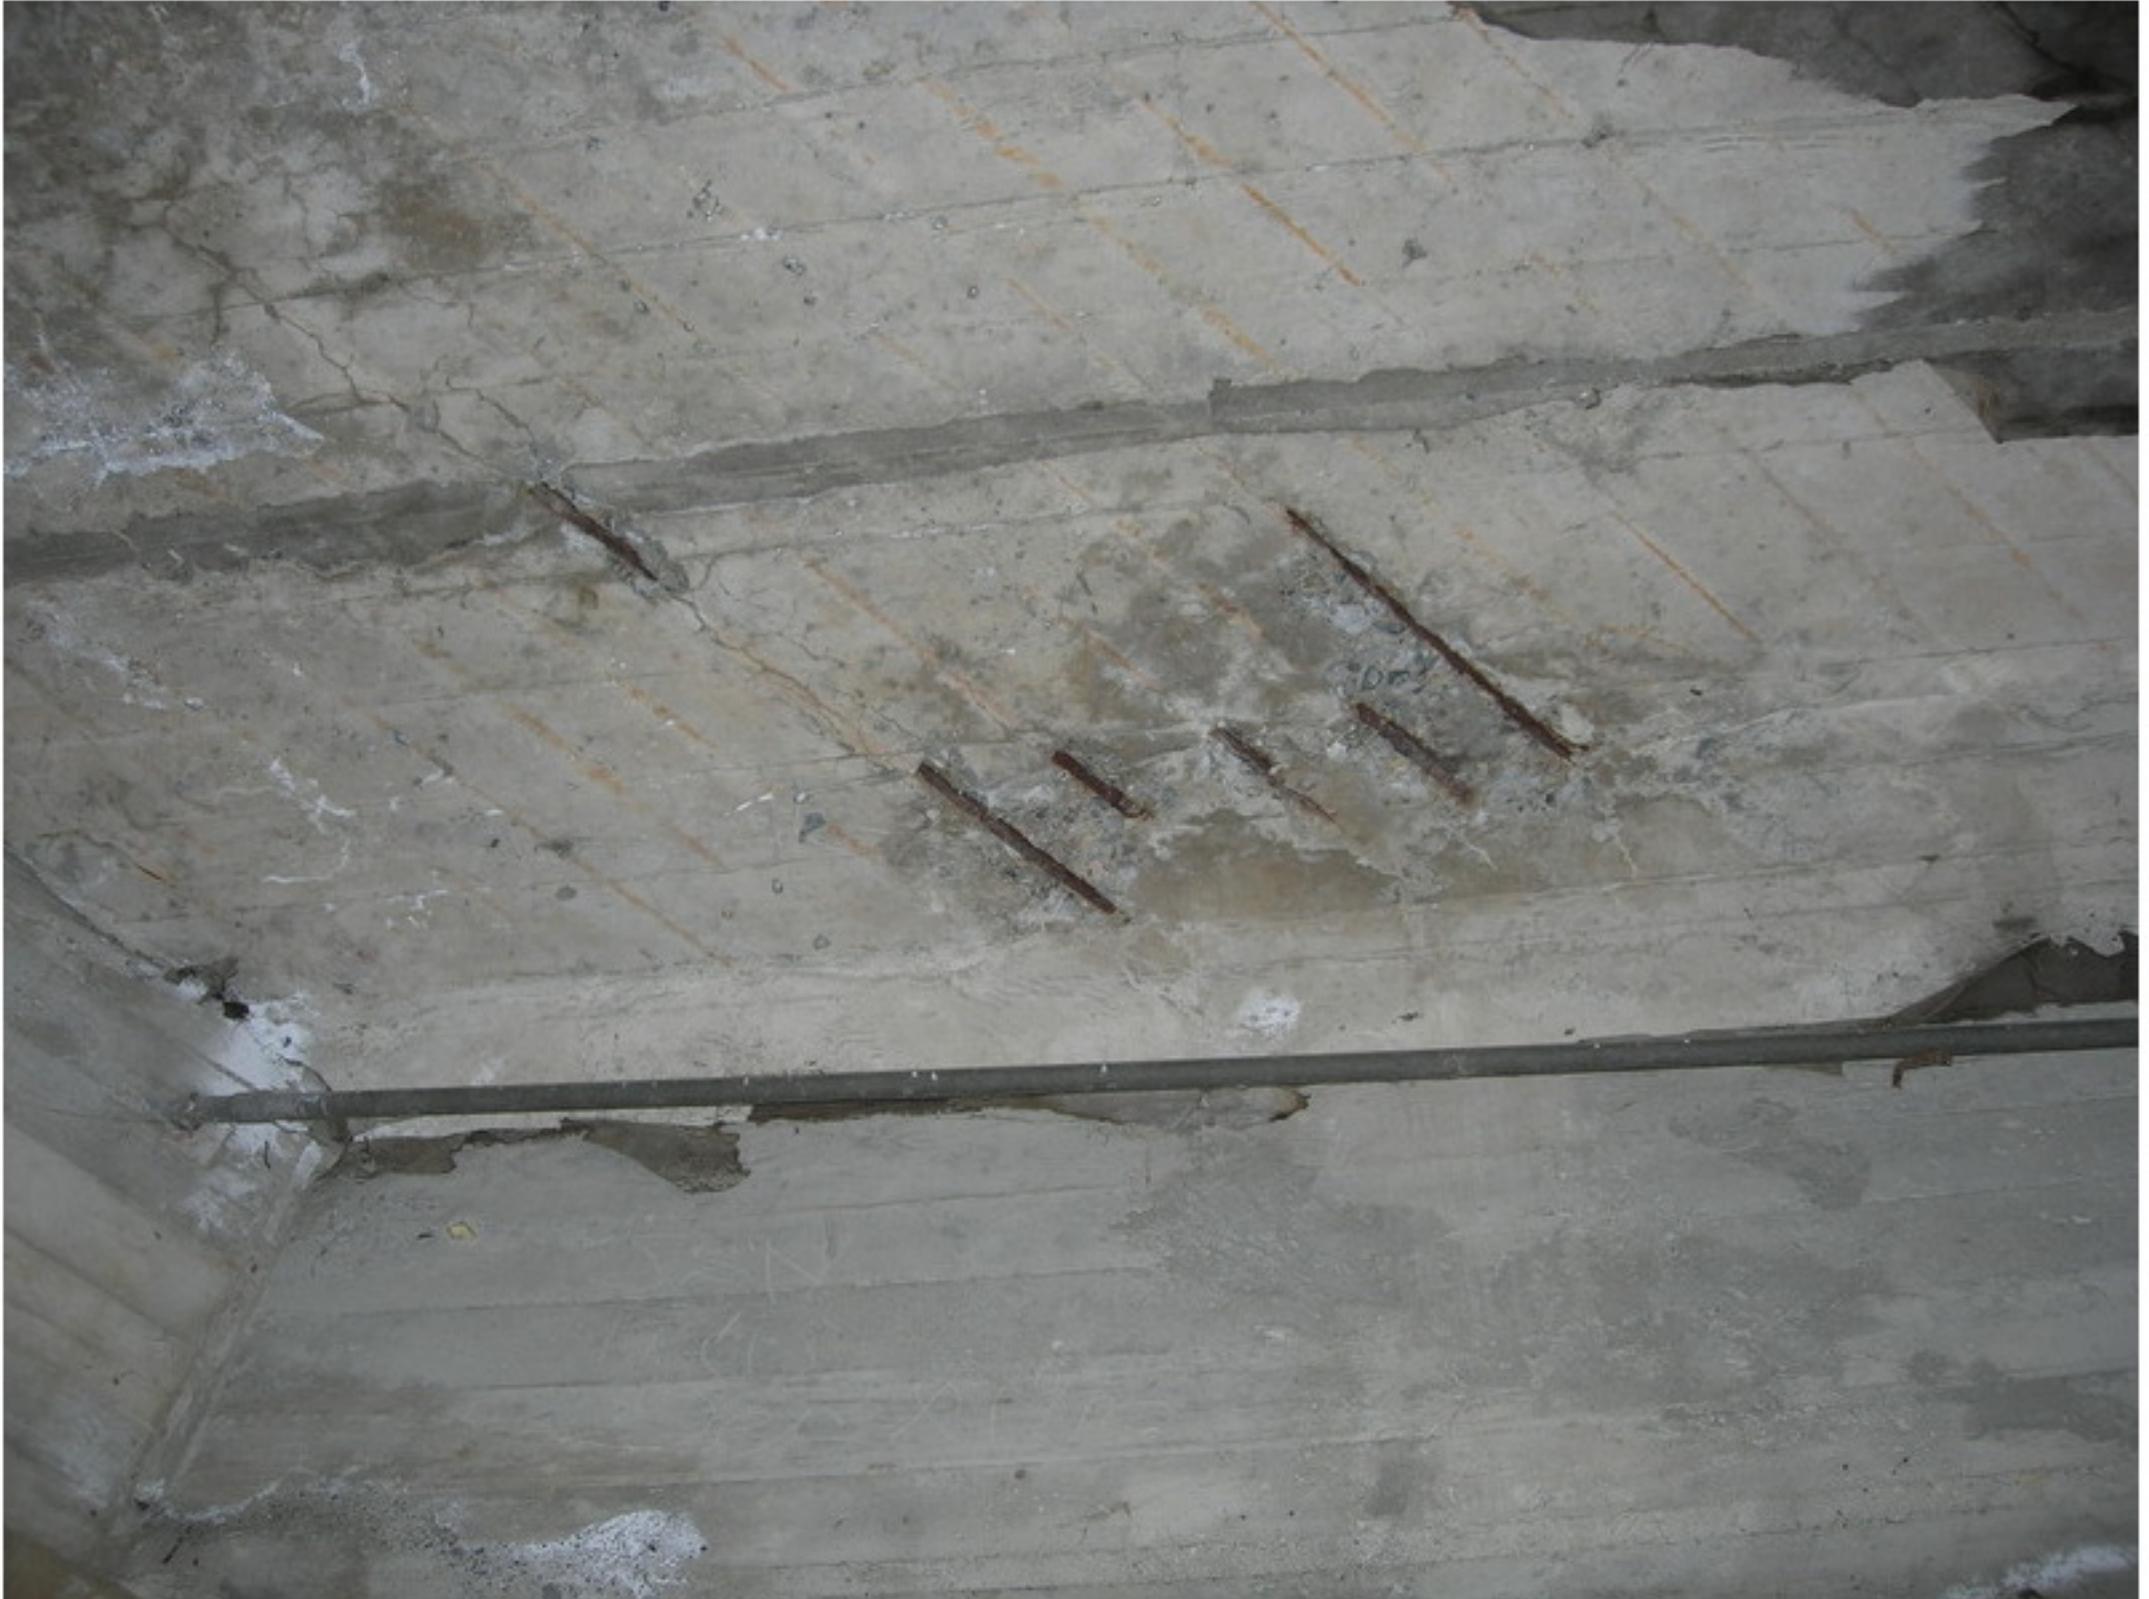
Photo No. 3  
Soffit spalls.

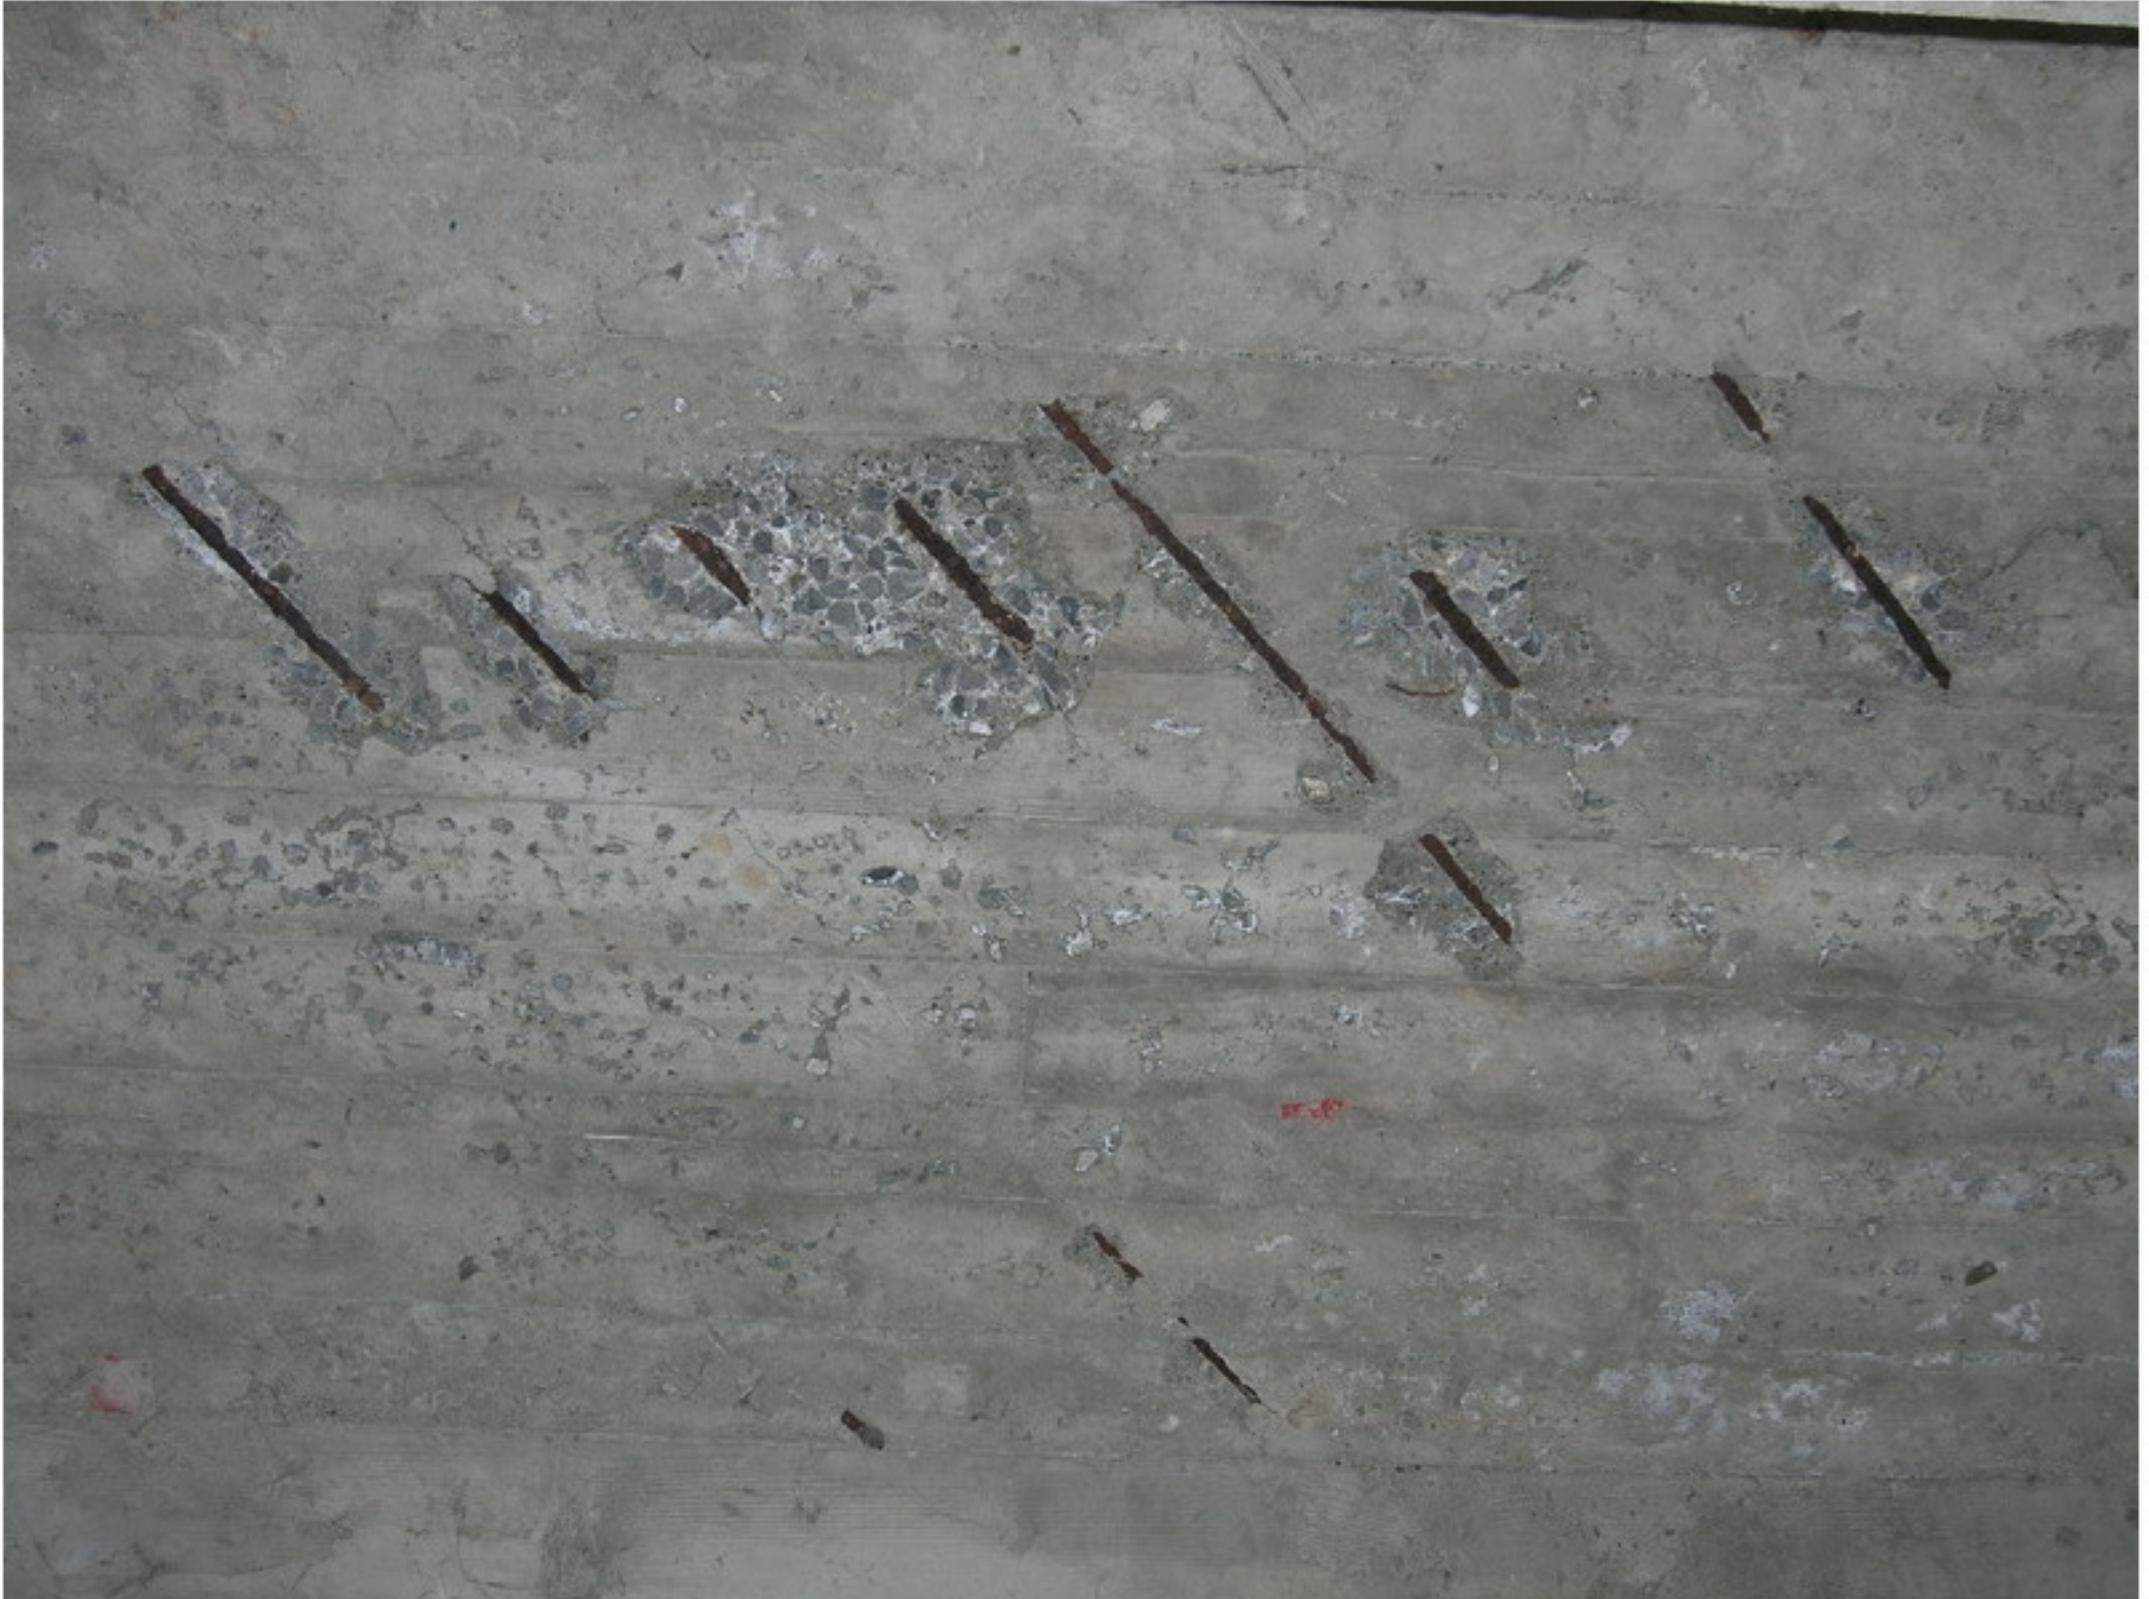
Photo No. 4  
Soffit spalls.

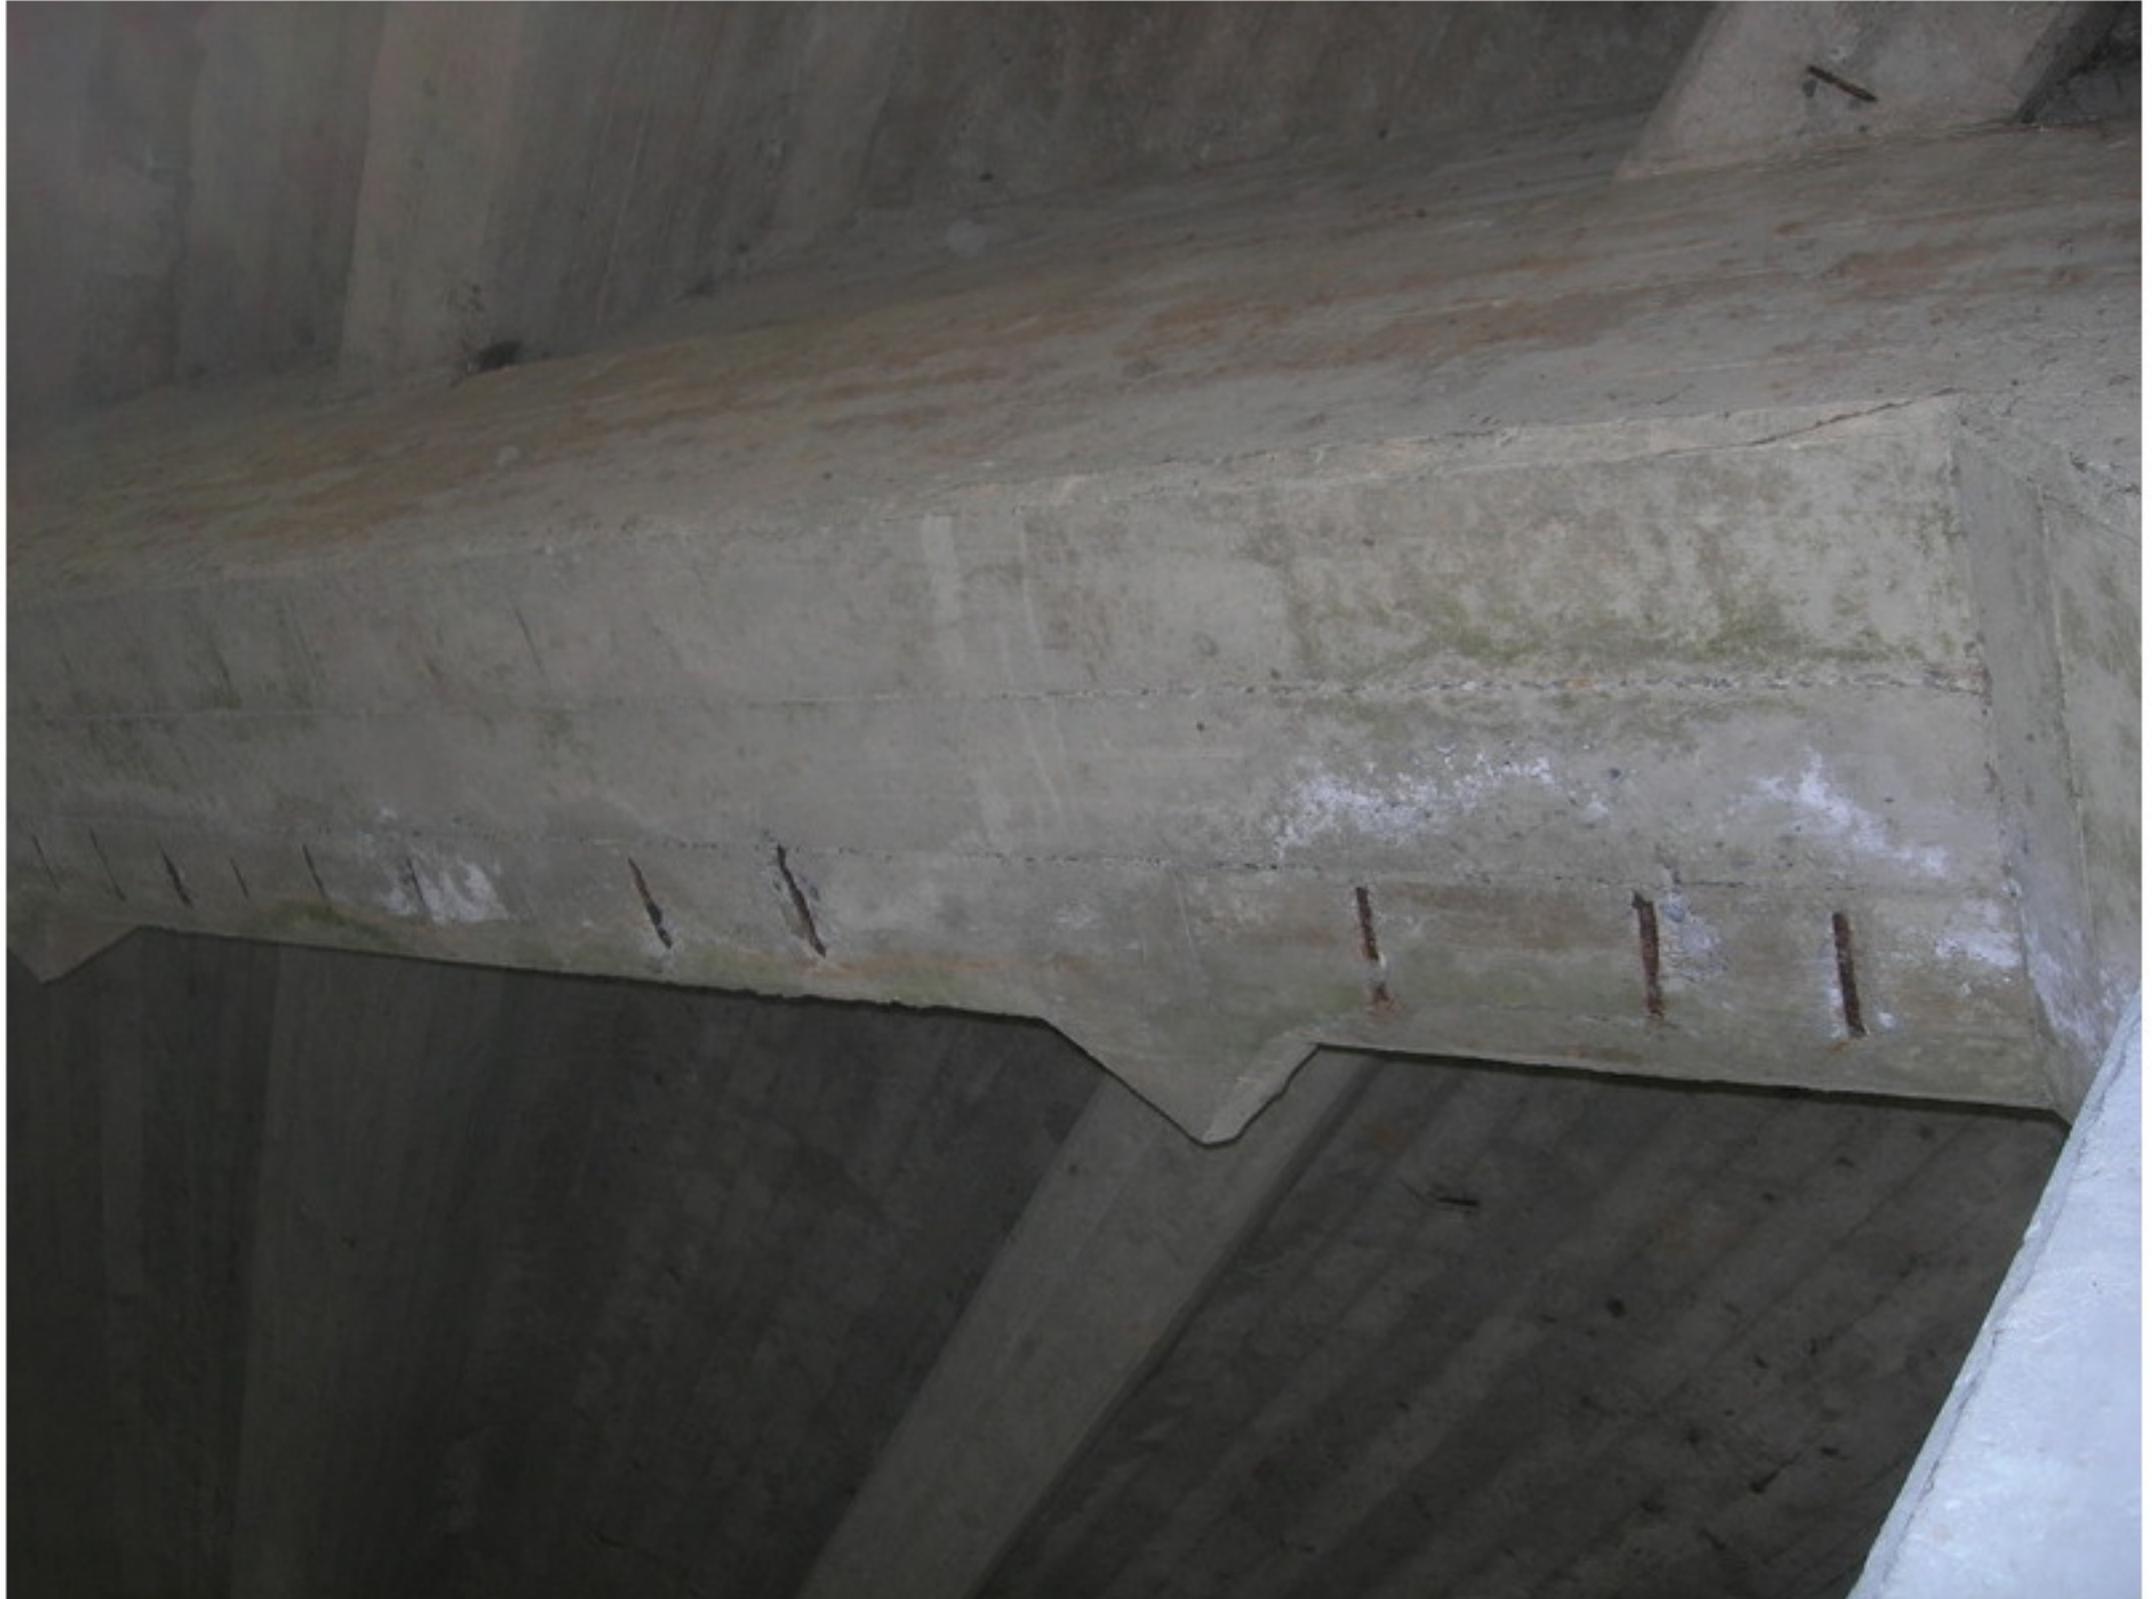
Photo No. 5  
Spalls in the reinforced concrete caps.

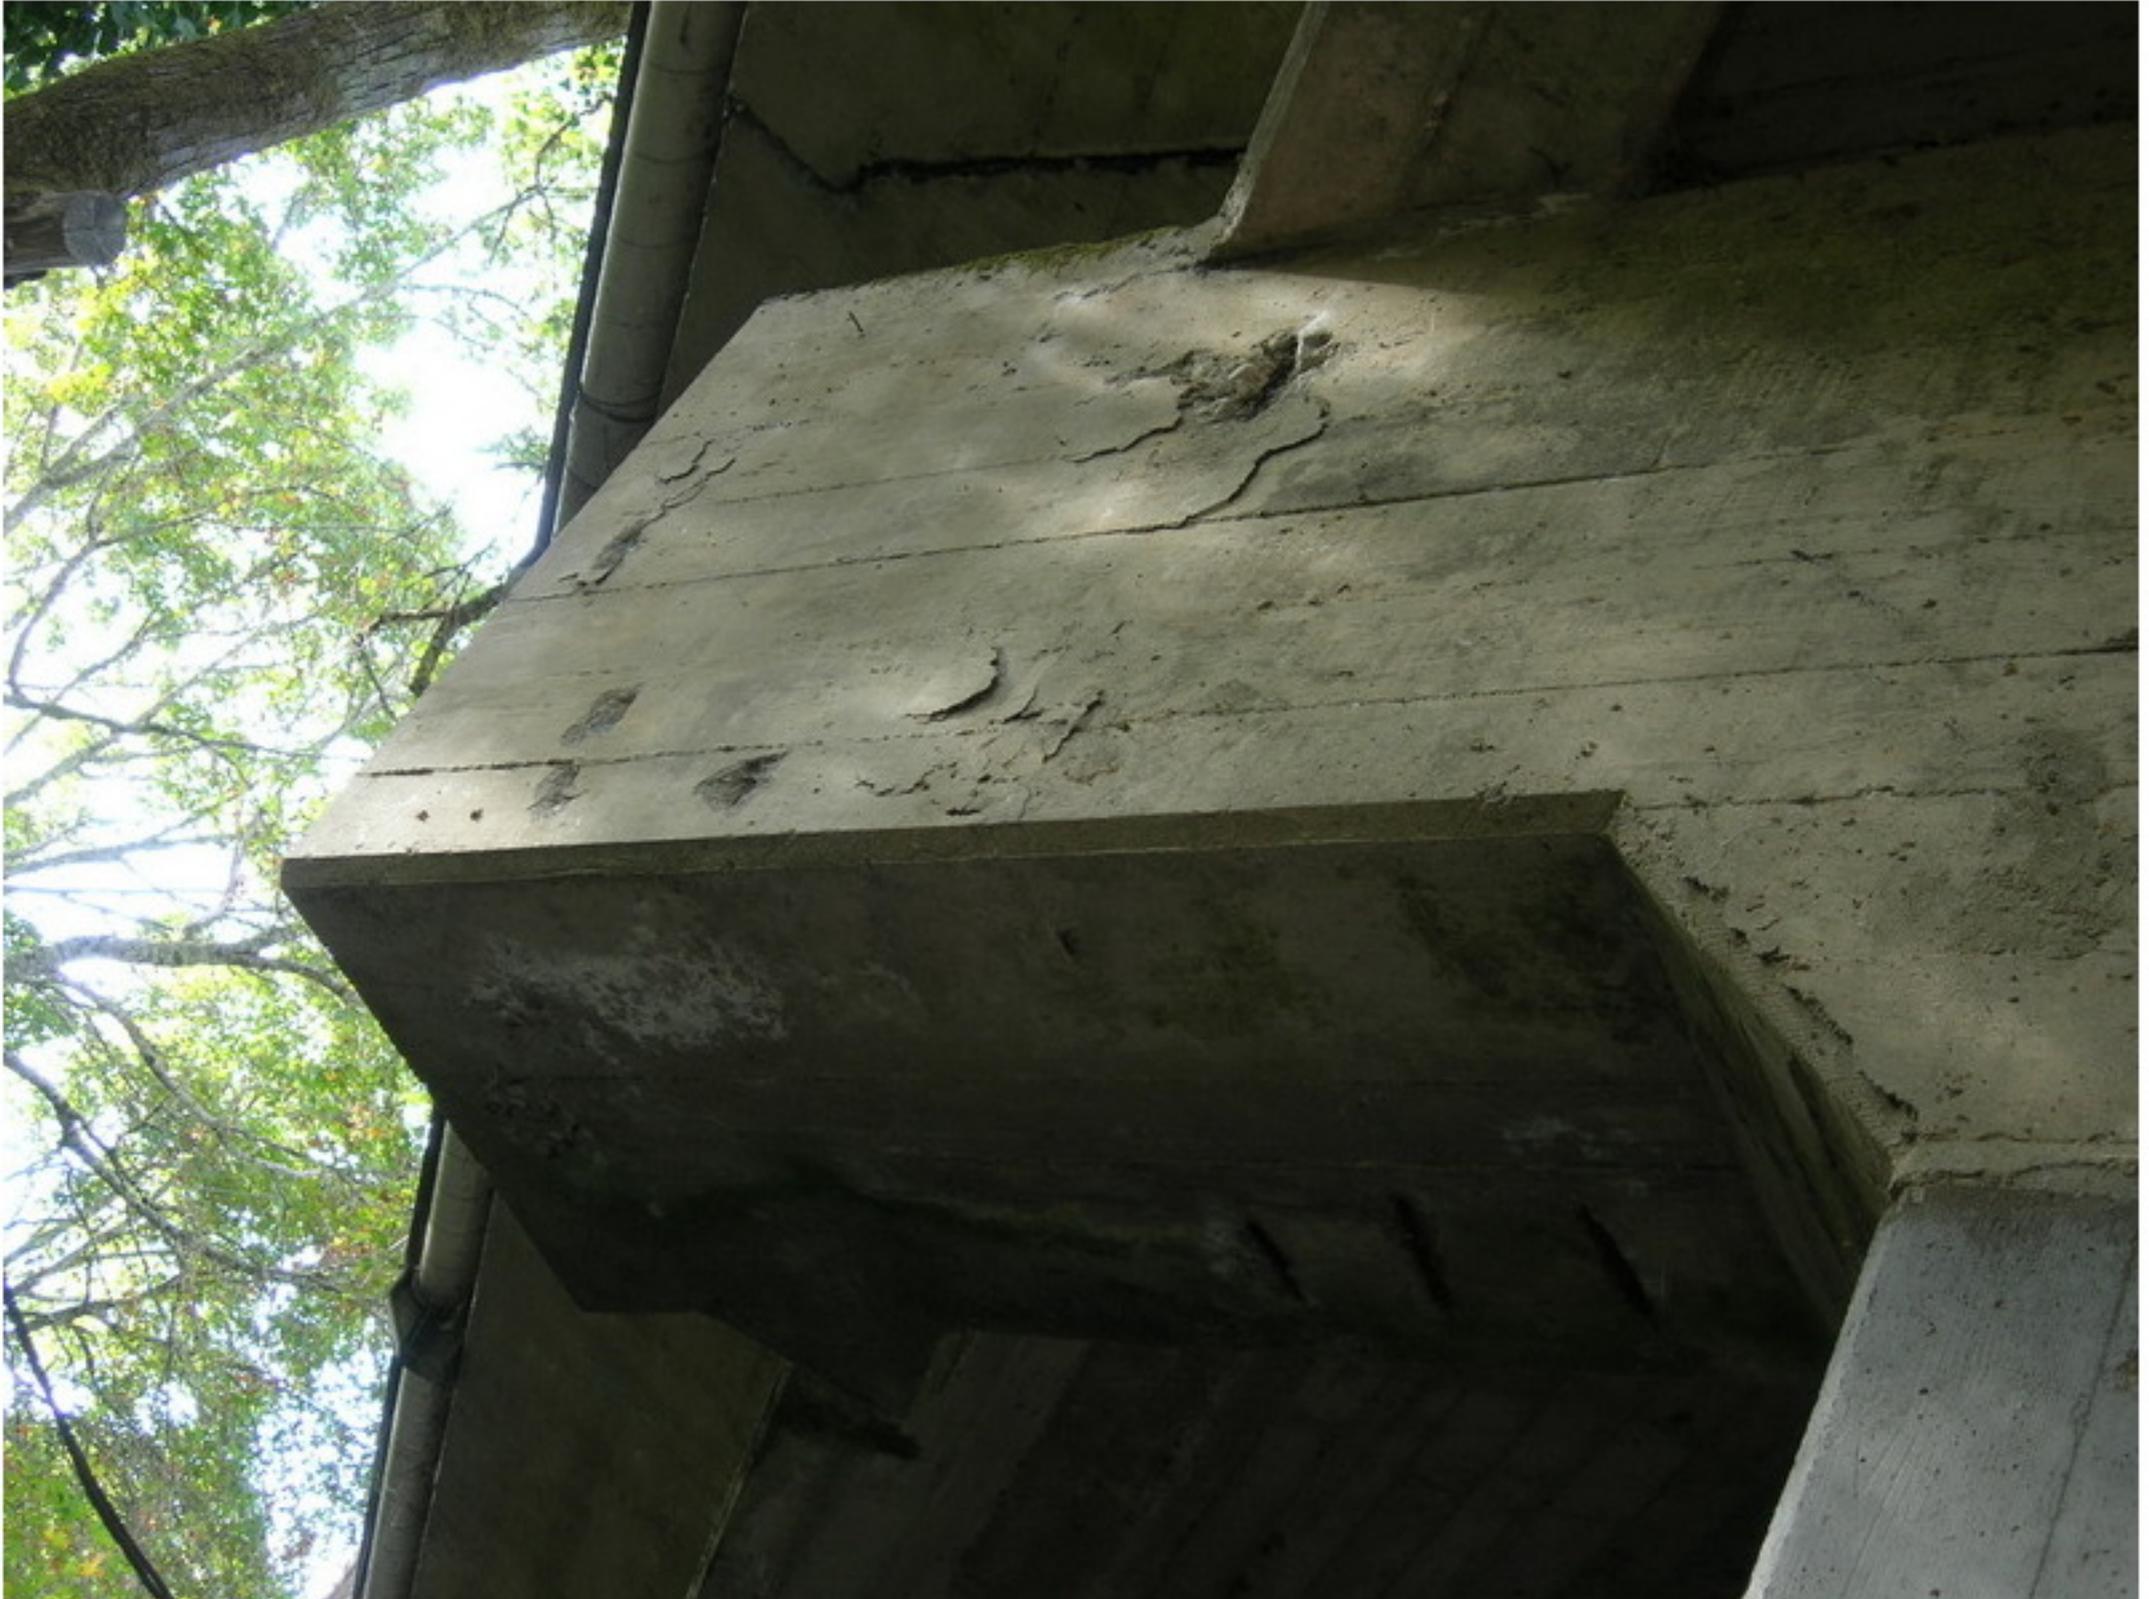
Photo No. 6  
Incipient spalls in the reinforced concrete caps.
