Bridge Type Selection Report for Replacement of Meadow Way Bridge over San Anselmo Creek (Bridge No. 27C-0008)

EXECUTIVE SUMMARY

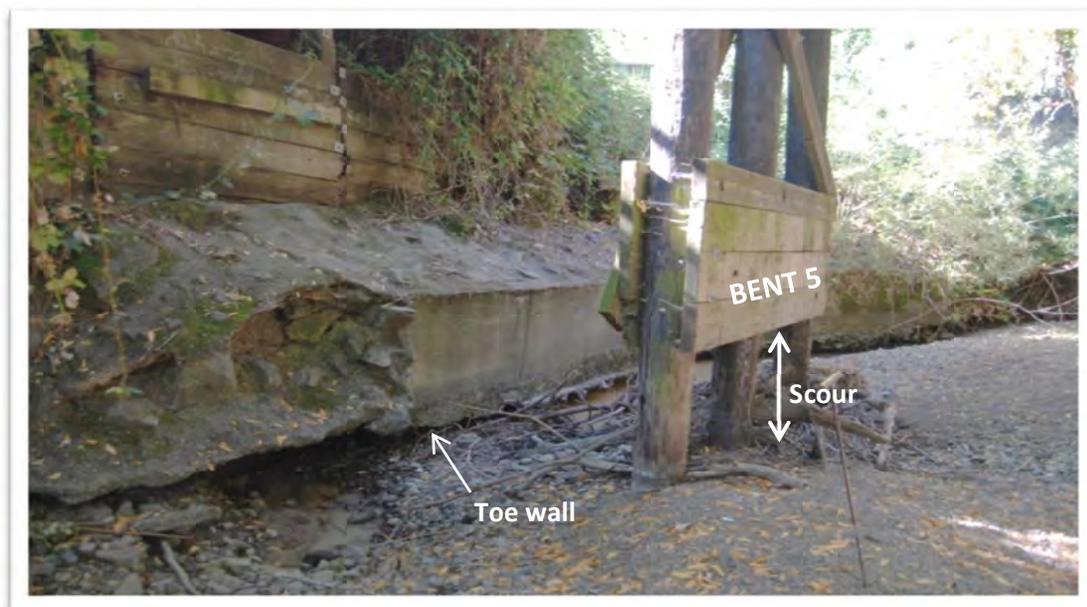
Scour under fortifications of east abutment, as well as 3.5'± of creek bed drop at Bent 5

Since the bridge is set in its current crossing, the above hydraulic impacts and preventive mitigation for them will need to be built into the new bridge design and its abutments. Early in the preliminary design it was decided that a retaining wall at the upstream west bank, connecting with that bridge abutment, wingwalls at the other three corners of the bridge, and rock riprap armoring the abutments and walls would be necessary to maintain the stability of both the bridge and its adjacent embankments. Accordingly, this Bridge Type Selection report considers options and alternates for a retaining wall adjacent to Abutment 1, and takes into account the riprap protection needed at both bridge abutments.

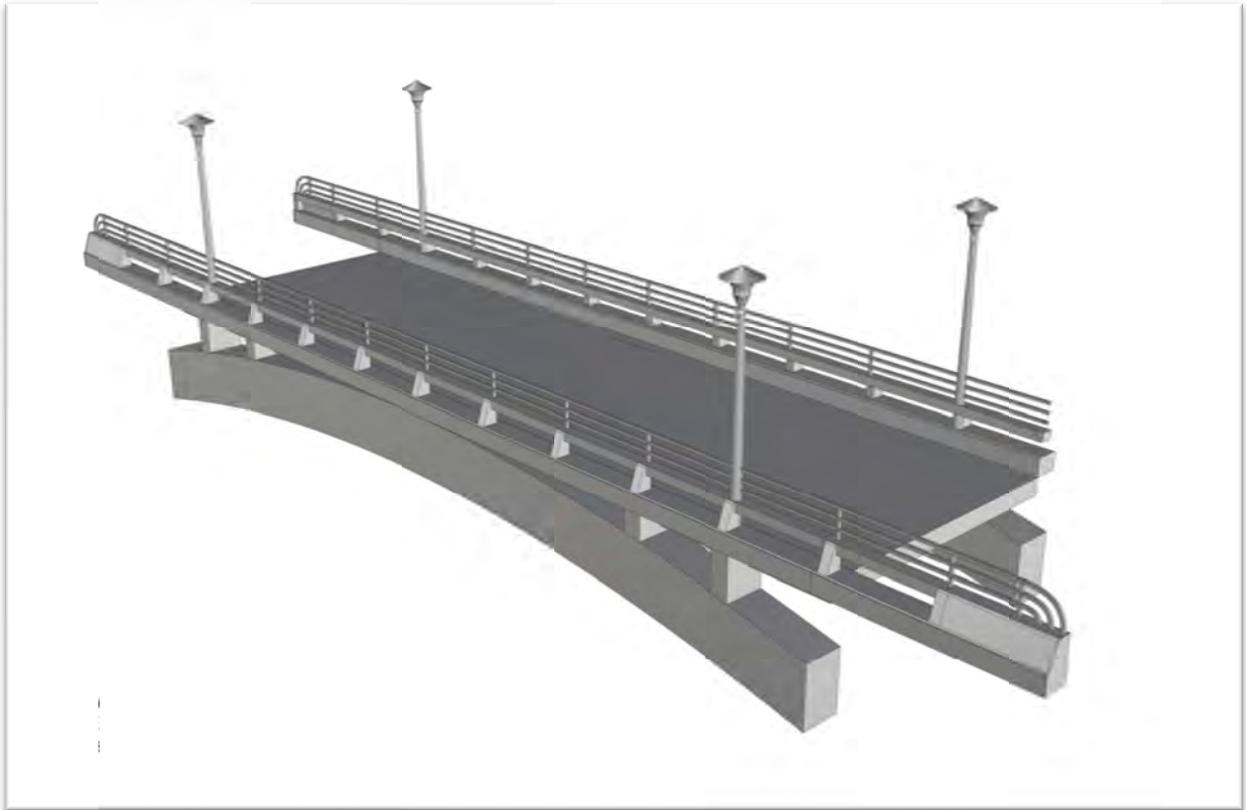
Glulam Superstructure Perspective

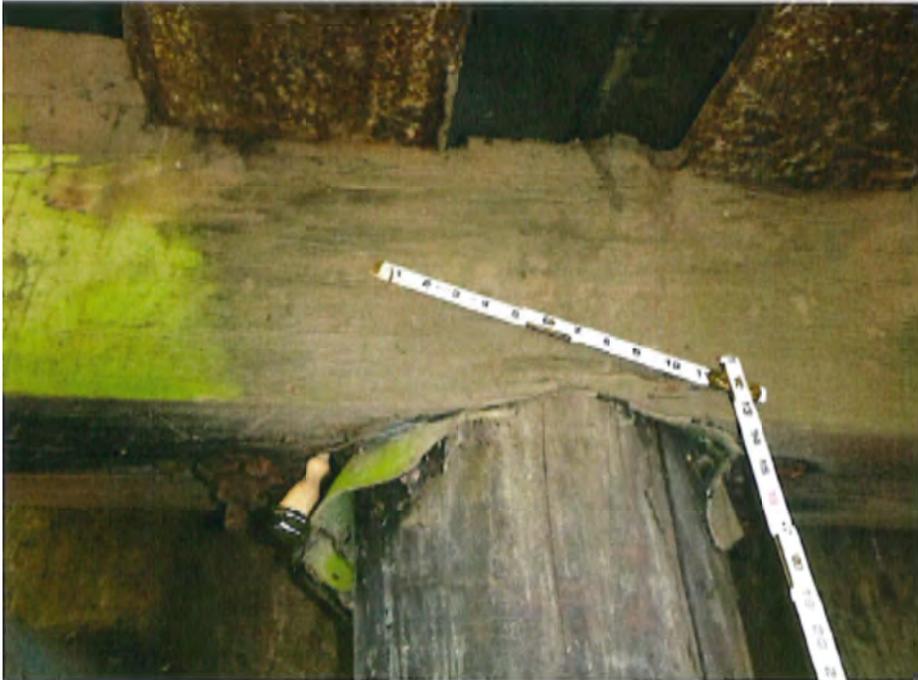
Photo No. 1

Timber cap crushing at Pier 5 Column 1.

Replace timber bent cap at Pier 5.

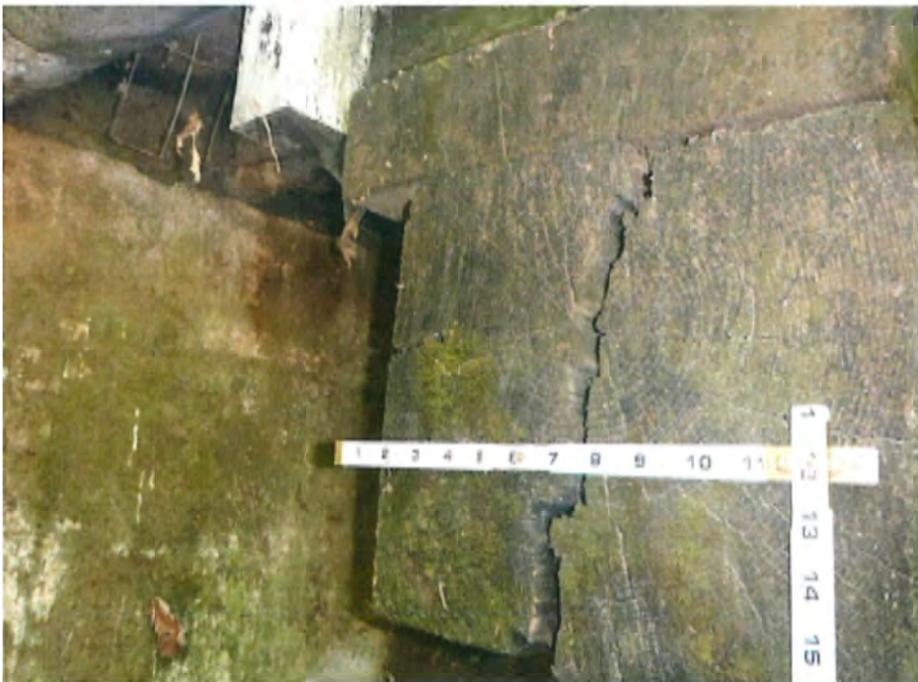
Photo No. 2

There is a vertical split in Bent cap 2, which extends from the left end to half length of the bent cap. Based on a field comparison of the photo from the 9/2010 report, this condition has not changed.									
332		Railing-Timber	2	42	m	42	0	0	0

Timber cap split at Pier 5.

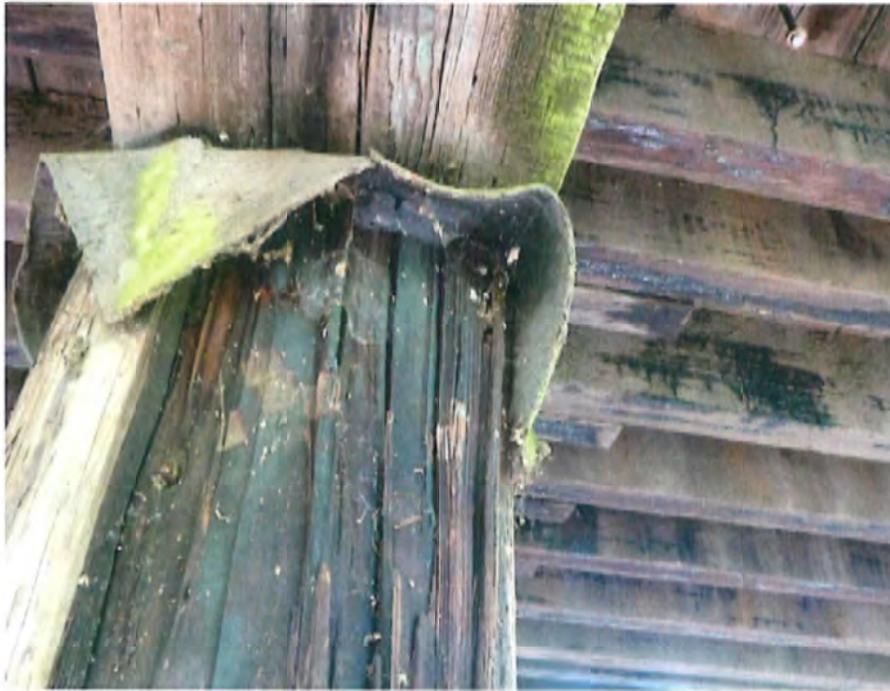
Photo No. 3

Elem No.	Defect /Prot	Element Description	Env Qty	Total Qty	Units	Qty in each Condition State			
						St. 1	St. 2	St. 3	St. 4
(206-1170)									
There are splits in the timber column at Column 3 of Pier 3. The splits are about 2 feet long by 2 inches deep around the perimeter. Currently, this condition does not affect the load capacity, but it is recommended to be repaired; install steel banding at the top of the column.									
215		Abutment-RC	2	9	m	9	0	0	0

Timber splits at Column 3 of Pier 3.

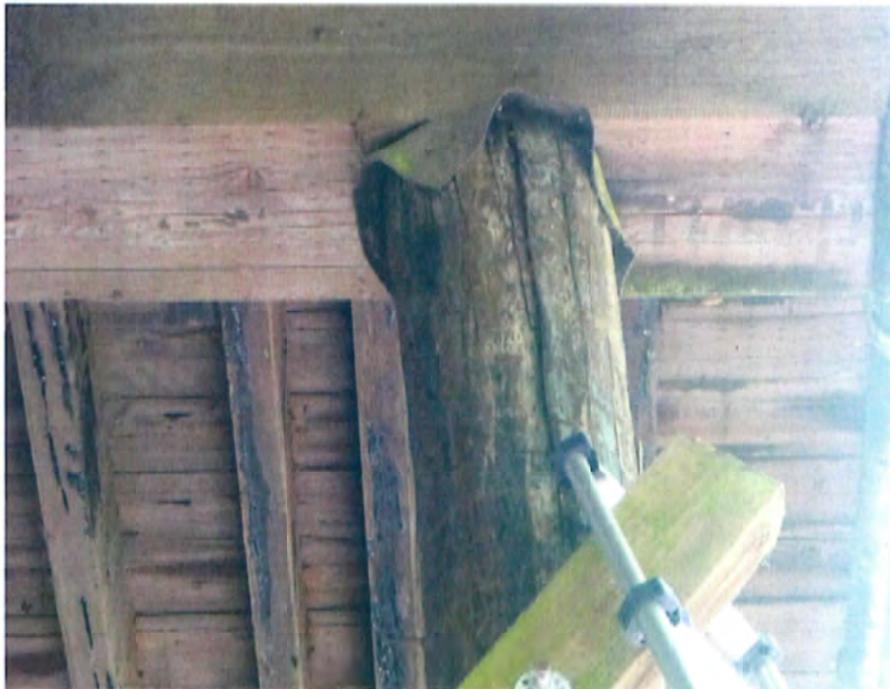
Photo No. 4

Timber splits at Column 3 of Pier 3.

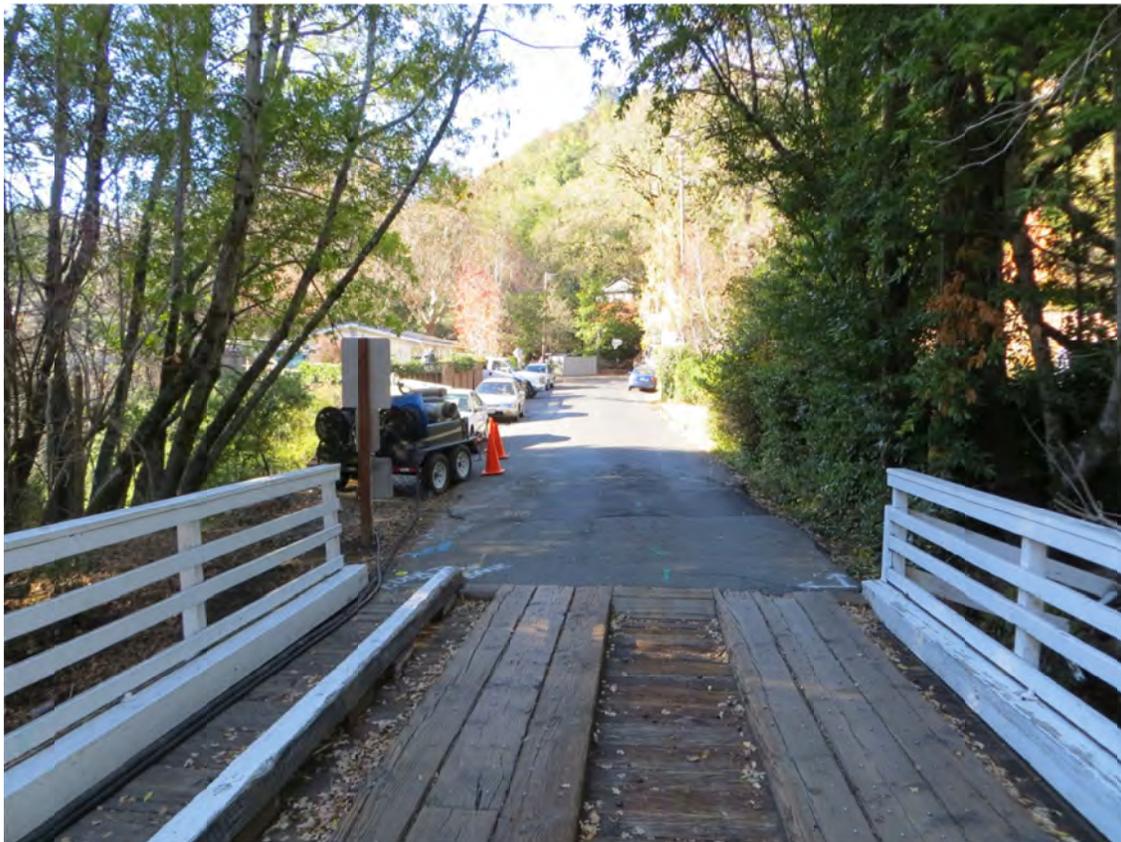
Photo 2. Bridge Deck – Closer view of 2xdeck runner planks (note the horizontal checks on the planks)

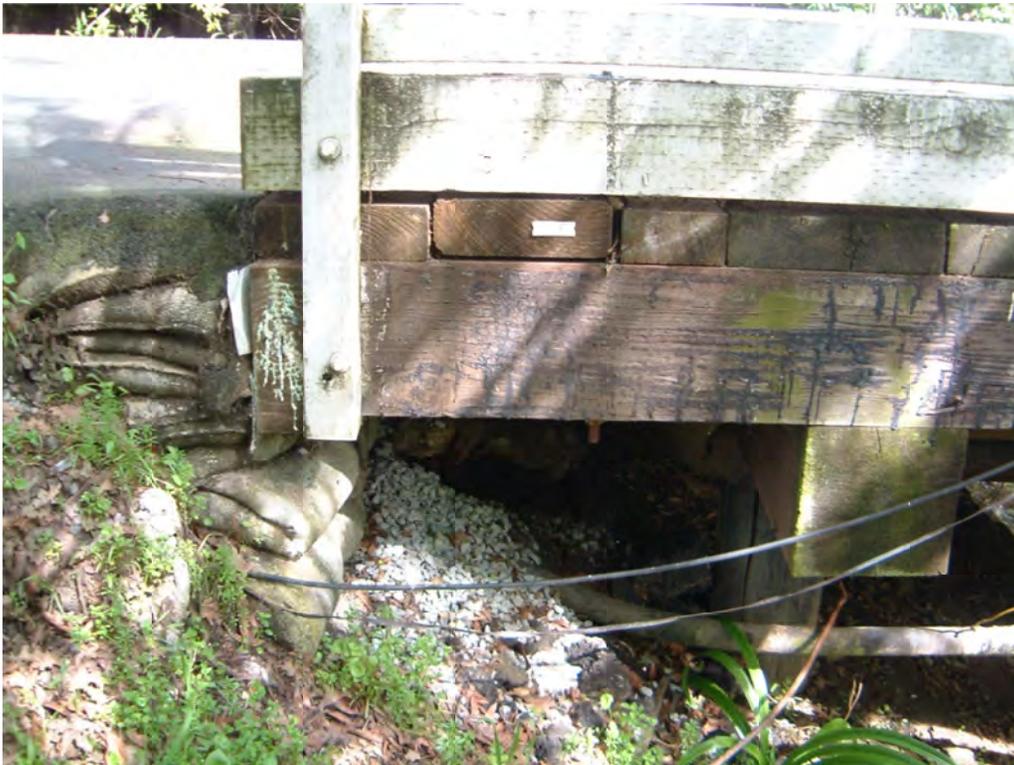
Photo 3. Bridge Superstructure – Showing 2x6 deck planks, 4x12 stringer and 12x12 bent cap adjacent abutment.

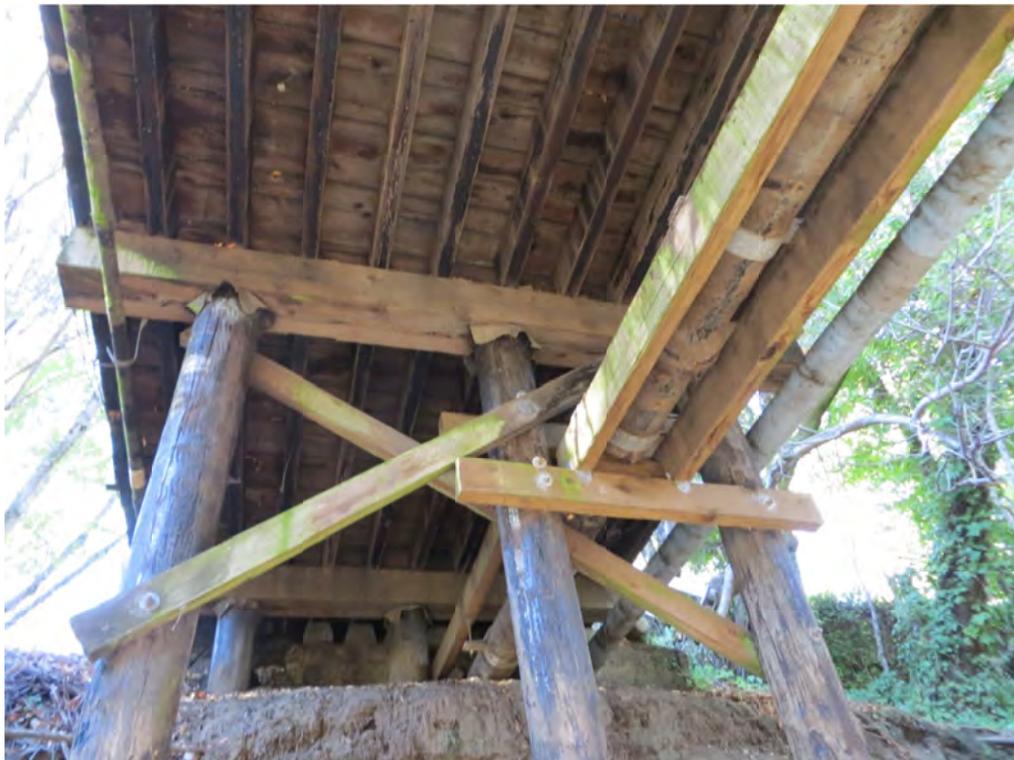
Photo 4. Bridge Superstructure and Substructure – View under bridge looking up at stringers, bent cap and wood piling.

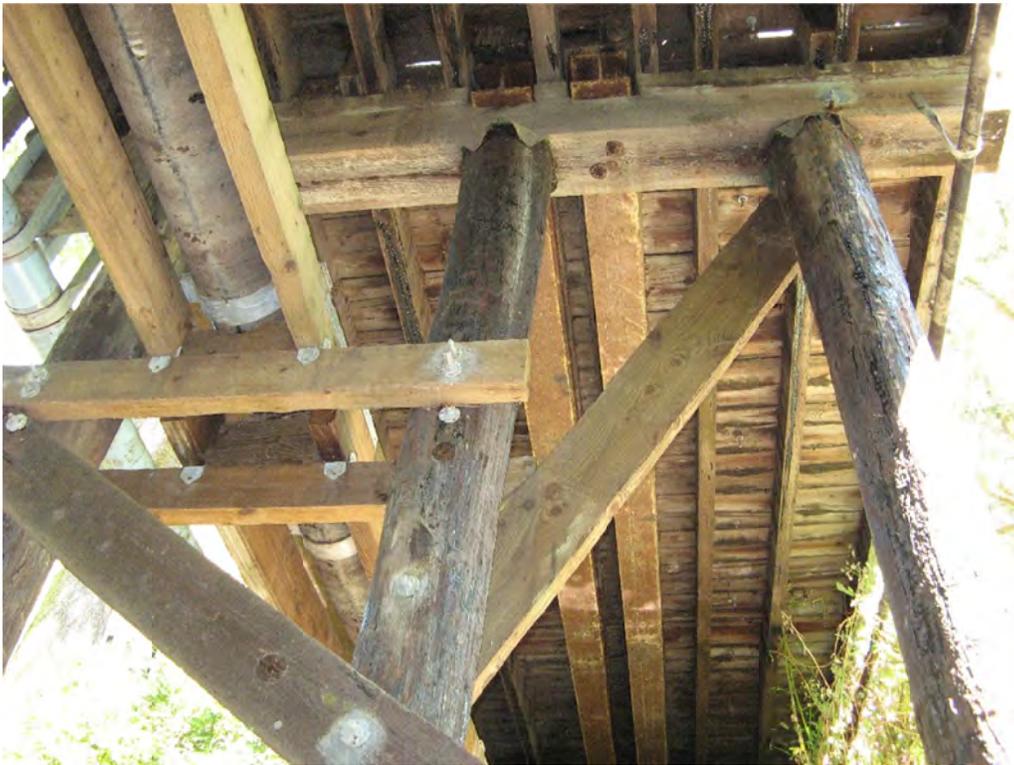
Photo 5. Bridge Superstructure and Substructure – View under bridge looking up at stringers/steel beams, bent cap and wood piling.

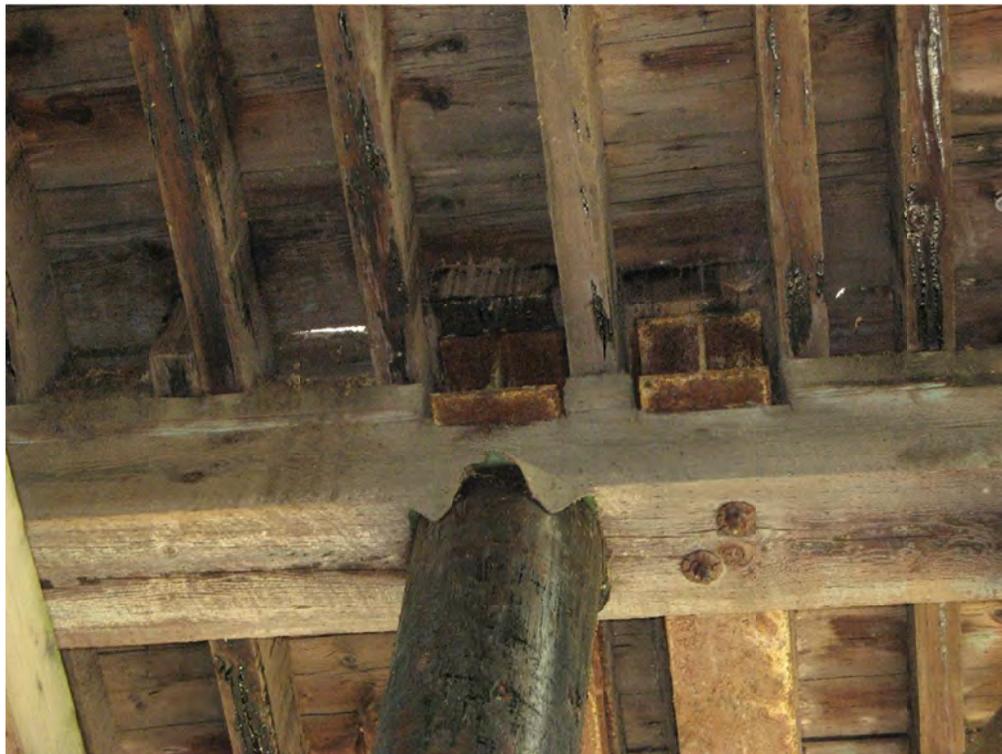
Photo 6. Bridge Superstructure – Closer view under bridge looking up at stringers/steel beams, bent cap and wood piling.

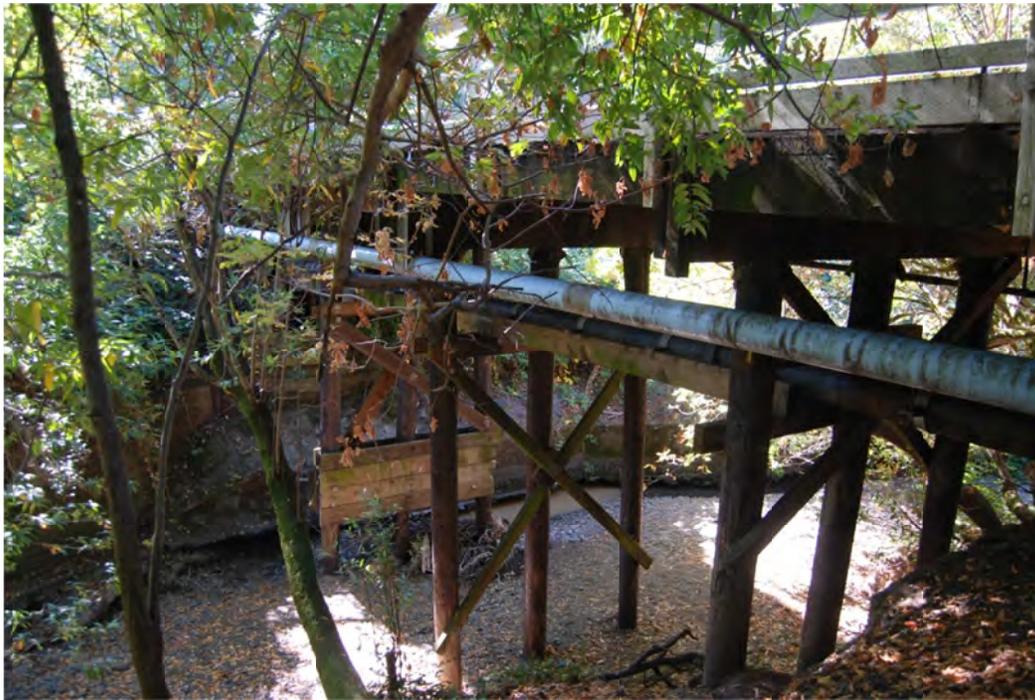
Photo 7. Bridge Substructure – View looking southeast towards bridge showing wood piling and bracing.

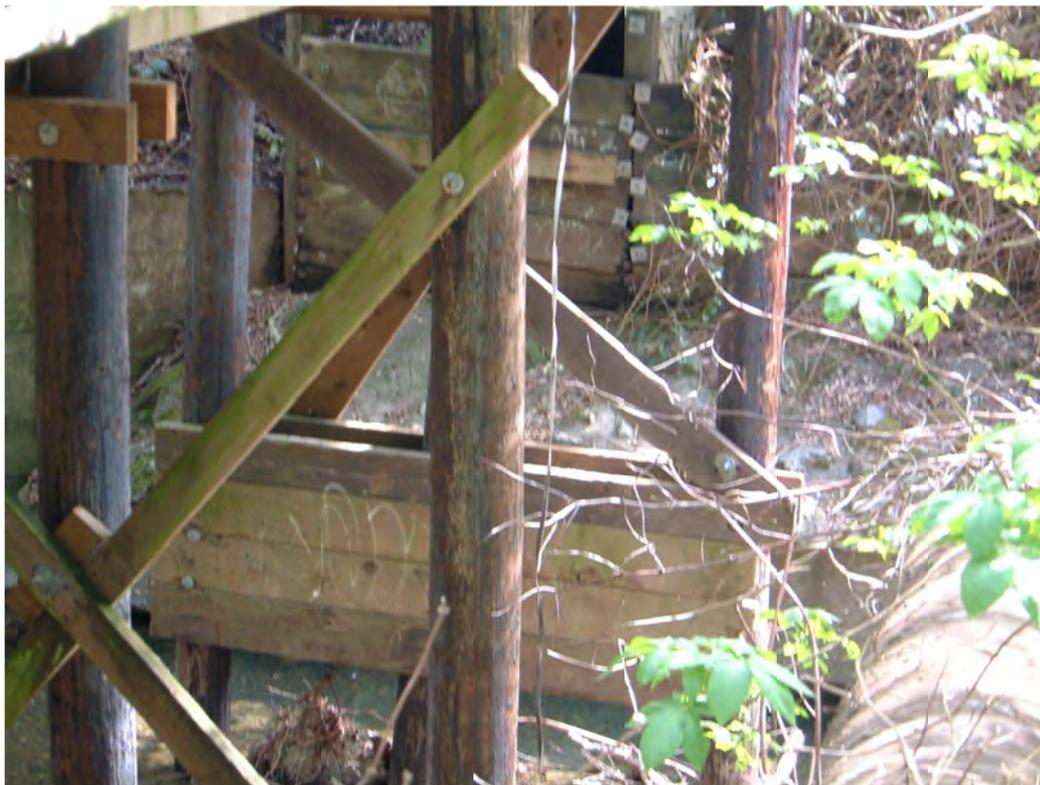
Photo 8. Bridge Substructure – View looking at wooden pile bracing using thru-bolts.

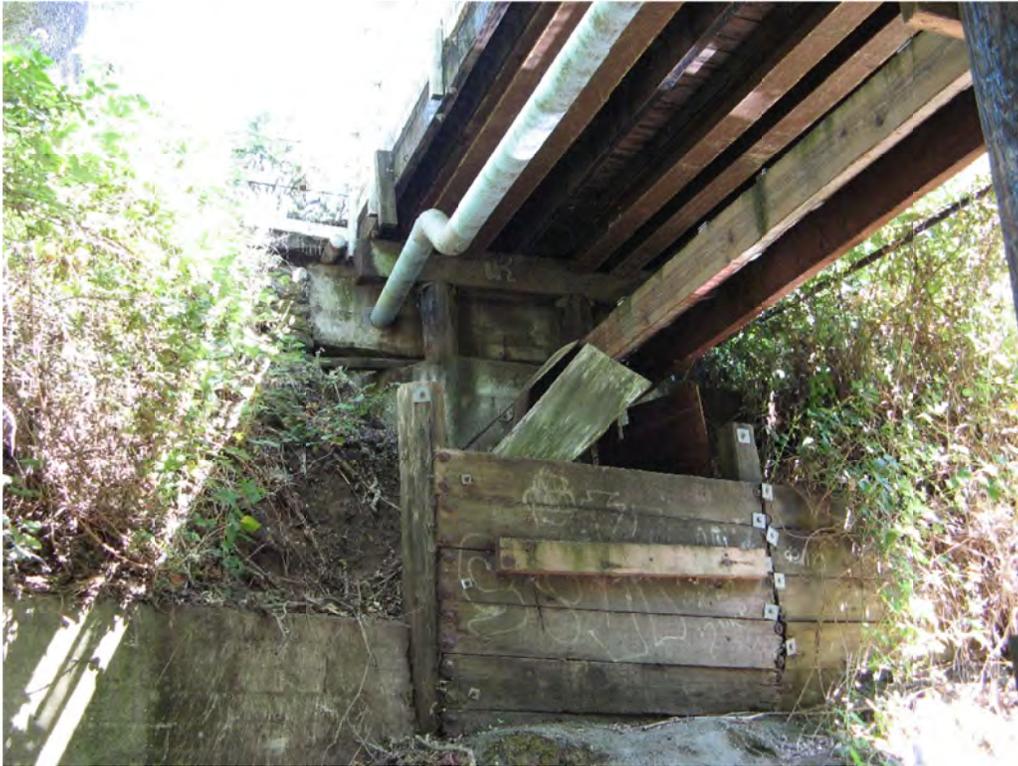
Photo 9. Bridge Substructure – View below bridge looking southeast towards bridge pier and abutment.
