## Draft Initial Study / Mitigated Negative Declaration

### Bridge Preventative Maintenance Program

Town of Fairfax, California

January 2026

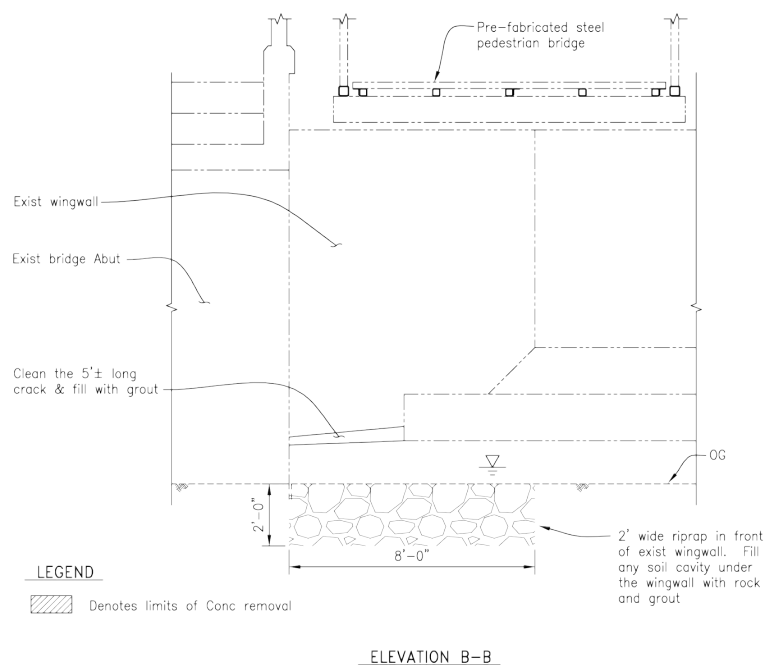
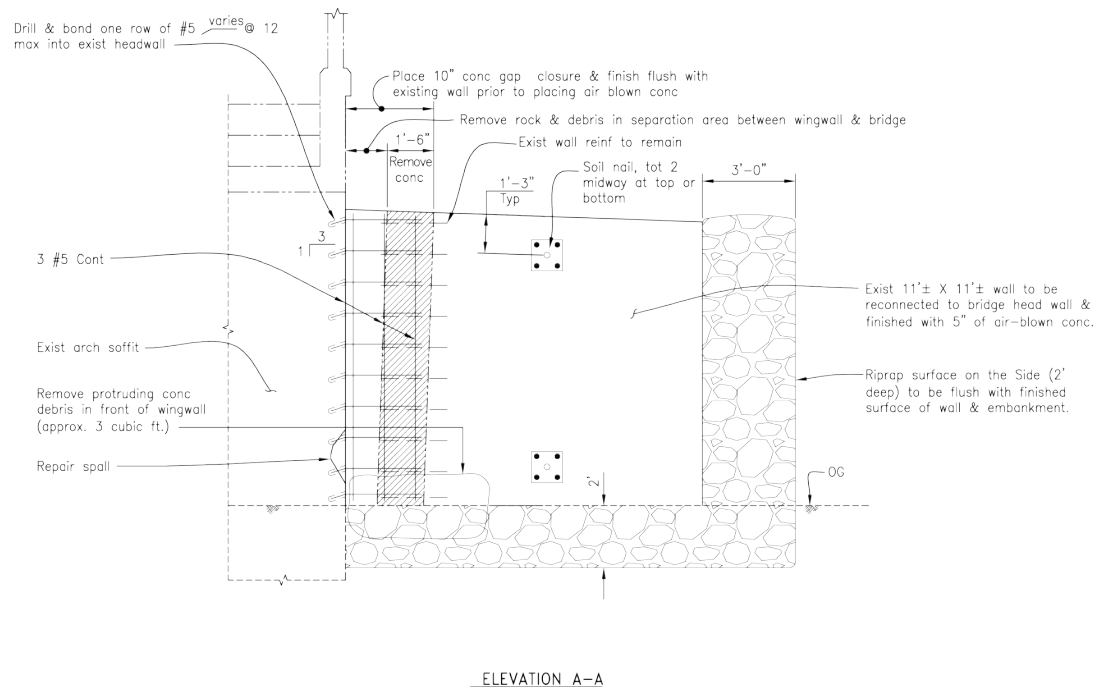
**Figure 11. Marin Road Bridge Repair Details**

The BPMP repairs for Marin Road Bridge and the method of construction consist of the following components (as shown on Figure 11):

- **Repair of the toppling bridge wingwall:** The leaning, rotating and separated concrete wingwall on the southeast side (downstream of the bridge) would be repaired in-situ. The existing wingwall is approximately 10 feet long and eight feet high. The wingwall would be repaired by reconnecting it to the existing bridge with steel dowels and rebar. The wingwall would be surfaced with a fresh layer of lightly reinforced air-blown concrete (shotcrete) and stabilized with soil nails pinning it to the soil. Soil nails are steel tension elements placed in holes drilled through the concrete wingwall and the soil behind it for a distance of approximately 15-20 feet, inclined at an angle of 15 degrees. The ends of these tension elements are buried in a bulb of grout pumped into the end of the drilled hole, called bond zone, allowing the bond zone to mobilize the soil through friction. The other end of the tension elements would protrude out of the wingwall surface and buried in the wingwall concrete overlay, anchored with special hardware and tensioned slightly to take the slack out of the line, creating a fastening system that would disallow the future movements of the wingwall.

- **Repair of the tattered rock slope protection (RSP) around the above wingwall:** The existing rocks making up the scattered riprap would be collected and a new course of rock riprap would be installed, which would be sized for the top anticipated creek flow velocity. The soil volume below the bottom of the wingwall would be excavated along the front for a width and depth of two feet each to create a trench to place the rock in as a buttress against future scour. On the free edge of the wingwall not connecting with the

- **Repair of the structural damage to another wingwalls:** This second wingwall is on northwest side (upstream of the bridge) and is positioned vertically. The wingwall connects with the bridge headwall at an angle and is cracked horizontally near the bottom for five to six feet and has dropped five to six inches below the crack due to gravity. The repair work would consist of cleaning the damaged and cracked concrete, patching the crack with special grout to prevent further deterioration of the bridge, and burying some rock below the creek bed surface and in front of the wingwall to prevent further deterioration. The surface of the rock riprap would be flush with the creek bed in order to not protrude into the waterway and impact water flows or flow capacity. Geotextile lining would be placed around the rock riprap.

- **Repair of structural concrete spalls in the underside of the bridge:** A couple of structurally damaged spots in the concrete underside of the bridge would be repaired manually. After cleaning the rust from the steel rebars and removing the unsound concrete within the spall, a special agent, such as epoxy grout, would be applied and made flush with the concrete surfaces to protect the reinforcement and patch the concrete.

An APE drawing (Figure 2) and a preliminary Bridge General Plan (Figure 11) for the repairs have been developed for this bridge work. The work would be at both the deck and below deck levels and is expected to take as many as ten working days from start to finish. The bridge would remain entirely open to motorized and non-motorized traffic throughout project construction; however, a flag person directing traffic may be necessary at times to ensure safe travel through the site.

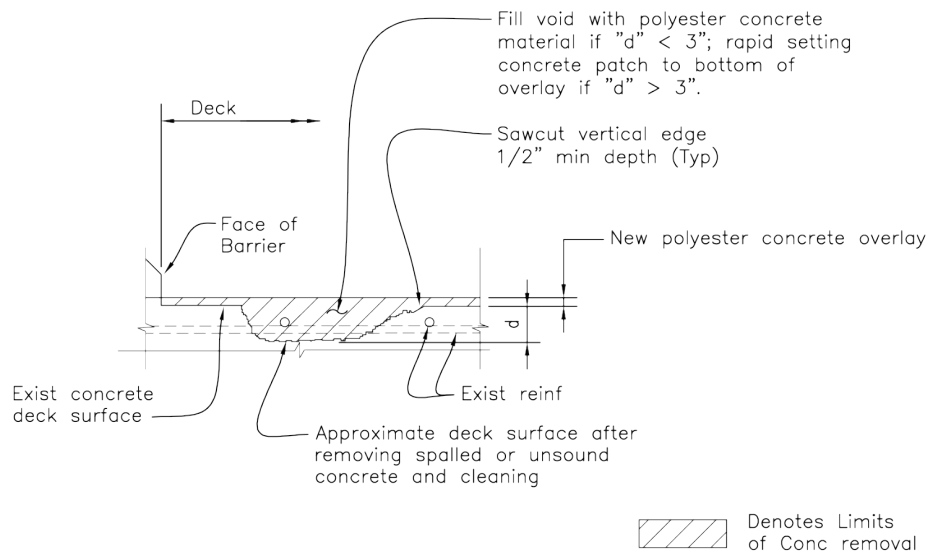
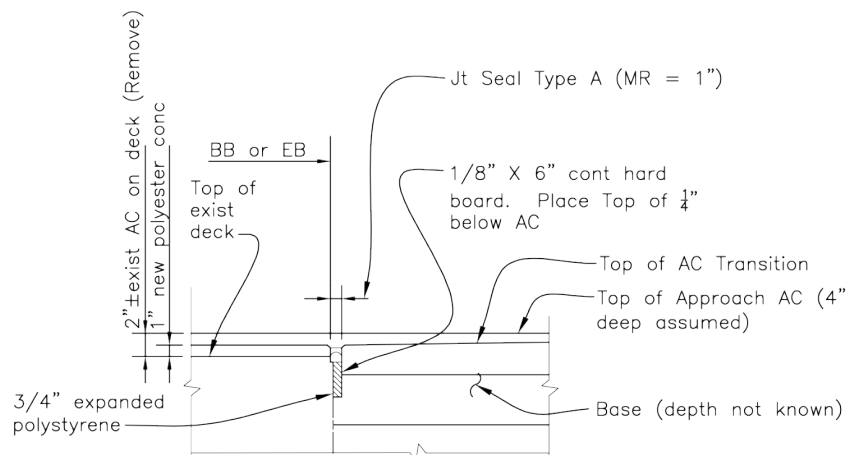
**Figure 12. Spruce Road Bridge Repair Details**

The BPMP repairs for Spruce Road Bridge are shown in Figure 12 and consist of the following:

- **Sealing of the deck:** The asphalt concrete on the bridge deck would be removed with a specialized asphalt grinder. After cleaning the deck and repairing any unsound concrete, work would be followed by the application of a concrete sealant called methacrylate. The sealant would be applied with a mop throughout the deck and sprinkled with a light layer of sand while it is still tacky, which would ensure better tire grip along the bridge deck surface. Sealing the deck would be followed by applying a layer of polyester

- **Repair of expansion joints:** The rubber bridge expansion joint seals at each end of the bridge would be replaced. The new concrete deck grades at the ends of the bridge would be transitioned to the asphalt surface on the approach roadways within 10 feet of the ends of the bridge.
- **Repair of structural concrete spalls in the underside of the bridge:** The numerous bridge spalls in the structural members would be cleaned up and patched with special epoxy grout. The work under the bridge would be done using a “snooper” truck lift parked on the deck, eliminating the need for scaffolding or working in the creek.

#### UN SOUND CONC REPAIR DETAIL

#### B6-21 SECTION THRU ABUTMENT - JT SEALS DETAILS

An APE drawing (Figure 3) and a preliminary Bridge General Plan (Figure 12) for the repairs have been developed for this bridge work. The work would be completed entirely from the bridge deck and street level; no work in the creek would be needed. The work is expected to take as many as ten working days from start to finish. The bridge would be closed off to motorized traffic for a number of hours a few times during this period but would remain open to foot traffic on the sidewalks. Motorized traffic would be detoured via Arroyo Road and Azalea Avenue during the temporary closure, as shown in Figure 13.

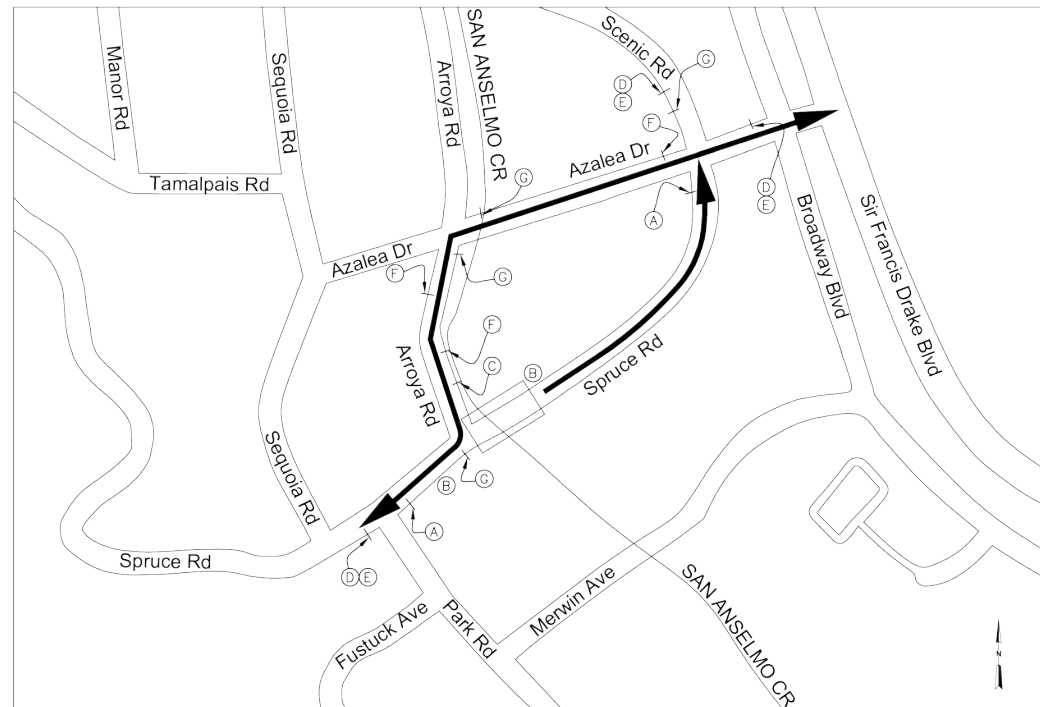
Figure 13. Construction Detour Plans

1. Locations of construction area signs as shown are approximate. exact locations will be determined by the Engineer. TTC shall be in accordance of the latest edition of the ca MUTCD.
2. Sign dimensions are shown in inches.
3. Regulatory signs shall have black lettering on white background.
4. Spruce Rd. Bridge sidewalk will remain open during construction.
5. Sign codes are California MUTCD, unless otherwise noted.
6. See Canyon Road Bridge General Plan sheet traffic handling during deck sealing operations.
7. For permanent sign locations at Canyon Rd. Bridge see Canyon Road Bridge General Plan.

SPRUCE ROAD DETOUR PLAN AND CONSTRUCTION AREA SIGNS

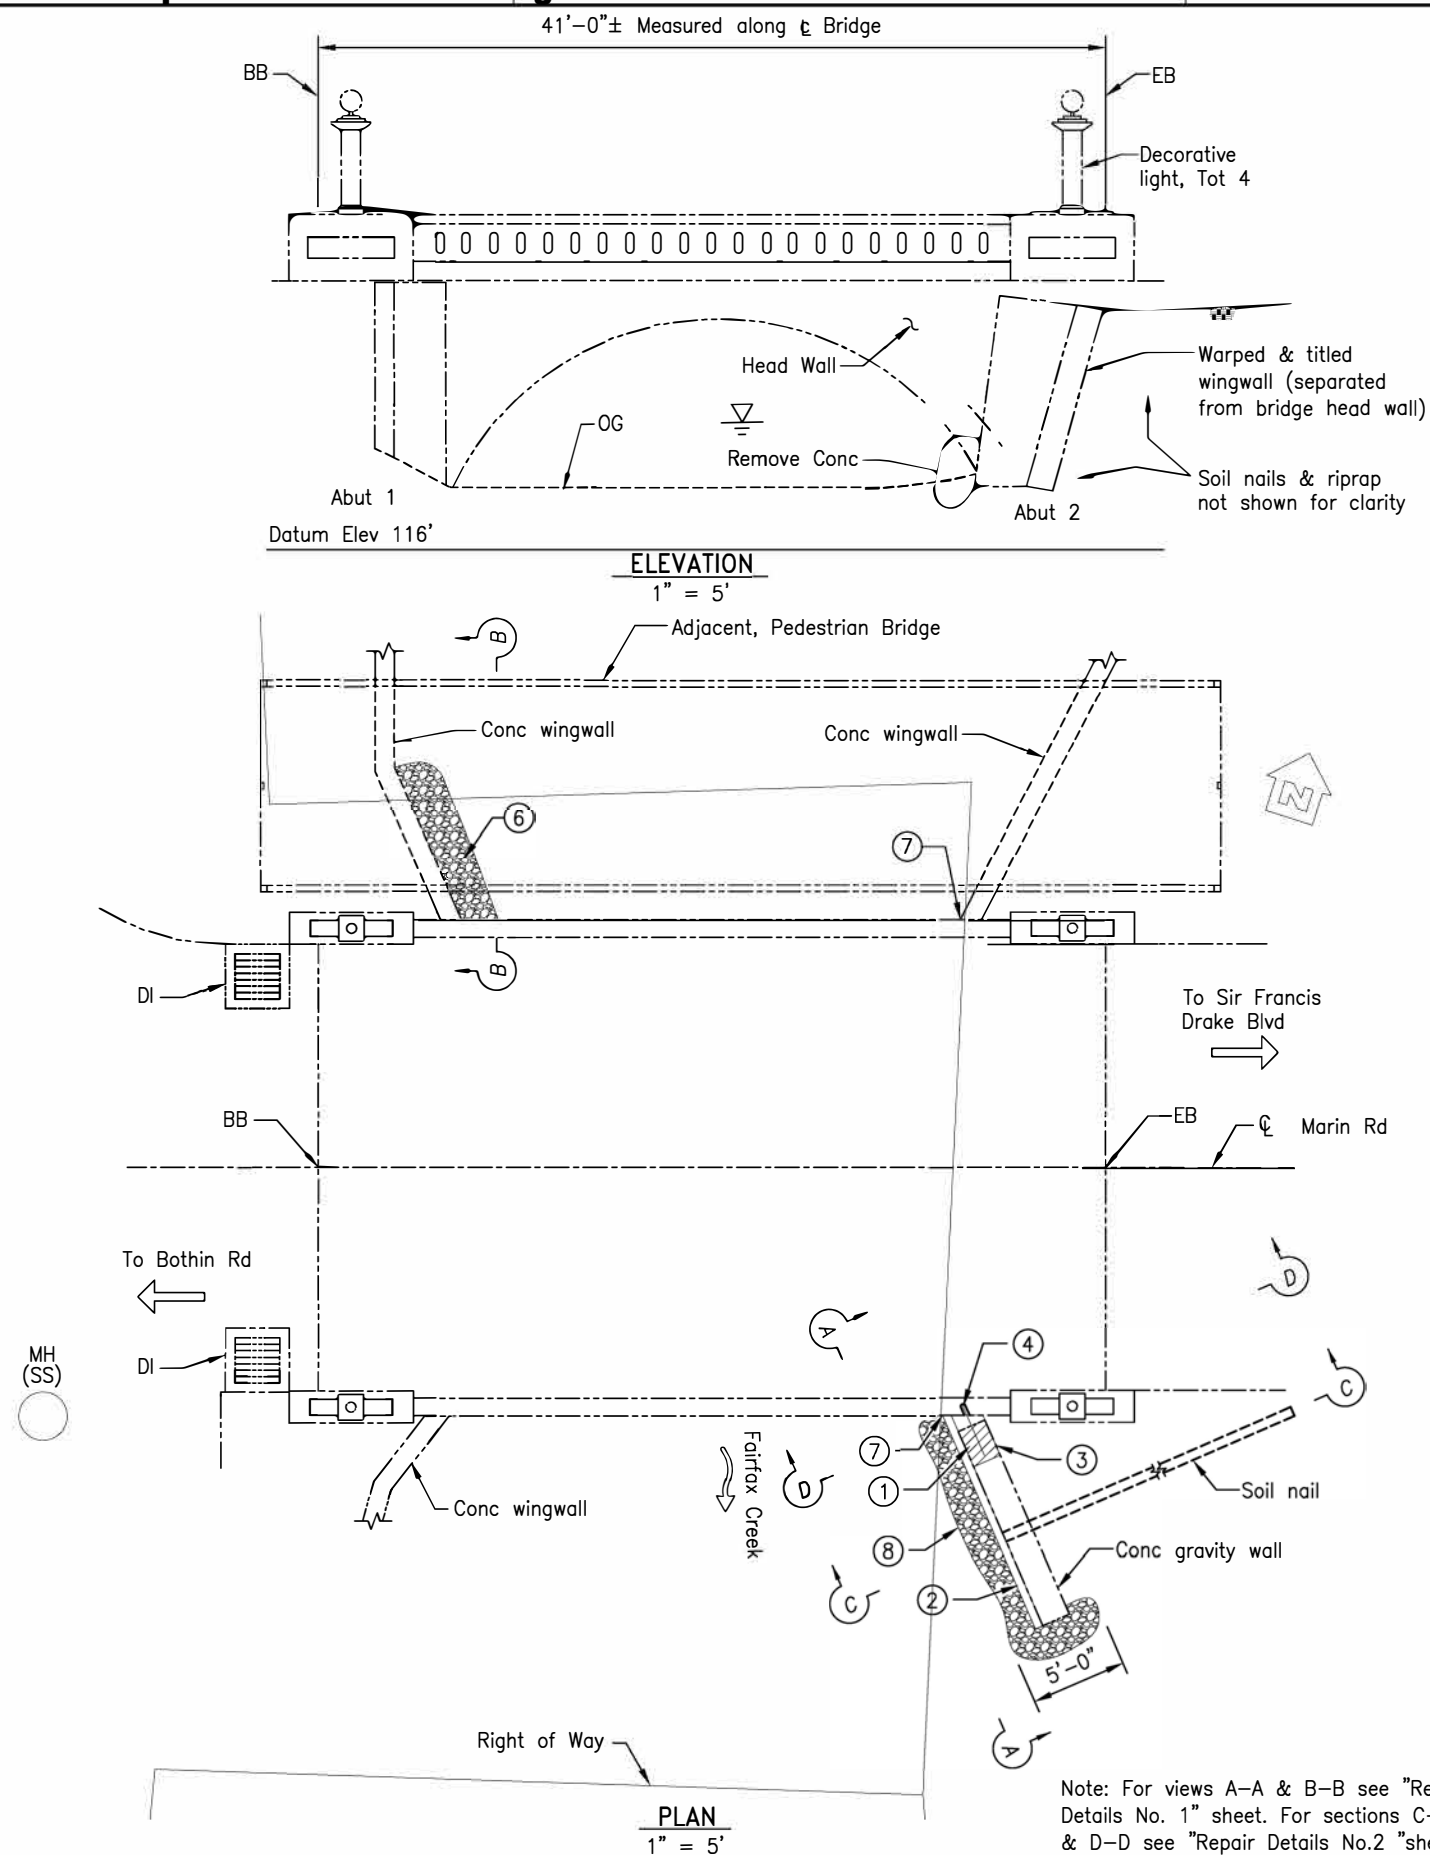
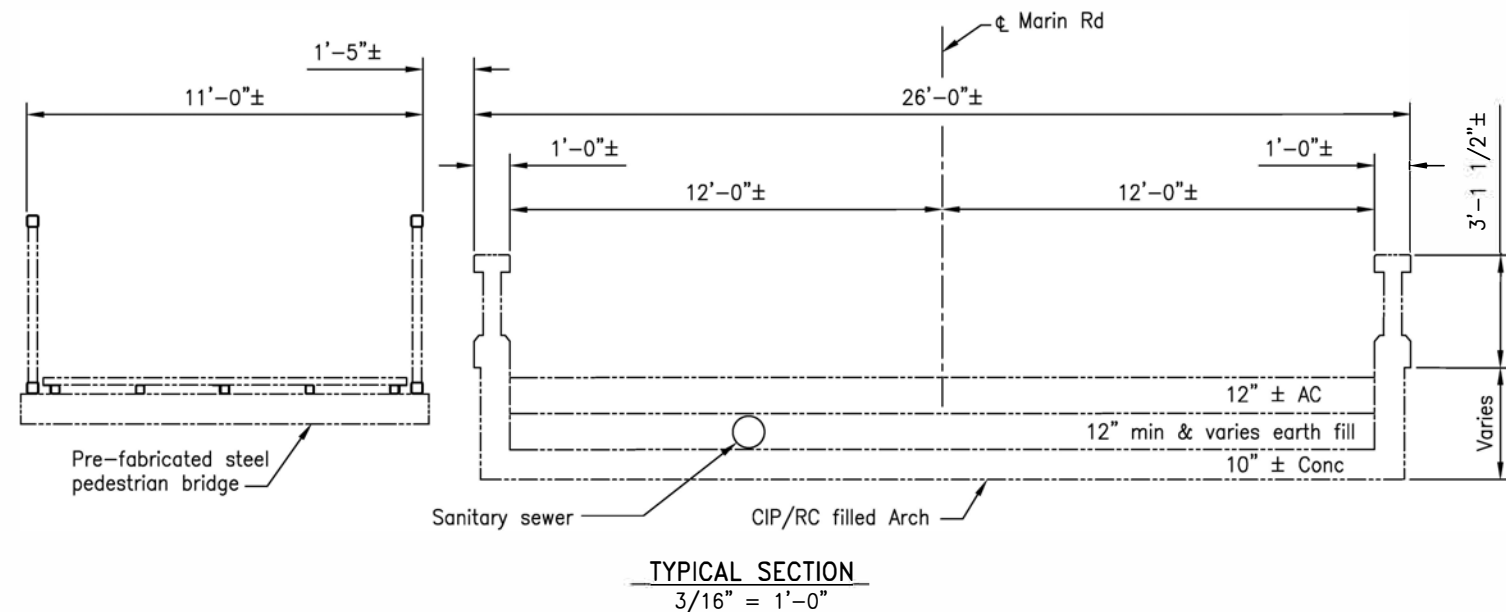
### Figure 2. Proposed Marin Road Bridge General Plan

- ### NOTES:
- ① Remove debris and portion of exist conc wingwall to construct new wall (shown hatched)
  - ② 5" air-blown conc surface
  - ③ New Conc wall addition. Attach to head wall
  - ④ Drill & bond dowels
  - ⑤ Crack in exist wingwall, fill with grout
  - ⑥ Rock riprap, 2'-0" Min below OG. Repair crack in Wingwall
  - ⑦ Repair and patch spall at abutment, Typ at bottom corners of north and abutment 2
  - ⑧ Rock riprap, extend 2'-0" min below OG

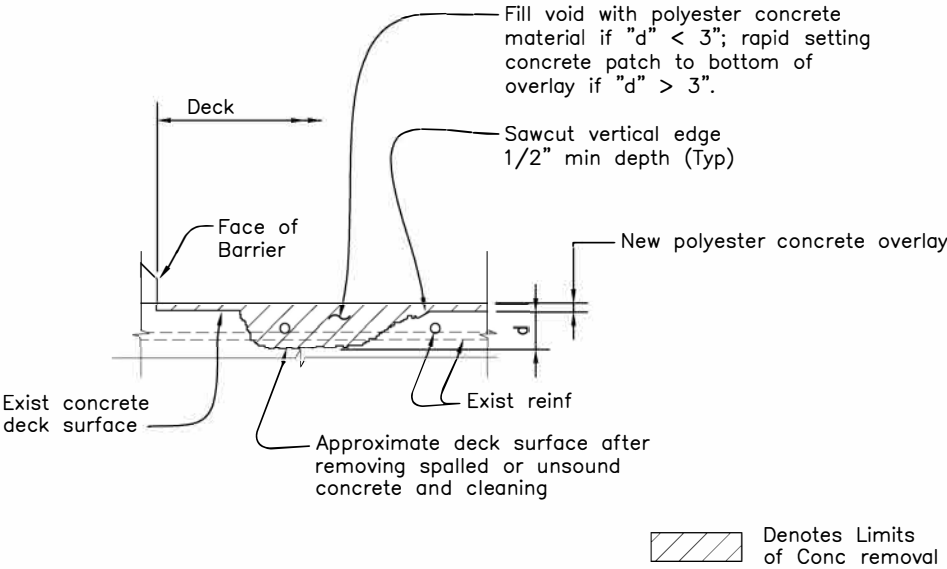
UNSDOUND CONC REPAIR DETAIL  
No Scale

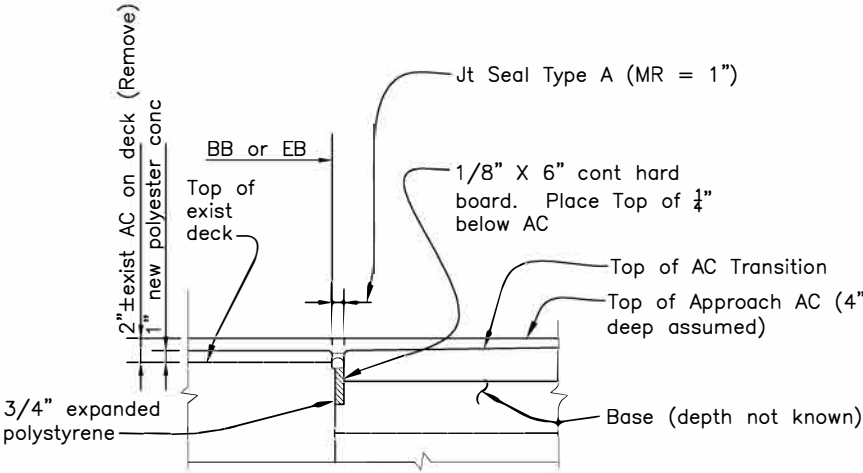
B6-21 SECTION THRU ABUTMENT - JT SEALS DETAILS  
Scale: 1-1/2"=1'-0"

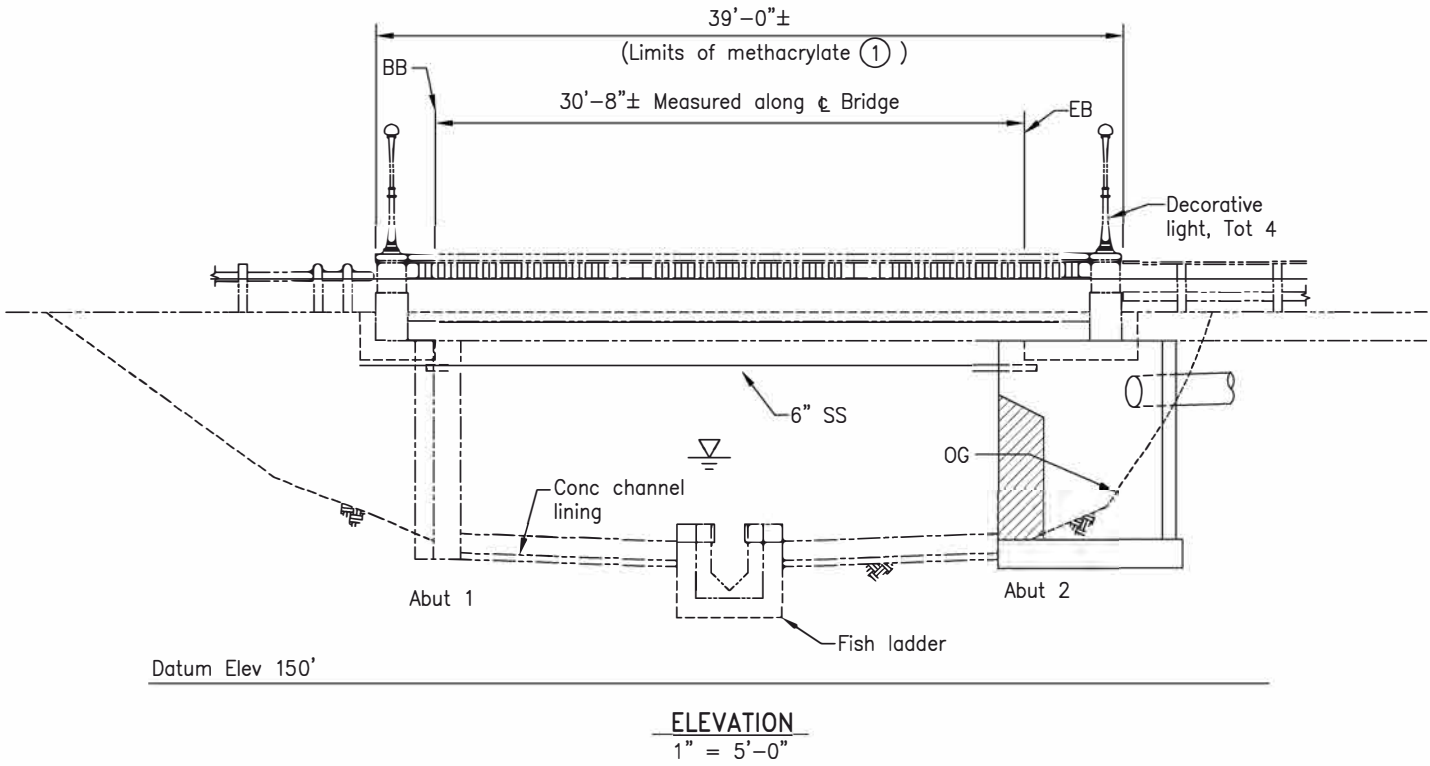
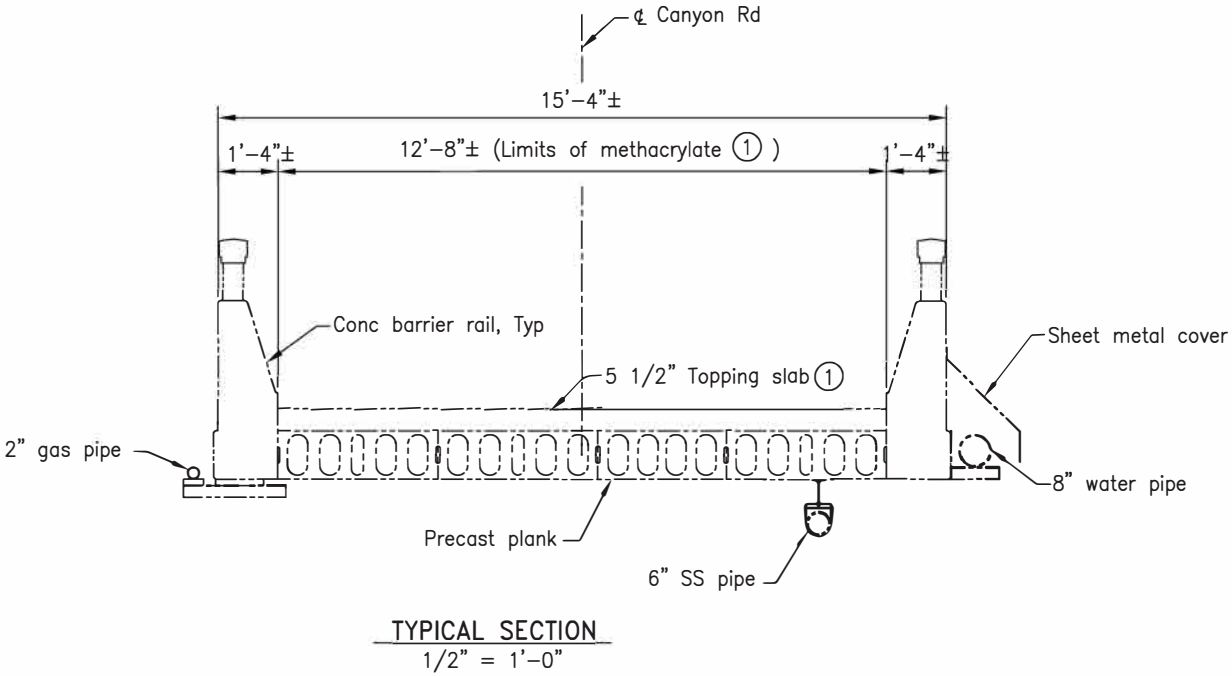
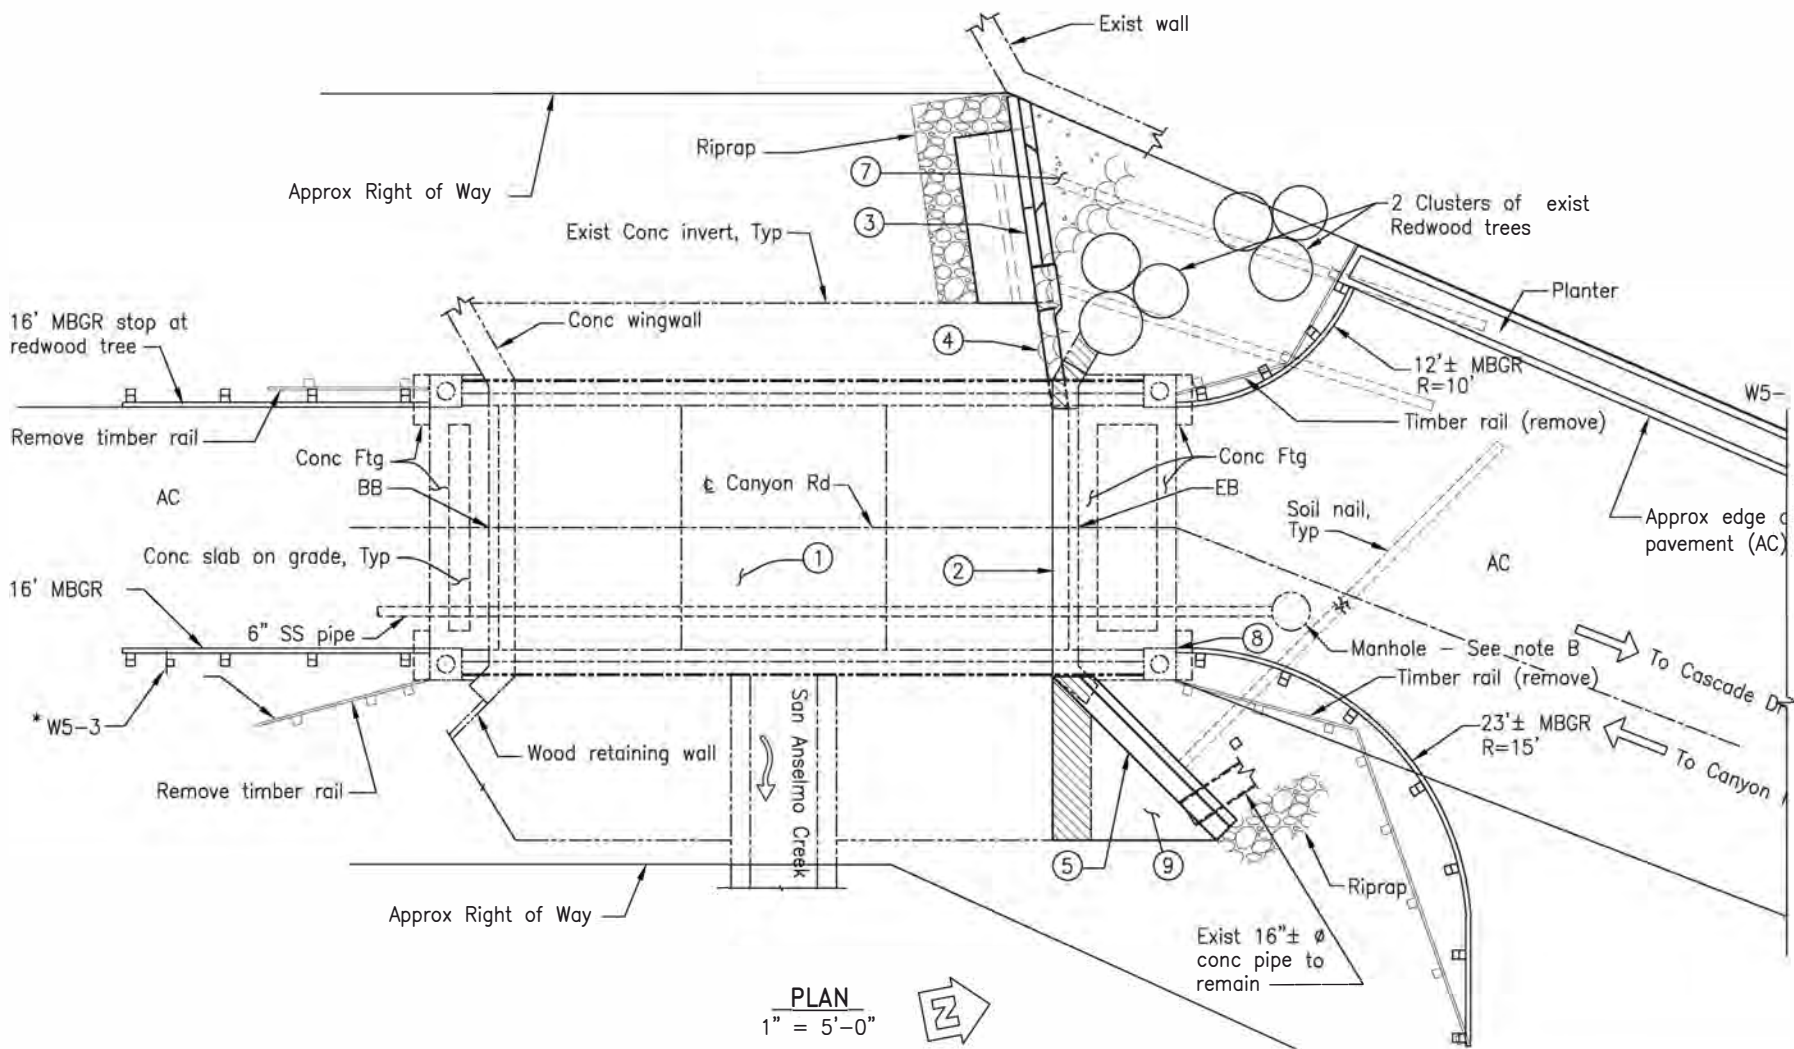
- ① Clean deck and seal entire surface with methacrylate
- ② Repair concrete surface at abutments.
- ③ New conc wall with soil nails in front of trees
- ④ Remove all exist conc bags
- ⑤ New "L" shaped conc wall with soil nails
- ⑥ Remove partial exist conc wingwall/Abut for new wall
- ⑦ Soil backfill (lightly compacted)
- ⑧ Repair spall at rail post
- ⑨ Extend conc invert to new wall as shown

The Canyon Road Bridge BPMP repairs are shown in Figure 14 and consist of the following:

- **Replacing the existing northwest wingwall:** The northwest wingwall is currently made up of stacks of solidified concrete sacks. A cluster of old redwood trees behind the wingwall is causing the wingwall to bulge, making the possibility of its collapse a hazard. The stacked concrete sacks would be removed one by one manually and hauled away. The redwood tree cluster would be exposed and protected in place during project construction. The new vertical wingwall would be an approximately 15 foot-wide by seven- to eight-foot-tall reinforced concrete wall, located a short distance in front of the redwood cluster and connected to the left edge of the existing bridge abutment. The new wingwall would be stabilized with several soil nails going through the trunks and/or roots of the redwood trees. The new wingwall surface would come to the edge of the concrete

- **Repair of the structural damage to the north abutment:** To prevent the further deterioration of the north abutment, approximately two inches of concrete on the surface of the north abutment wall would be removed manually in order to expose the rebar grip and clean the reinforcement. The concrete and dust from chipping and grinding the concrete surface would be captured and hauled away. Once the area is clean, the reinforcement grid in the wall would be covered with a new two-inch layer of special grout and finished smoothly.

- **Repair of the northeast bridge wingwall:** The short existing northeast wingwall on the right side of the north abutment would be removed and replaced with an extended wall to envelope an existing storm drainpipe daylighting adjacent to the bridge. The existing pipe discharge is eroding the creek next to the bridge. The new wingwall would be doveled into the abutment wall and angled into the creek bank, avoiding any intrusion into the current creek channel. The wingwall extension would be fortified with a couple of soil nails into the exiting bank. This wall would also have a short triangular footing in front, the top of which would be flush with the creek bed, joining with the existing invert slab. The downstream edge of the wall would be protected from erosion with a two-foot wide by two-foot-deep course of rock riprap buried into the creek bank and flush with the exposed slope. A new cable railing would be installed on top of the wall for fall protection.

- **Sealing the cracks in the bridge deck:** The bridge deck would be sealed with methacrylate, similar to Spruce Road Bridge; however, no polyester concrete would be used. Sealing of the deck would require bridge closure for approximately four to five hours, which would be completed at nighttime. In order to ensure the safety of residents during this time, a first-response crew and vehicle from Ross Valley Fire Department would be positioned on the south end of the bridge for any emergency situations. Secondly, the bridge would be opened for crossing by covering the sealing agent with plywood if an emergency crossing is needed during the short duration of bridge closure. Prior notifications would be sent to the neighborhood to inform them of the work schedule and details.

- **Installation of safety signage and guard railings:** Two narrow bridge signs would be installed at each approach to the bridge to enhance safety over the crossing. The existing wooden approach railings at all four corners of the bridge would be replaced with metal beam guard railings.

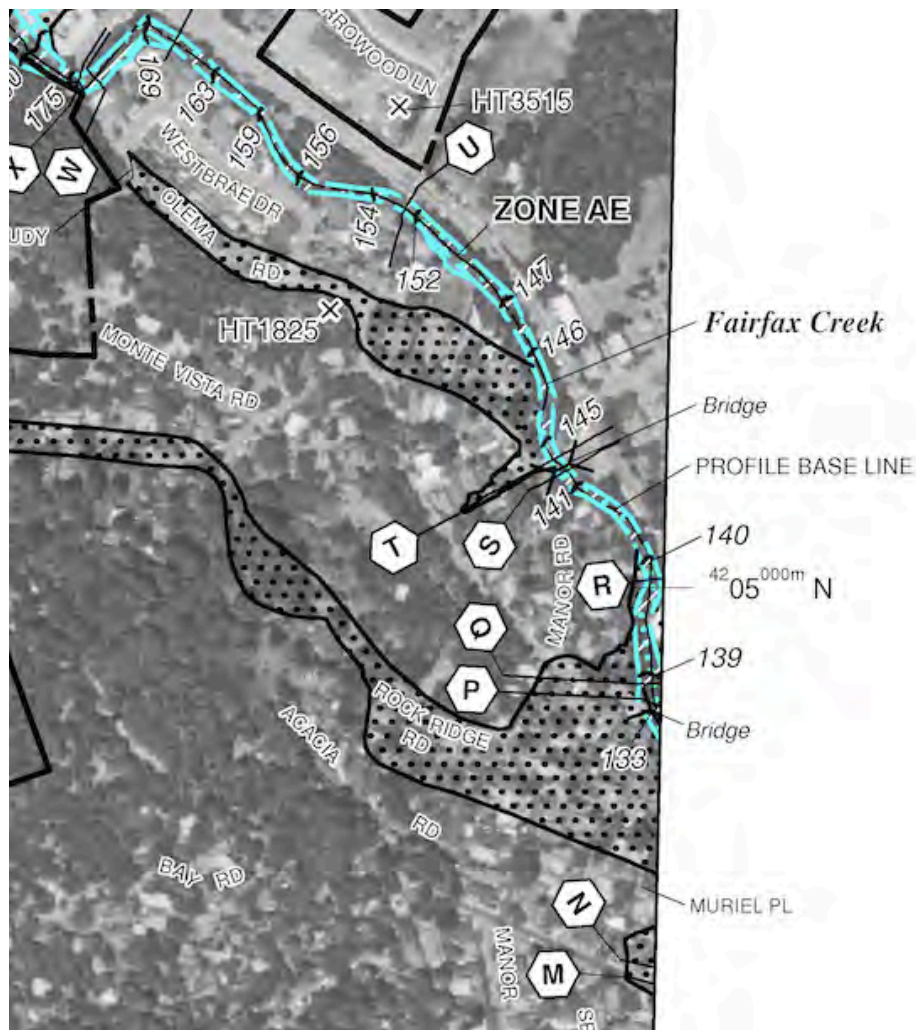
Figure 2 – Excerpt from 2014 FEMA FIRM Panel 451 showing the regulatory floodway and Special Flood Hazard Areas (SFHAs) in the vicinity of Marin Road Bridge Site.

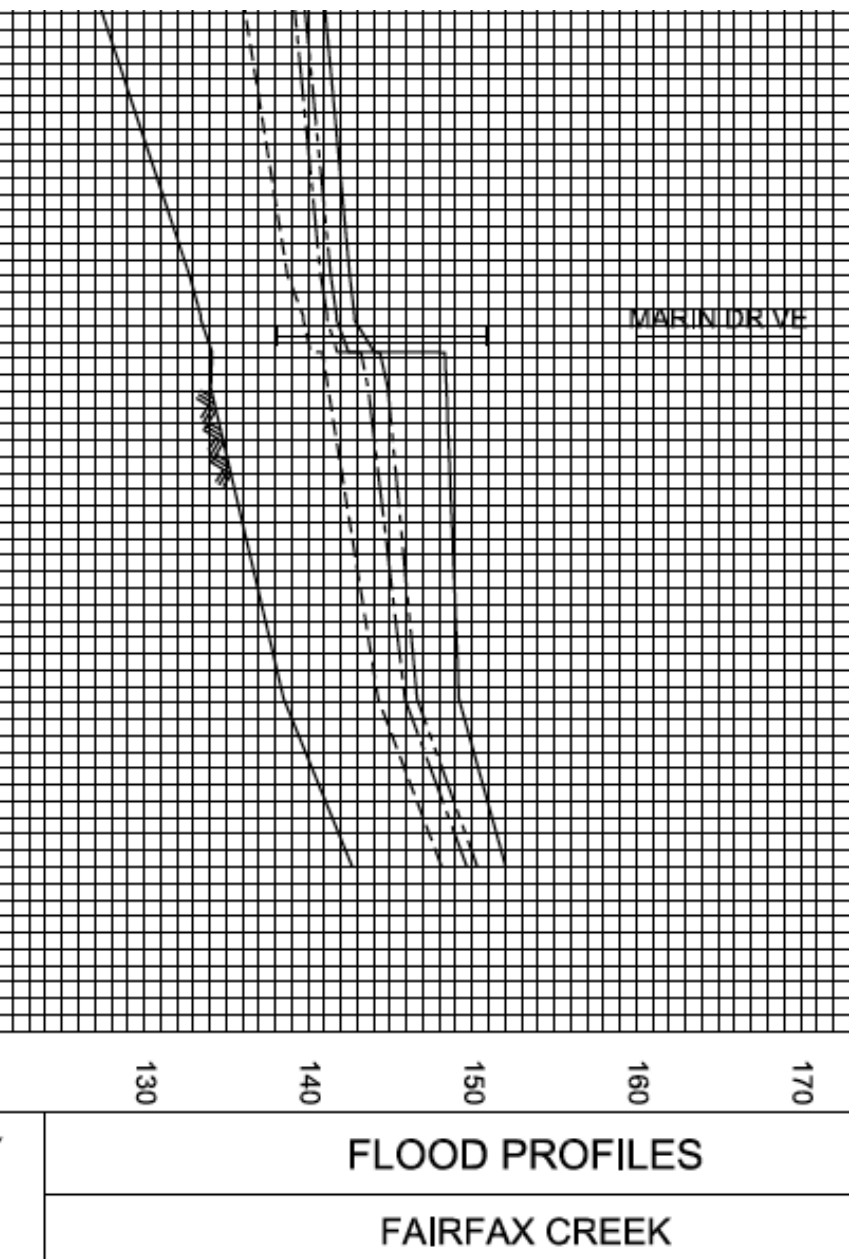
For the purposes of this analysis, it is presumed that the FEMA contractors applied design discharges for the reach including the site were 1,450 cfs (1977) and 1,511 cfs (2014) – the peak flow values estimated for a location immediately upstream from the Bothin Creek tributary mouth where the drainage area is about 2.81 square miles.

**Figure 3 – Excerpt from 2014 FEMA FIS Flood Profiles (p. 121 of 123) showing calculated 0.2-, 1-, 2- and 10% annual chance flood water surface elevation profiles upstream and downstream from the Existing Conditions Marin Road Bridge (Elevations NAVD88 datum).**

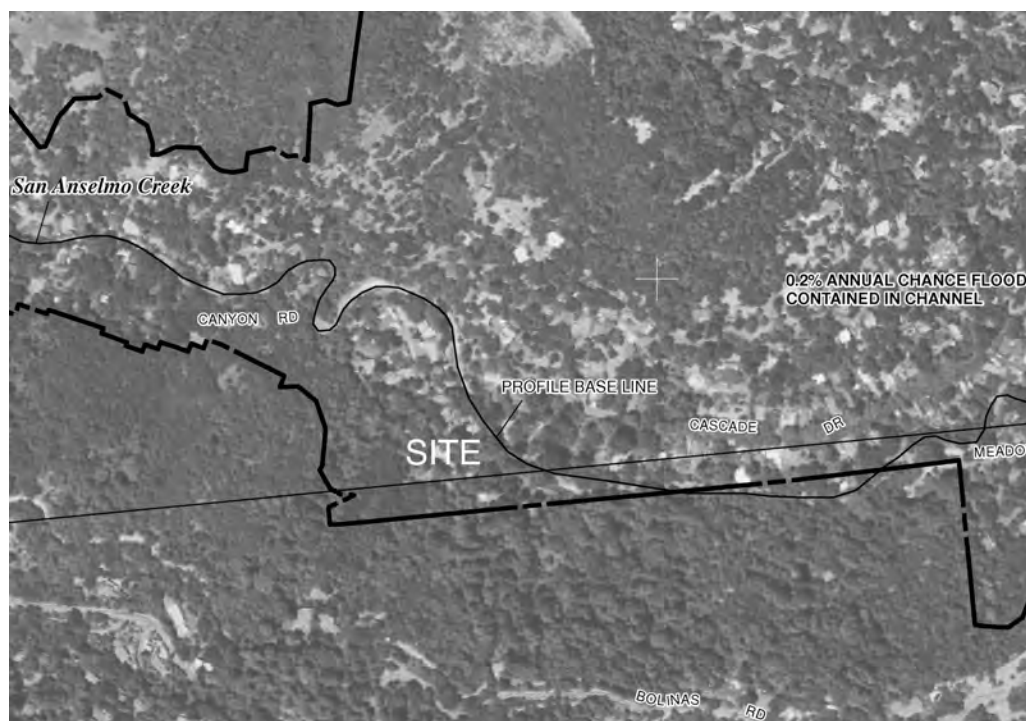
**Figure 2 – Excerpt from 2014 FEMA FIRM Panel 451 showing that the 0.2% annual chance flood is contained in the San Anselmo Creek channel upstream and downstream from the site.**

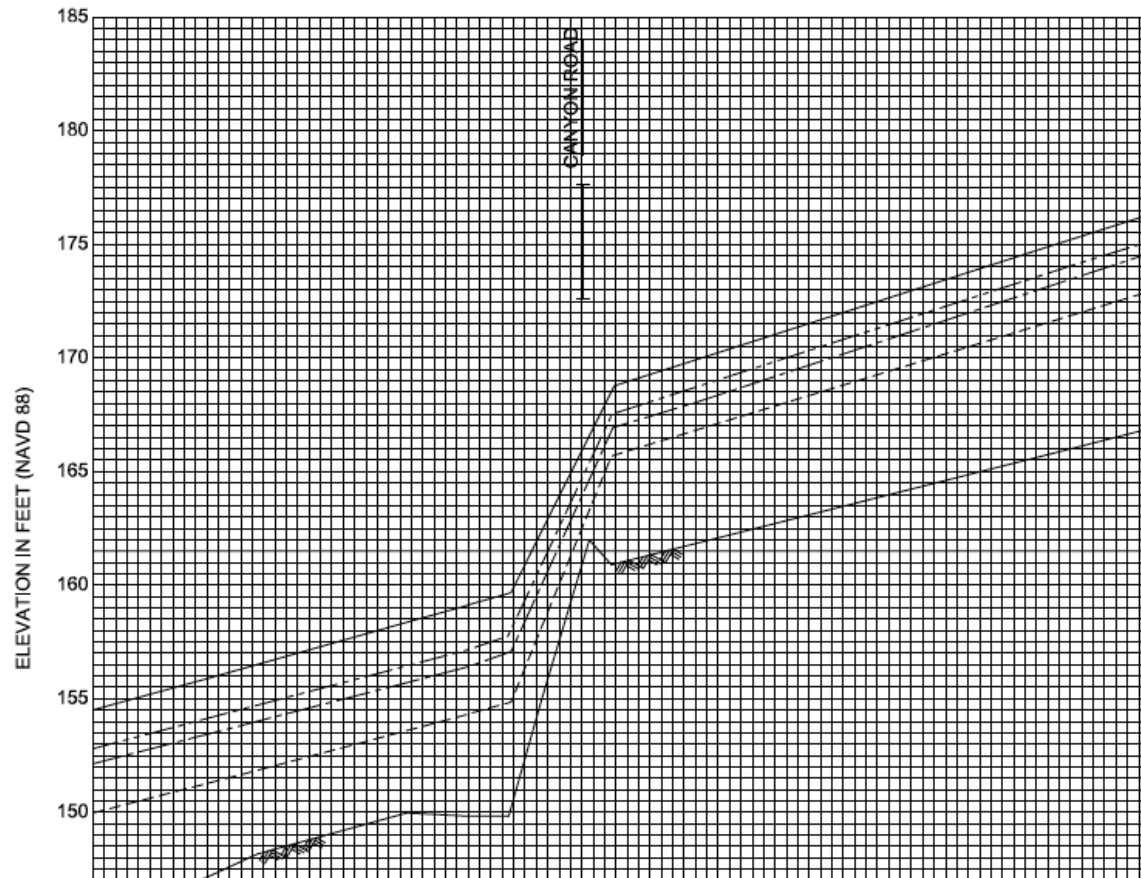
**Figure 3 – Excerpt from 2014 FEMA FIS Flood Profiles at p. 81P(c) showing calculated 0.2-, 1-, 2- and 10% annual chance flood water surface elevation profiles upstream and downstream from the Existing Conditions Canyon Road Bridge (Elevations NAVD88 datum)**
