# Proposed Meadow Way Bridge Project

## Natural Environment Study

Meadow Way Bridge

Bridge Number: 27C-0008

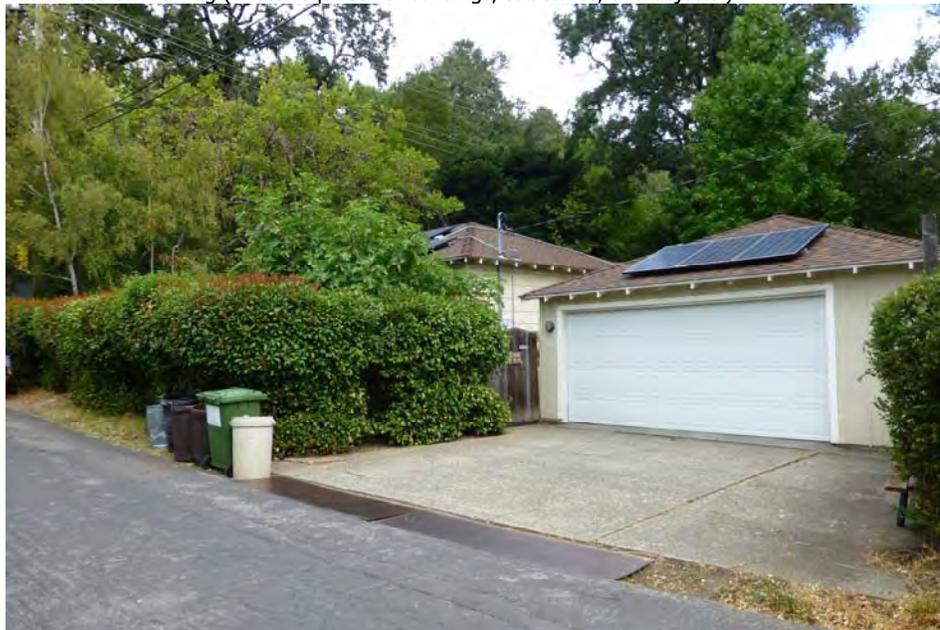
**P5b. Description of Photo:** (View, date, accession #) **Photograph 1: East side of residence and south side of garage, facing north September 20, 2017**

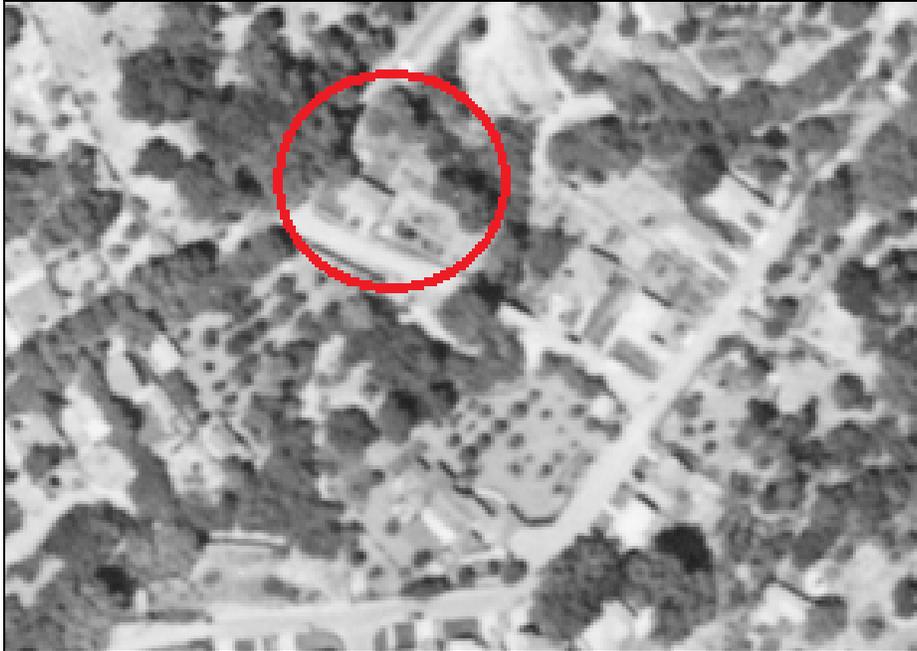
**Plate 1:** 1952 aerial showing original configuration of the residence.<sup>18</sup>

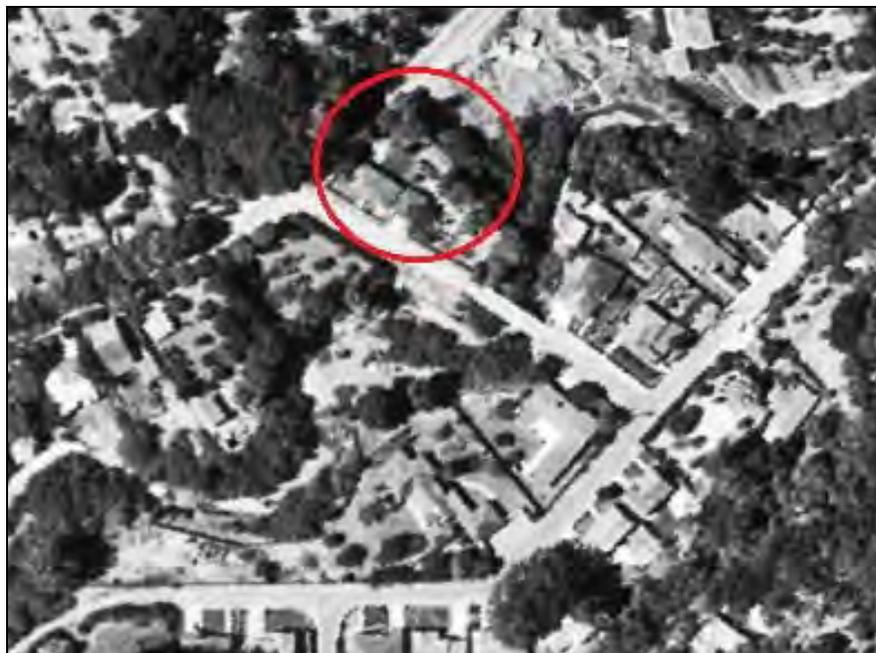
**Plate 2:** 1957 aerial showing construction of garage.<sup>19</sup>

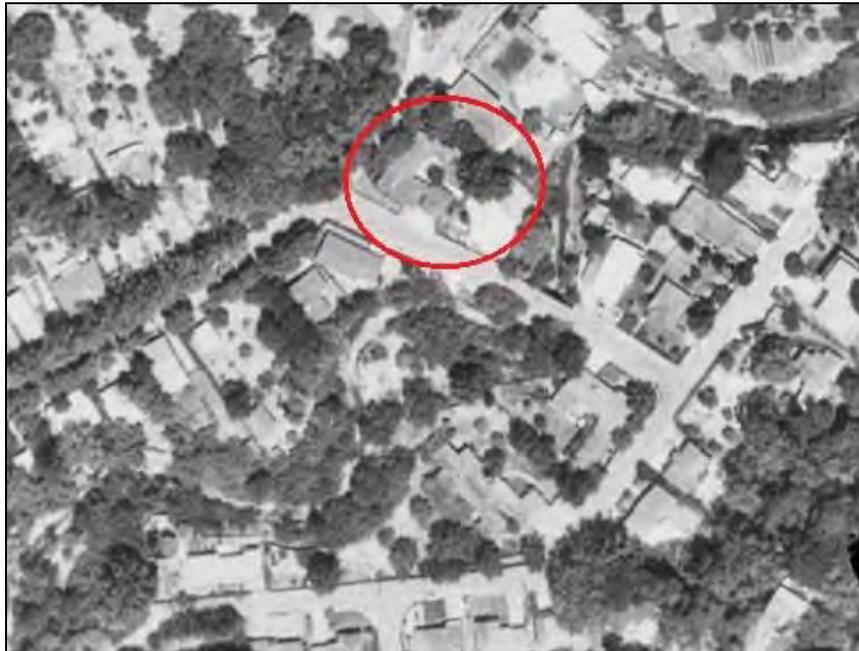
**Plate 3:** 1965 aerial showing additions to residence to present configuration.<sup>20</sup>

While the integrity of location, setting, workmanship, feeling, and association remains intact, the property's historic integrity of design has been diminished through the construction of the detached garage and the large addition to the residence. However, regardless of integrity, the property lacks historical and architectural significance and does not meet the criteria for listing in the NRHP or CRHR.

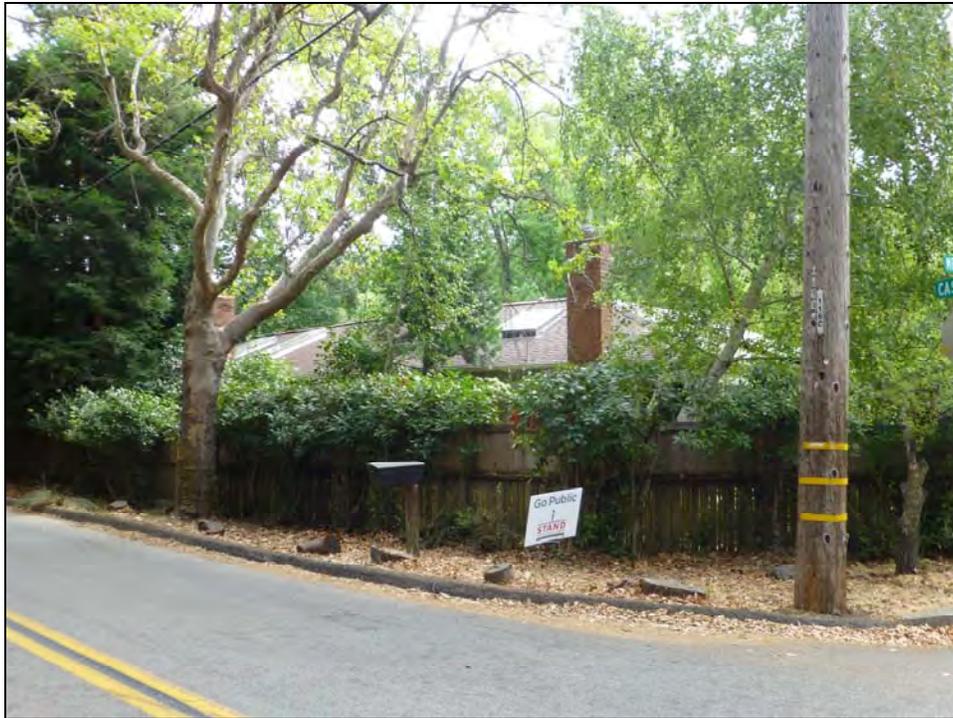
**Photograph 2:** West side of residence, showing two external chimneys and skylights, facing northeast, September 20, 2017.

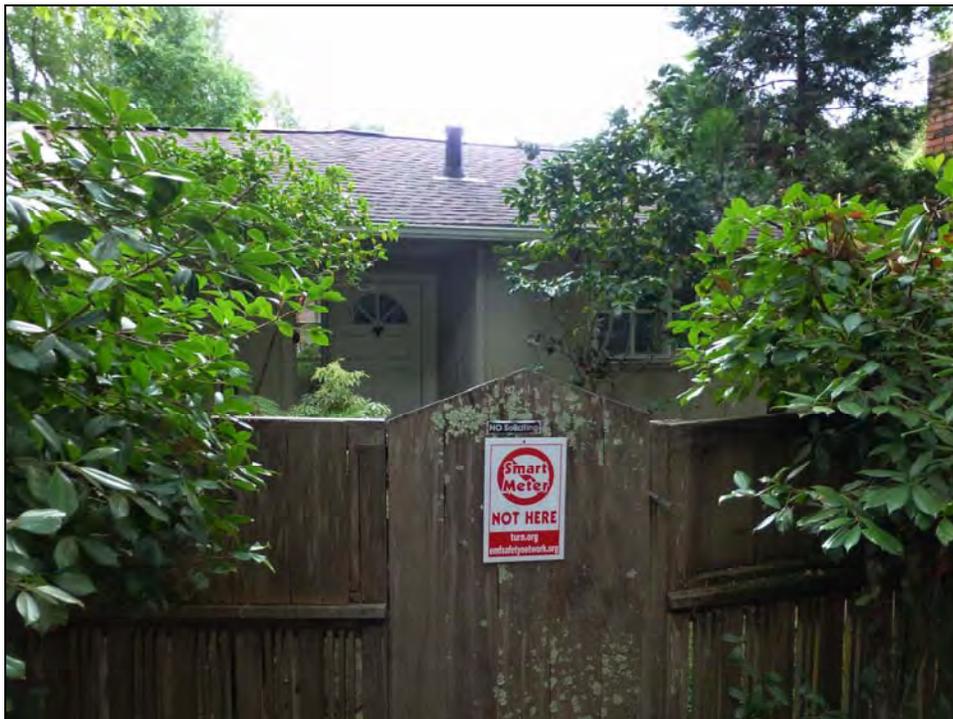
**Photograph 3:** Detail of entry on west side of residence, facing east, September 20, 2017.

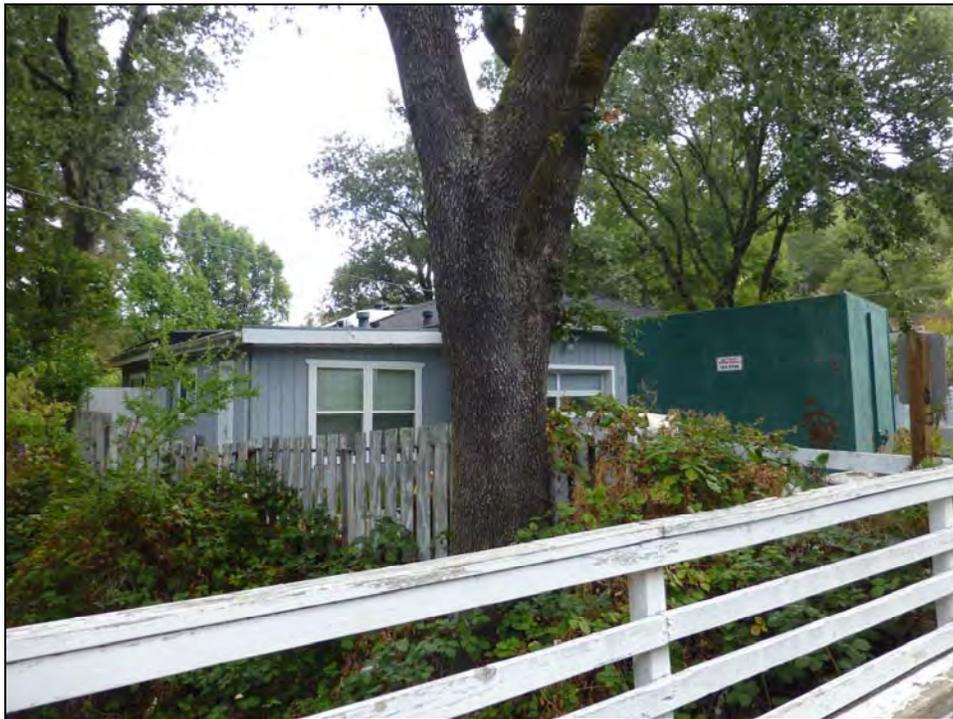
**Photograph 2:** North and west sides of residence, with addition on far left, bridge rails in foreground, facing northeast, September 20, 2017.

This residence has been altered with the construction of the shed roof addition along the west side, as well as replacement siding. These changes have diminished the property's historic integrity of design, workmanship, and materials. While the residence's integrity of location, setting, feeling, and association remains intact, however, it lacks historical and architectural significance and does not meet the criteria for listing in the NRHP or CRHR.
