# ASSESSMENT REPORT – FAIRFAX BRIDGE PREVENTIVE MAINTENANCE PROGRAM

Submitted to the Town of Fairfax  
Department of Public Works  
January 14, 2014

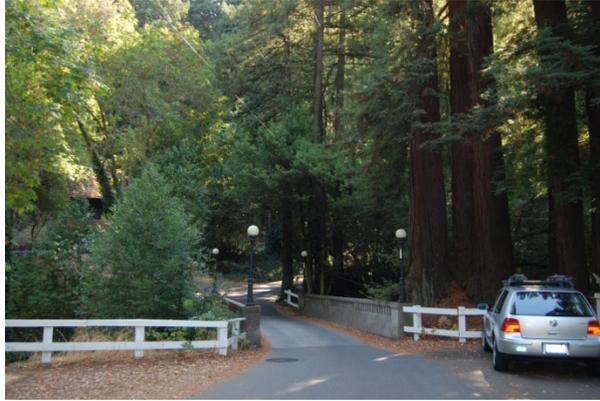
Figure 1- North entrance to the bridge

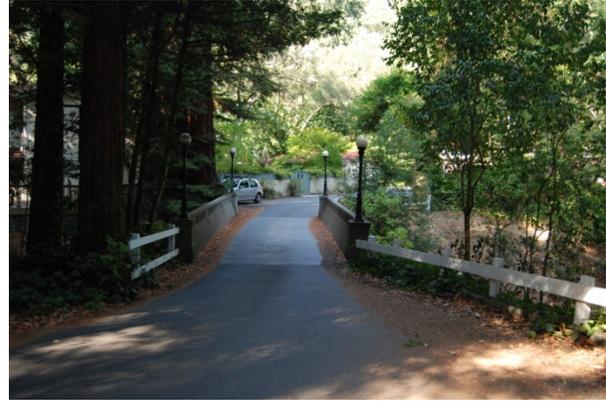
Figure 2 – South entrance to the bridge

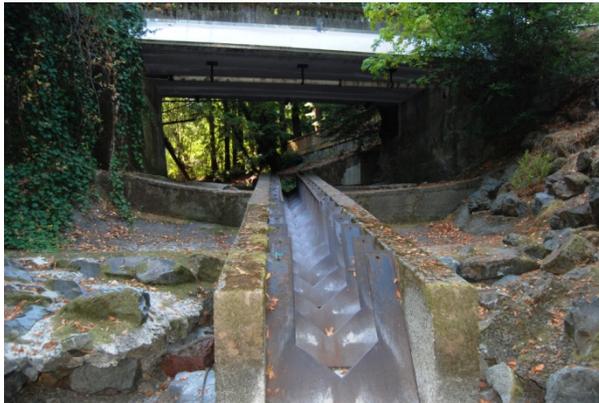
Figure 3 – Fish ladder running under the bridge

The Creek bank slopes up- and downstream of the structure are variable and a low-flow channel and modest terracing is apparent. The bank slopes exhibit an average inclination of about 1:1 (horizontal to vertical) with locally steeper areas, and are vegetated with scattered mature trees, grasses and ivy. Bedrock is not exposed in the creek channel in the immediate vicinity of the bridge but it is apparent in a very steep eroded slope approximately 100 yards downstream. Grouted rip-rap and a few gabion baskets are located at the downstream end of the concreted channel bottom as noted above. A Denil-type fish ladder structure (originally developed by a Belgian scientist in 1909) was installed in the 1970s or 1980s by a fishery conservation organization. The ladder does not function optimally for fish passage according to current passage suitability criteria (Ross Taylor and Associates, 2006). The concrete invert under the bridge from the fish ladder extends a few feet upstream and approximately 50 feet downstream where it transitions to rock rip rap and other armoring. Since the creek bed is concrete lined for the fish ladder, scour at the bridge is not an issue and the bridge was not deemed necessary for inspection as part of the 2010 Caltrans/FHWA Scour Plan of Action Program. However, undermining of the apron downstream from the bridge does threaten the local stability of this invert apron (but not the bridge). Please see photos 3 and 4 on page 7.

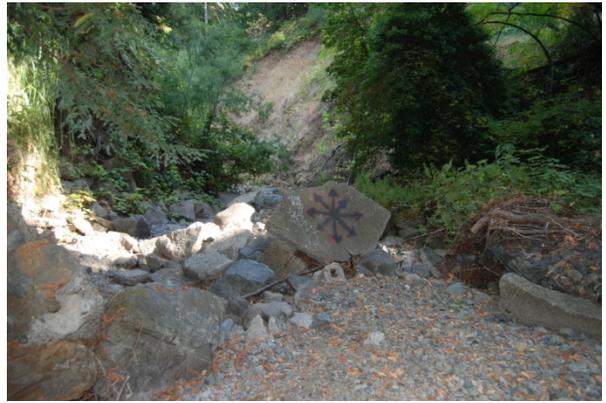
Figure 4 – Immediately downstream of fish ladder

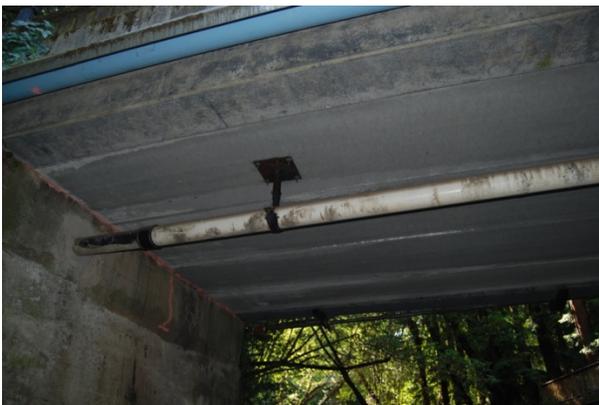
Figure 5 – Utility pipe hung from bridge soffit

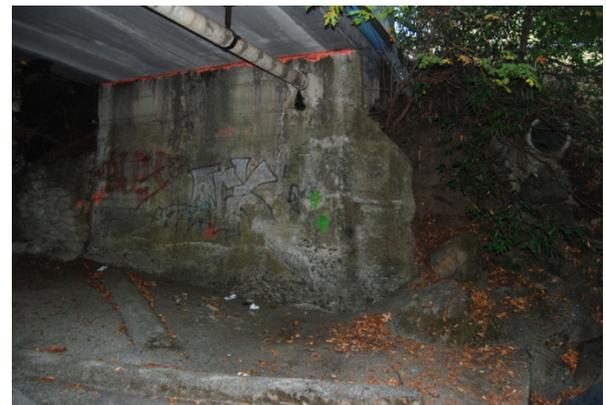
Figure 6 – North abutment face

- Removal of a portion of the north abutment wingwall, both downstream and upstream, to construct new concrete walls with soil nails. For the upstream concrete wall, removal of the existing concrete bags and backfilling with rock and soil is required to contain the redwood tree. A team arborist will be rendering professional opinions as to the proper approach to working around this tree.
- Repair the concrete surface at left abutment (looking downstream) by applying a 4"-thick layer of air-blown concrete (or shotcrete).
- Repair minor superstructure spall located at the northeast rail post.

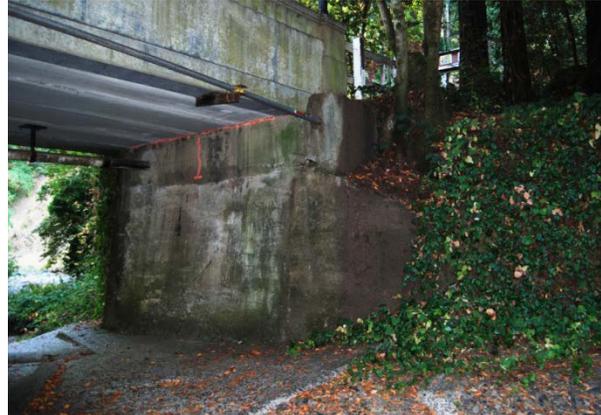
Figure 8 – South abutment looking downstream

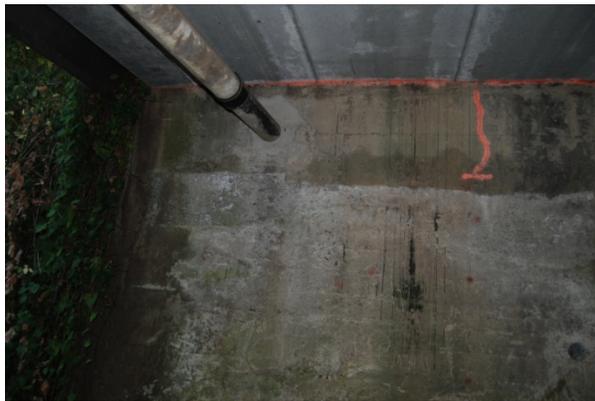
Figure 9 - Close up of south abutment face

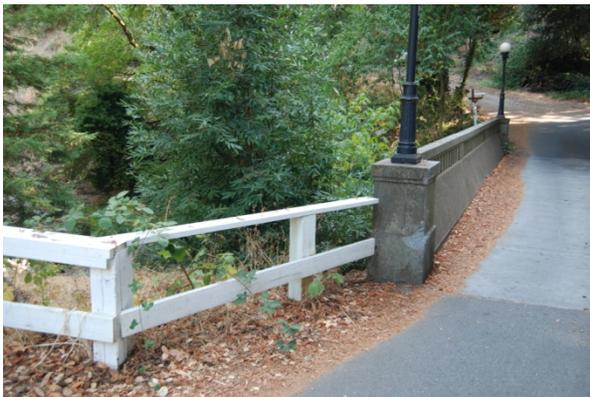
Figure 11- Substandard right approach guard rail at n. abutment

The above improvements are shown on the Bridge Plan and Elevation attached and expected to take approximately three weeks to complete during construction. Two additional items concerning safety should be discussed here. The approach guard railings at each end of the bridge are made of light wooden beams. This is substandard and hazardous even considering the low auto speeds crossings the bridge. CIC recommends replacing the unsafe timber approach rails with standard crashworthy metal beam guard rails. The metal rails may be made of the Corten steel if the residents find the shiny galvanized look unsuitable for the natural bridge setting. This type of steel develops a controlled protective cover of rust on itself, which the residents may find to complement the natural surroundings better. Posting of two Narrow Bridge signs near the north and south approaches to the bridge will also be a good precautionary measure. The construction cost estimate for these items is \$4,500. This cost not covered by BPMP and Caltrans/FHWA considers it "non-participating," but it's a relatively small cost and will be a wise investment in bridge safety by the Town of Fairfax.

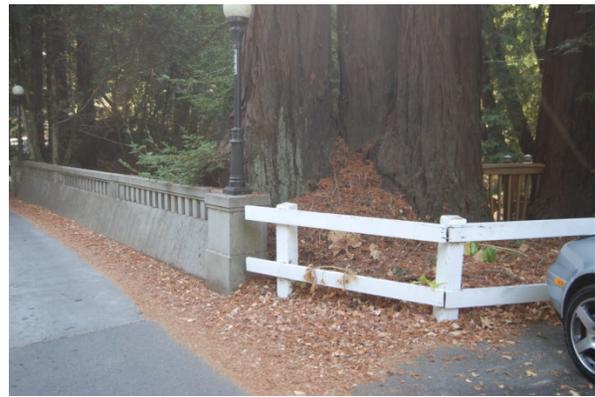
Figure 12 – Substandard right approach guard rail at n. abutment. Note the large redwood tree in the back.

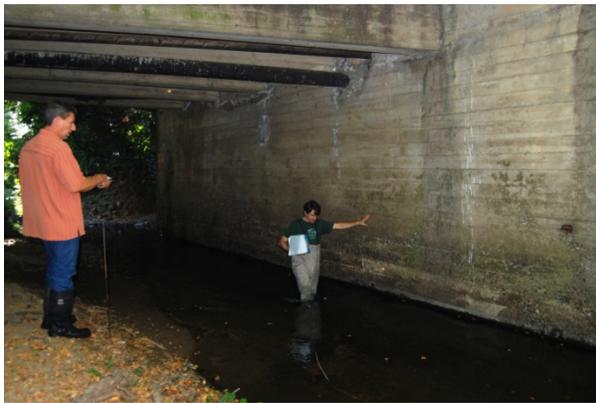
Figure 2 – Inspecting for bridge scour in 2010

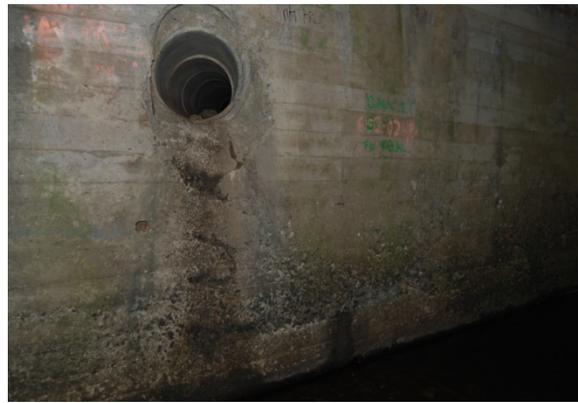
Figure 3 – Storm drain daylighting through abutment

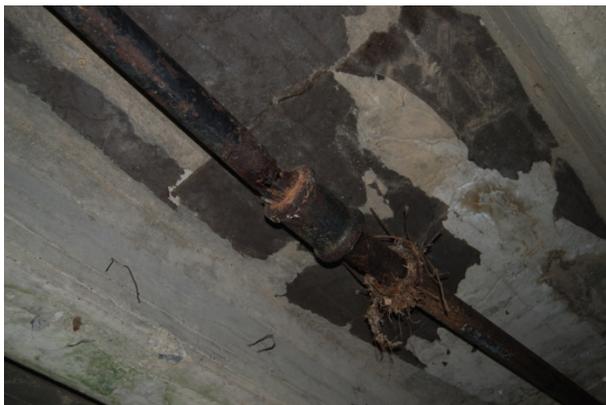
Figure 4 – Utility pipes tucked under the bridge

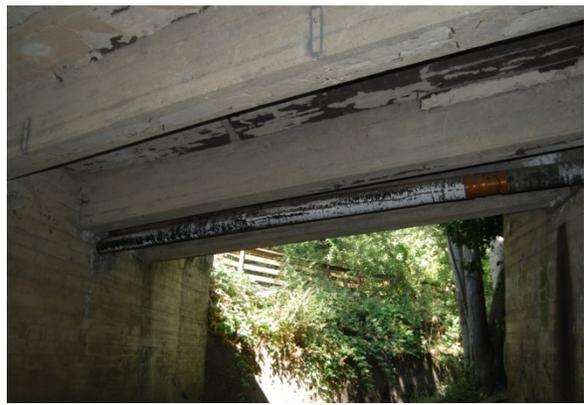
Figure 5 – Relatively small flow opening thru the bridge

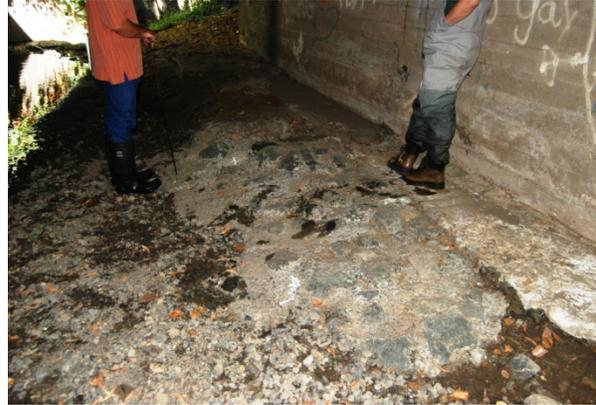
Figure 8 – Presence of bedrock under the bridge

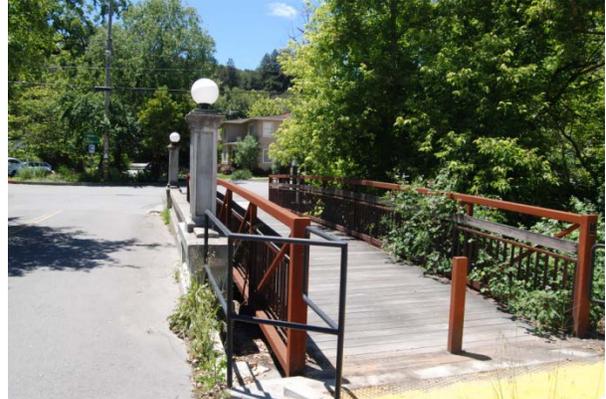
Figure 7 – Looking south at west side of bridge and the adjacent pedestrian bridge

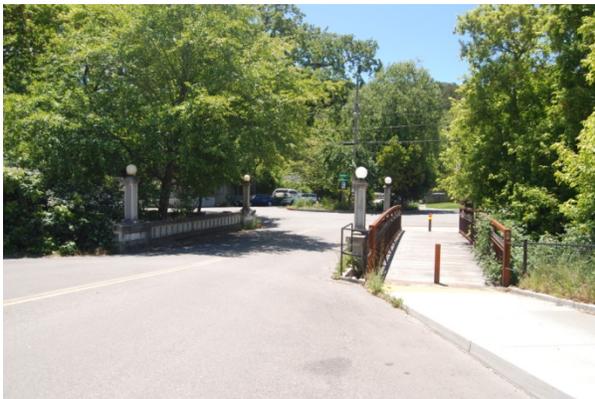
Figure 3 – Looking south at street level

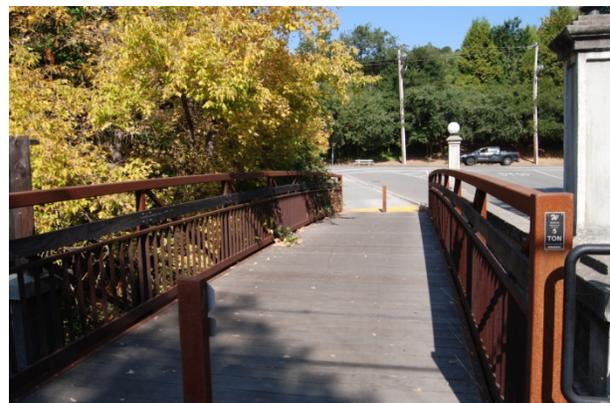
Figure 6 – Looking north at the pedestrian bridge

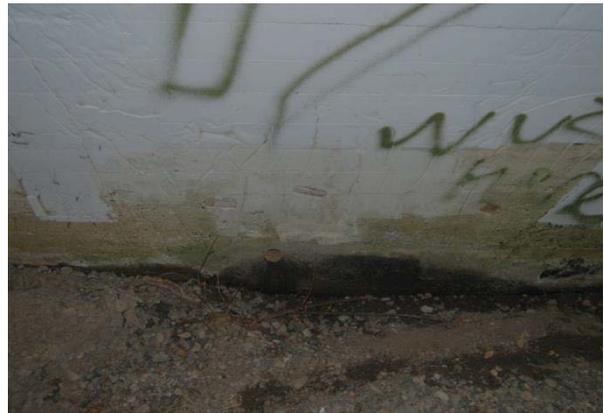
Figure 10– South base of the arch barrel

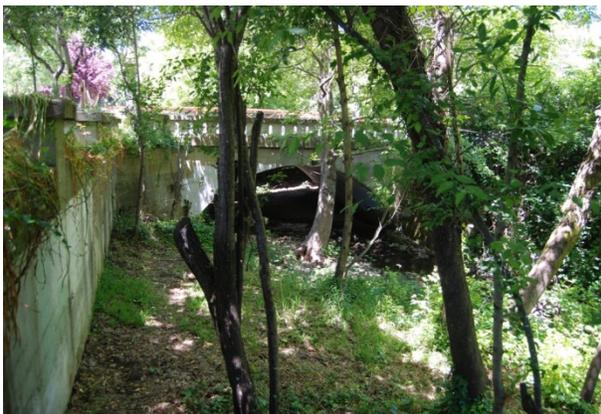
Figure 11 – Looking west at the bridge (upstream)

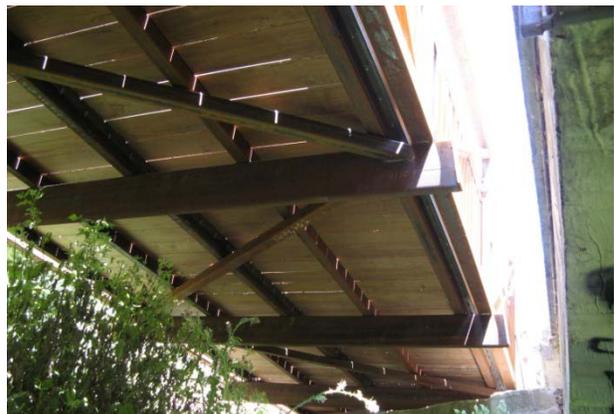
Figure 12 – Underside of the pedestrian bridge
